MINISTRY OF TRANSPORT

RAILWAY ACCIDENTS

REPORT ON THE COLLISION

**23rd November 1959 at
SLADE LANE JUNCTION
LEVENSHULME**

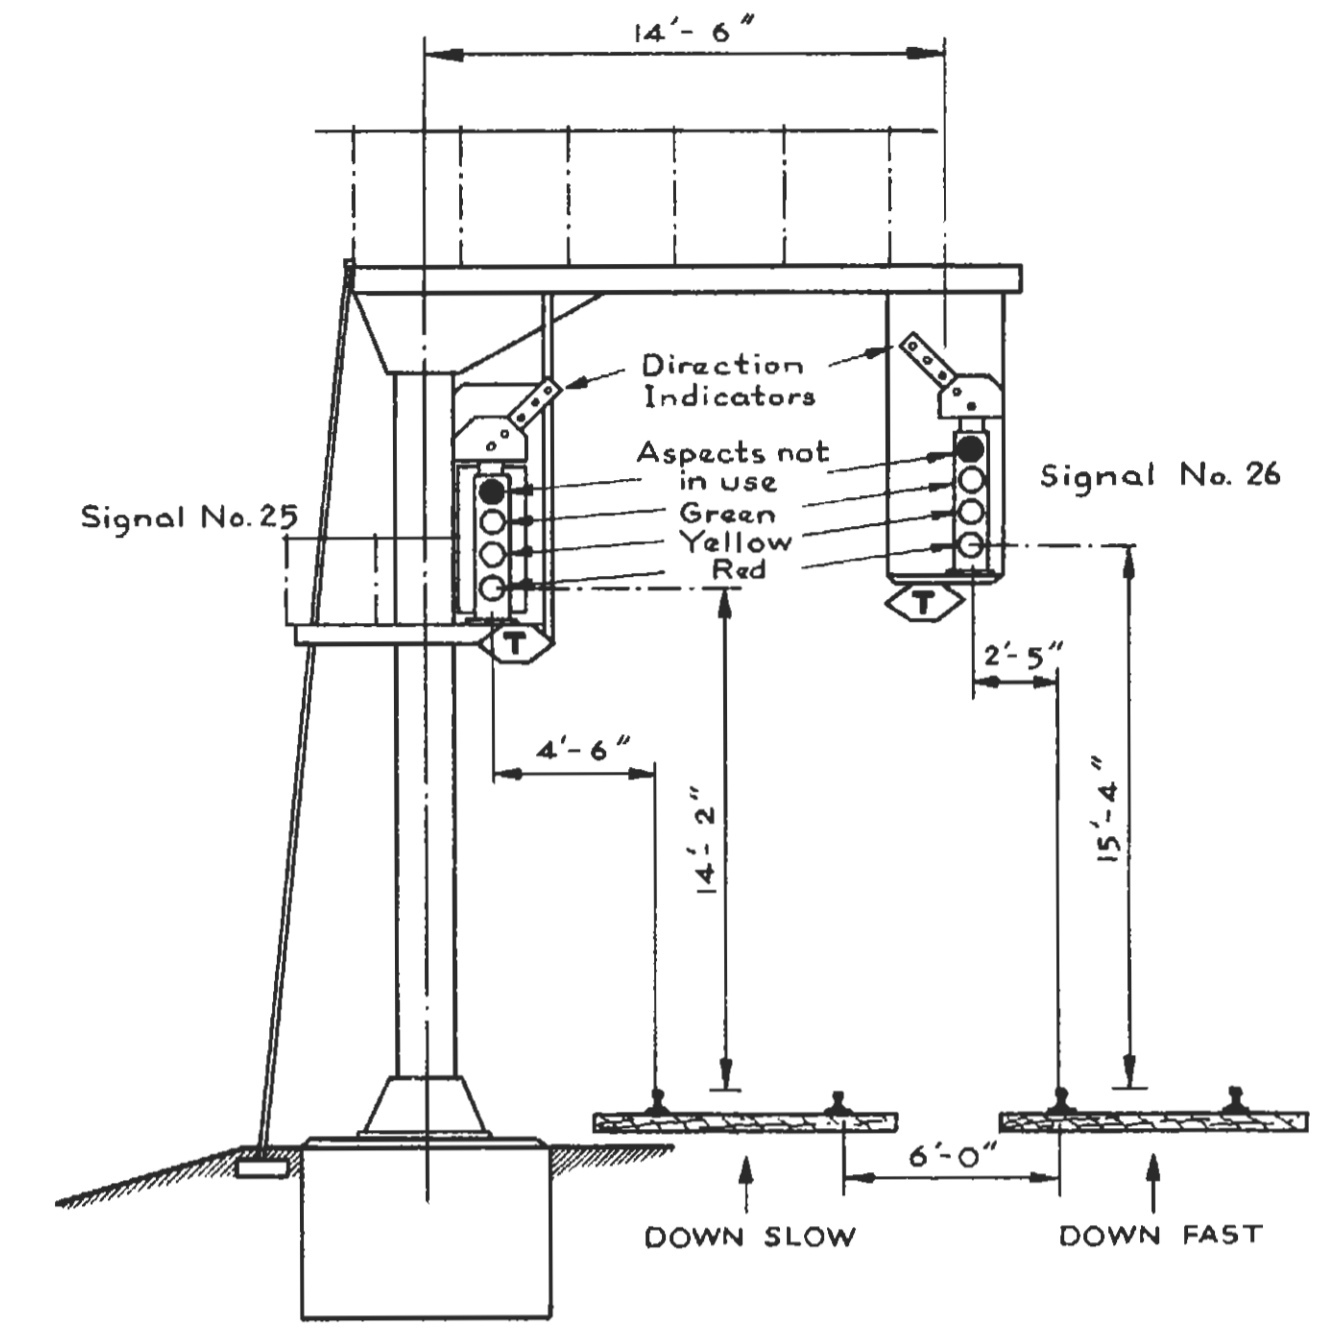
FIG. 3
SLADE LANE JUNCTION
SIGNALS No. 25 & 26
SCALE: 8 FEET TO 1 INCH

Figure No. 3 shows signals No. 25 and 26 which are respectively the Down Slow and Down Fast home signals, and which protect the converging junctions between these lines and the junctions between the main and branch lines. In clear weather these signals can be seen with ease from the Manchester end of the Levenshulme platform at a distance of about 350 yards. The signals are provided with direction indicators, the indicator on No. 25 being to the right and that on No. 26 being to the left.

All the signals are designed as four-aspect colour lights but at the time of the accident the fourth (double yellow) aspect of signals No. 25 and 26 had not been brought into use, because the signals next ahead, at Longsight No. 1 box, were semaphore home signals, and signals No. 25 and 26 were acting as distants to them. The direction indicators on these signals, which were at the time controlled from Slade Lane box, each consist of a diagonal horn with five white lights which become illuminated when the signal is cleared for a crossover movement. (Note—when illuminated a direction indicator is sometimes referred to by drivers as a “feather”). Signals No. 15, 17 and 21 on the Down Slow and No. 22 on the Down Fast are also controlled signals, while Nos. 16 and 18 on the latter line work automatically. At the time of the accident all train movement through Slade Lane Junction was controlled by a route relay control system of the “One Control Switch” type in the signal box; this system was installed in November 1958.

It seems quite evident that Driver Newton saw the Down Fast line signal No. 26 become clear for the Pines express, and that he took it to apply to his train on the Down Slow line. I have endeavoured to assess the position of the diesel train at that time by calculation, but I have found that there is insufficient data. For one thing the position of the express at that time is by no means certain. Taking all the evidence on this point into account I think that the diesel train had travelled probably only about 100 yards beyond Levenshulme when signal No. 26 was cleared, after which both signals No. 25 and 26 would have remained in Newton's view, and more or less directly ahead, for some 25 seconds. It is therefore extremely difficult to understand how he could have failed to see the bright red light of the Slow line signal No. 25, and why he thought that he saw that signal at yellow with a right hand direction indicator when in fact it was red and signal No. 26 was green with a left hand indicator. A medical examination showed that he is quite fit and that his eyesight and colour vision are normal. As Brigadier C. A. Langley mentioned in his Annual Report for the year 1958, the British Transport Commission are undertaking a special investigation into human failures of this nature, with the co-operation of the Trade Unions and with the assistance of the Medical Research Council, and the facts of this case have been made known to the latter.

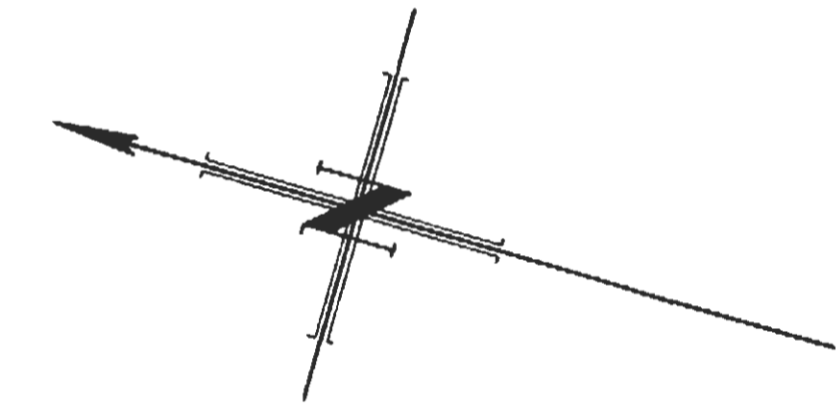
FIG. 2 GENERAL PLAN
LONGITUDINAL SCALE: 4 CHAINS TO 1 INCH
FEET 100 50 0 100 200 300 400 500 600 700 800 900 1000 FEET

Figure No. 2 shows the layout of Slade Lane Junction and the relevant signals on the Down Slow and Down Fast lines, which are adjacent to each other on the Levenshulme side of the junction. At the junction the lines become transposed and from there to Manchester the order from West to East is Down Slow, Up Slow, Down Fast, Up Fast. The figure also shows the position of the signal box which at the time of the accident controlled the junction points and signals; the box has since been closed and the control of the junction is exercised from Manchester (London Road). It will be noted that there are facing crossovers between the Down Fast and Down Slow lines on the Levenshulme side of the junction. The speed limit through these crossovers is 40 m.p.h.
