REPORT ON THE COLLISION

15th October, 1959

SMEDLEY VIADUCT SIGNAL BOX
near **MANCHESTER**

LONDON MIDLAND REGION
BRITISH RAILWAYS

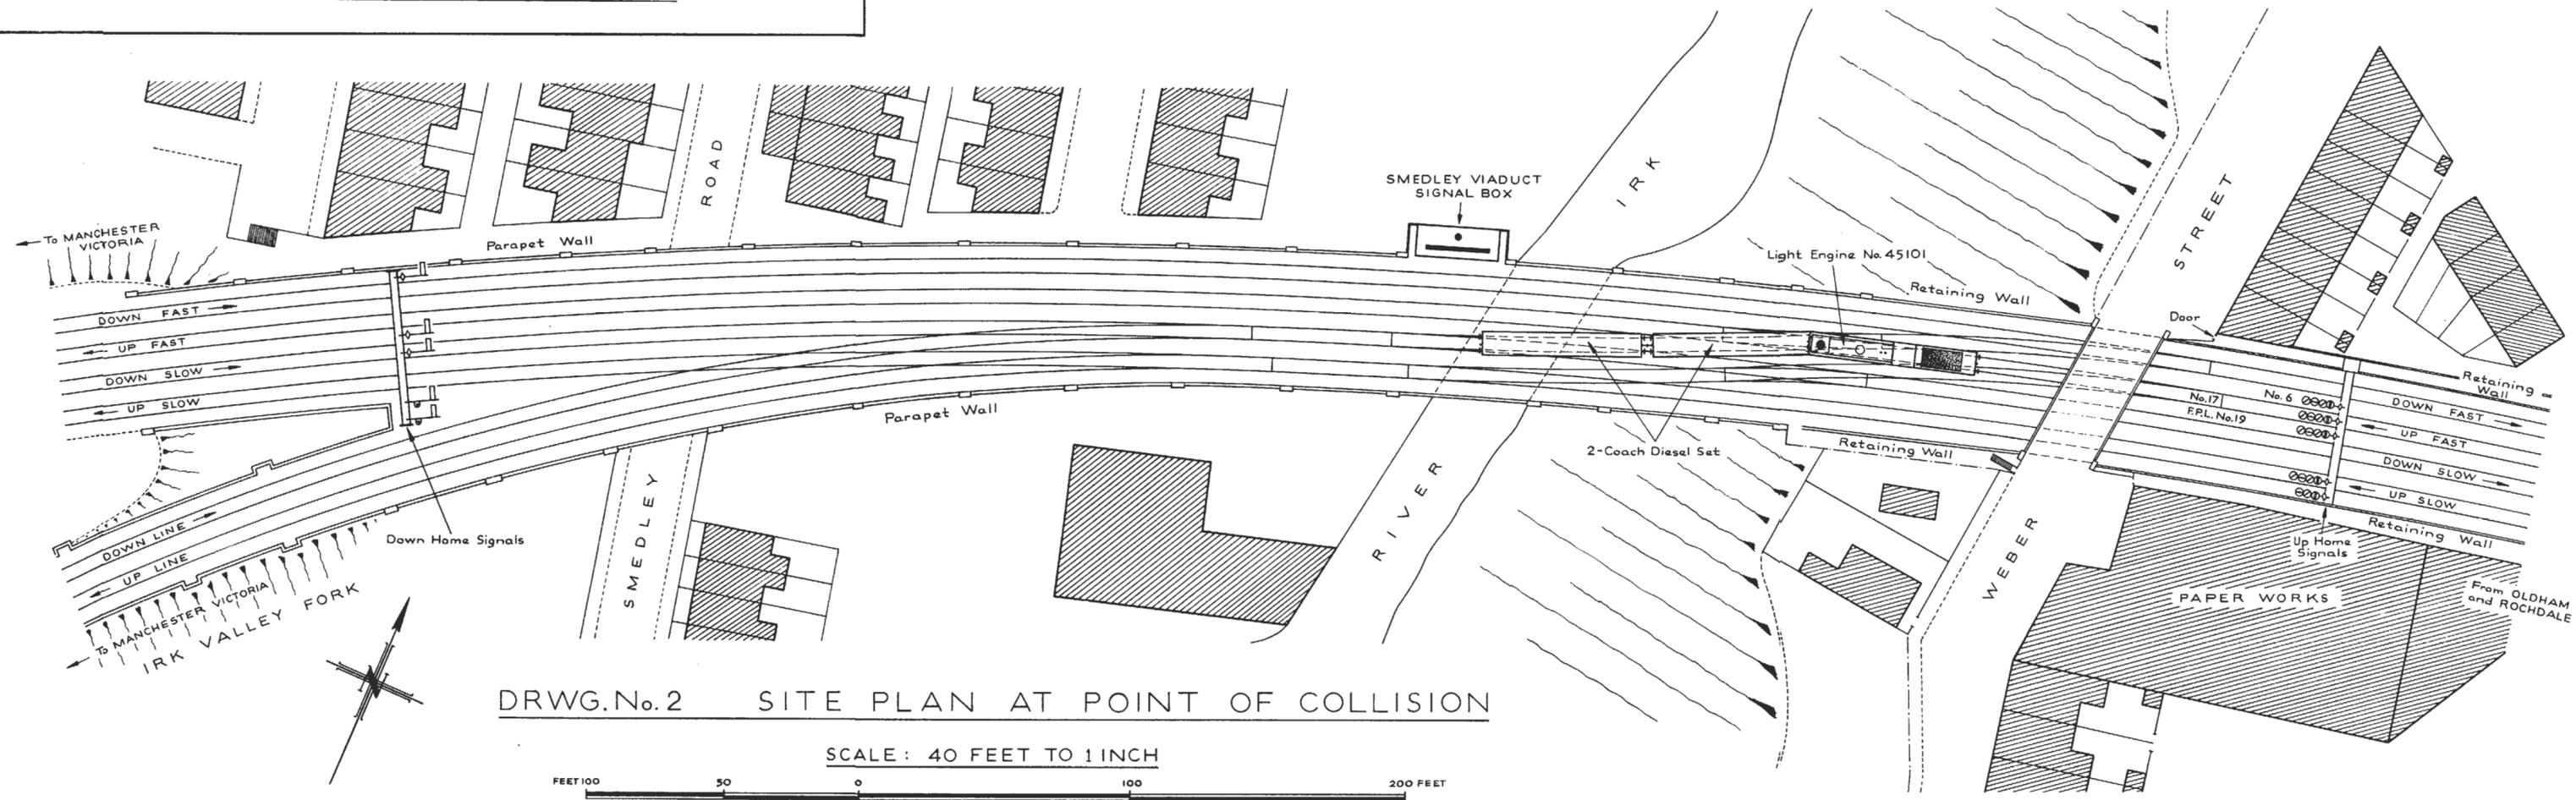
DRWG. No. 2 SITE PLAN AT POINT OF COLLISION

6. Dg. No. 2 shows the scene of the collision on the viaduct which is nearly 200 yards long and about 60 feet high where it crosses the River Irk. The Irk Valley Fork makes a double line junction with the Up and Down Slow lines which are to the left of the four-track main route looking towards Manchester; on the country side of the junction there are facing crossovers from the Up Fast to the Up Slow line and from the Down Slow to the Down Fast line on which

9. The position of the relevant signals is indicated on Dg. No. 2. They are semaphores, except the Up home signals which were converted to colour lights in 1936 because of the poor view offered to enginemen as their trains come through the tunnel. The colour light signals are fixed above the lines to which they apply on a signal bridge of lattice construction which spans the cutting on the country side of Weber Street bridge. The Up Slow line has separate 3-aspect signals for the fork and for the through line, and the Up Fast line has separate 3-aspect signals for the fork, for the crossover leading to the Up Slow, and for the through line. The two signals for the through lines each have a stand-by auxiliary yellow lamp. Berth track circuits are provided at the signals.

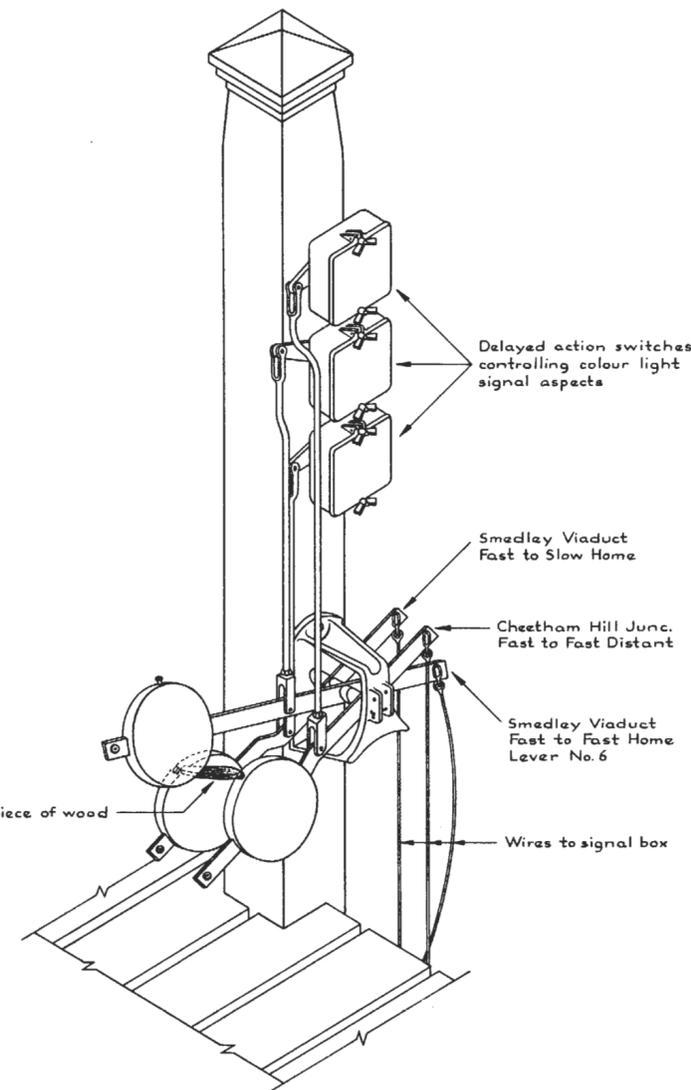
DRWG No. 3
VIEW OF OBSTRUCTION
IN WEIGHT BARS

18. Signal Lineman G. Gleaves arrived at Smedley Viaduct signal box within ten minutes of the accident. He saw that the Up Fast home signal lever No. 6 was normal in the frame but that the weight bar repeater for this signal was in the "OFF" position. He then accompanied Signal Inspector P. Fletcher and Telegraph Inspector B. Palin, who had arrived shortly after him, to inspect the signal. They saw No. 6 signal showing a yellow aspect, and then inspected the group of balance weights and bars for the home signals. The weight bar for this signal was found to be in the off position with the weight resting on a small piece of charred wood which had been placed under it across the weights of the bars on either side (see Dg. No. 3). Mr. Palin confirmed that when the wood was removed the weight descended to the on position and that the signal aspect changed to red.

27. The exact moment when the tampering with the signal weight bar took place was not discovered. I do not therefore reject Signalman Gillson's evidence that he saw the repeater return to the "ON" position when he replaced the Up Fast home signal lever in the frame after the previous engine passed at about 4.3 p.m., though I think it more likely for the piece of wood to have been placed under the weight when it was raised while the signal lever was in the pulled position to give the signal for that engine than for the weight to have been lifted by hand and for the wood then to have been placed under it.

33. The Up home signals are to be repositioned as a part of the modernisation of the East end of Manchester (Victoria) station which is to be put in hand shortly. In the meantime arrangements have been made to convert the existing signals to electrical operation with track circuit controls as a measure to avoid interference by trespassers.
