RAILWAY ACCIDENT

Report on the Derailment
that occurred on 15th June 1976
at Southerham Junction

IN THE
SOUTHERN REGION
BRITISH RAILWAYS

DERAILMENT AT SOUTHERHAM JUNCTION ON 15th JUNE 1976

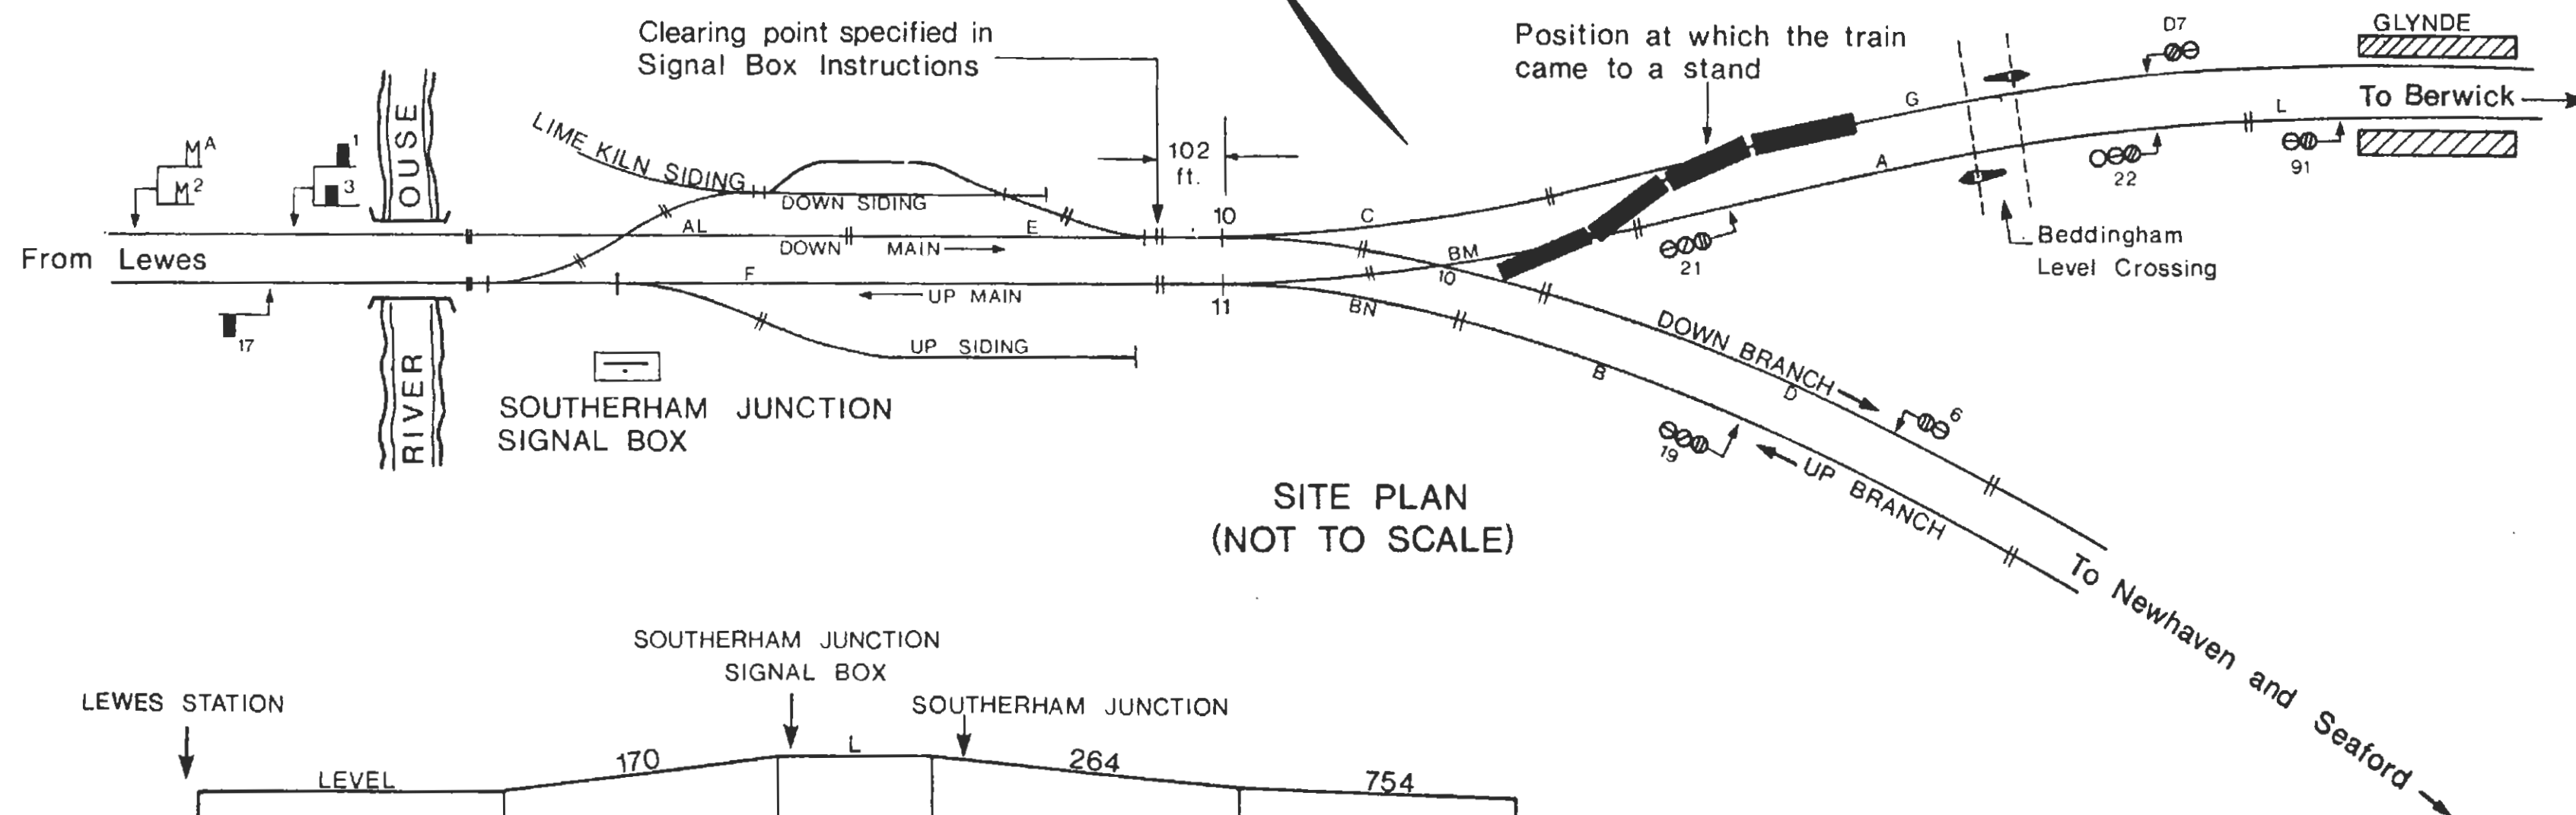
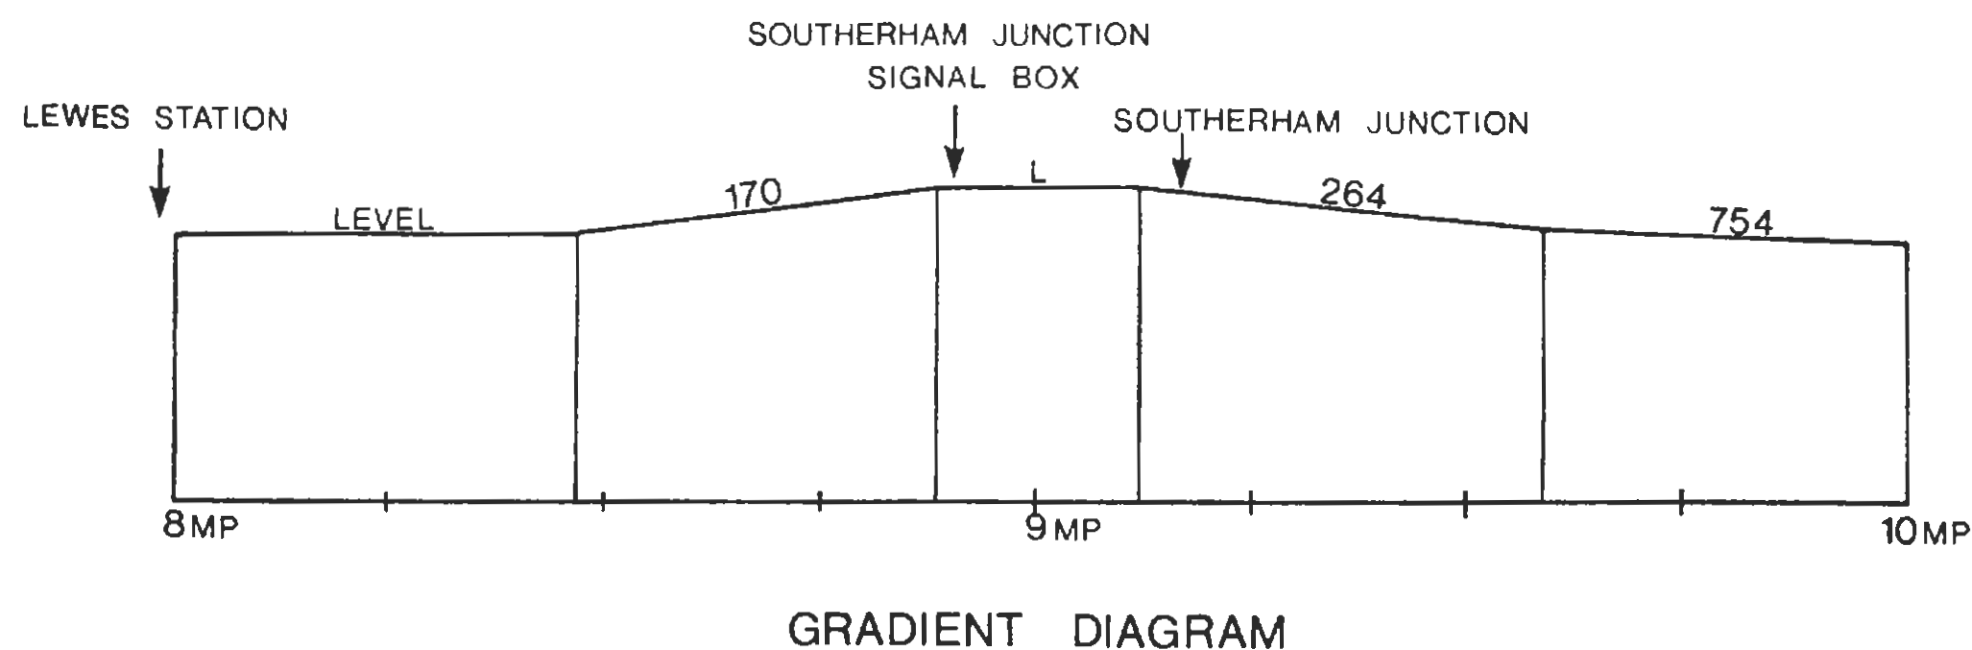
1. Southerham Junction lies approximately one mile east of Lewes Station and is the point where the branch line to Newhaven and Scaford leaves the main Lewes-Hastings line. Until April 1976 the junction was located immediately opposite Southerham Junction Signal Box but in that month it was repositioned about 500 yards further to the east, that is on the Eastbourne side of the signal box. This relocation, together with associated alterations to and simplification of the permanent way, was part of a scheme which included the eventual closure of the junction signal box and the transfer of control of the junction to Lewes Signal Box. The scheme itself stemmed from plans to build a road by-pass to the east of Lewes which involved a bridge crossing the railway immediately over the junction signal box and at a height which required the removal or complete rebuilding of the box. The relocated junction was laid in new 113 lb/yard flat bottom material to vertical design and was thus in virtually 'as new' condition at the time of the accident. A plan showing the new junction and its approaches together with the gradients and the layout of signals and track circuits is at the front of the report.

7. The train was signalled correctly through the junction on the Down main line and approached the junction under power at between 35 and 40 mile/h. Sometime after the leading coach had passed correctly over the facing points (No. 10A) the point motors started to operate under the second coach and the trailing bogie of this coach struck the partially open points and was diverted onto the branch line. This caused the second coach to slew sideways out of line until its rear bogie was forced into derailment and dragged across the junction, seriously damaging the switch diamonds. The third and fourth coaches were similarly dragged into derailment. Meanwhile the driver had felt the effects of the derailment and had made a gentle brake application, and the guard had used his brake handle to make a full emergency application. The train stopped just beyond the junction, in the position shown on the drawing.
