REPORT ON THE COLLISION

9th August 1957

STAINES CENTRAL STATION

BRITISH RAILWAYS

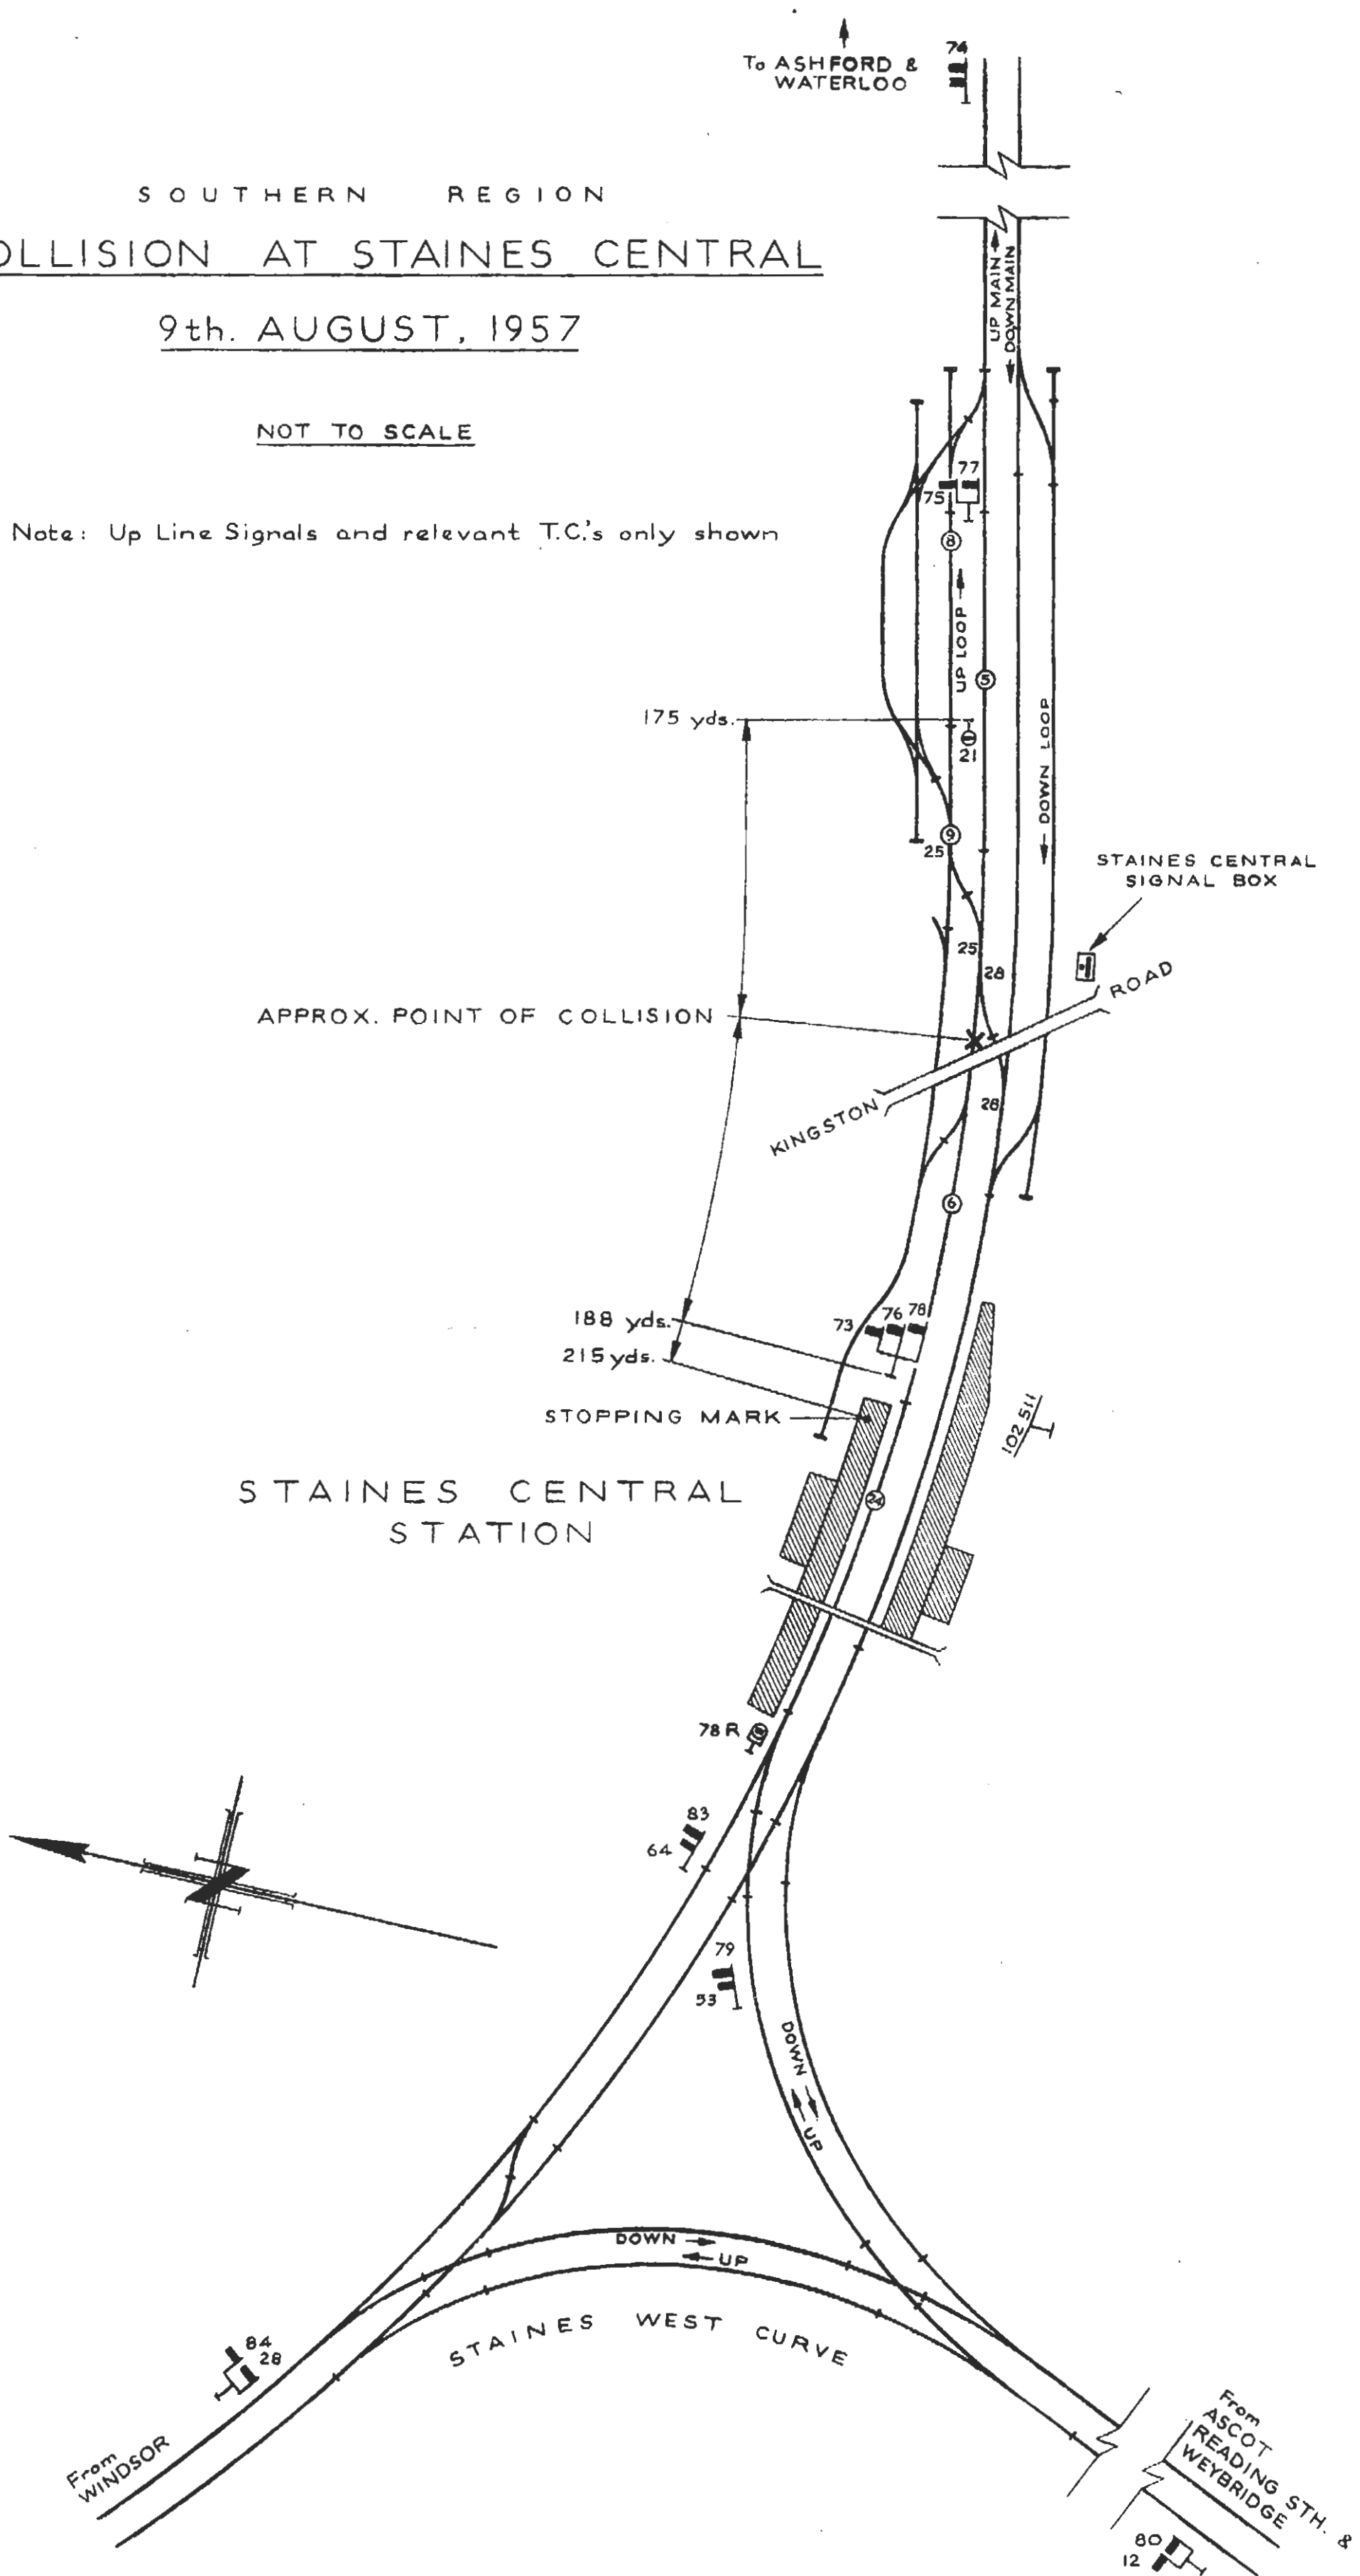
COLLISION AT STAINES CENTRAL

It will be seen from the accompanying drawing that the Up line through the station is on a left handed curve which continues for about 300 yards beyond the end of the platform, after which it runs straight towards Ashford (Middlesex). The gradient falls in the Up direction at 1 in 102 through the station, easing to 1 in 511 at the Waterloo end of the platform.

3. The curvature, which varies from 25 to 66 chains radius, and the overbridge restrict the view of the Up loop entrance from the cab of an approaching Up train, and at the time of the accident wagons on the siding in the station yard added a further obstruction. Consequently, the motorman could not see the light engine until his train was about 70 yards from the point of collision. The view of the station from the signal box is also restricted and the signalman cannot see the Up Inner Home (platform starter) signal nor does the Up train come into full view until it is close to the underbridge.

The Up Inner Home is on a bracket with signals leading to the loop and siding, and it is 27 yards beyond the end of the platform. Owing to the curvature of the line it cannot be seen by the driver of a train approaching from Windsor and a repeater has been placed at the foot of the ramp at that end of the station. The platform is covered by a canopy which prevents the station staff from seeing the Inner Home signal until they are about 60 yards from the end of the platform, i.e. at a point opposite the rear compartment of the third coach of an 8-coach train. Nor can the guard at the rear of the train see either the signal or the motorman, and the "right away" signal has to be relayed by the station staff.

4. The running signals are upper quadrant semaphores, and the position of those relevant to the accident are shown on the drawing. The Up lines are fully track circuited between the Outer Homes Nos. 80 and 84 and the Advanced Starter No. 74. Points and signals are interlocked mechanically in the usual way, and the electrical controls include sequential locking of the running signals and the release of the respective starting or advanced starting signals by line clear acceptance; sequential locking is also applied to the Up calling-on signals from the Reading and Windsor lines (Nos. 53 and 64). Operation of the running lines is controlled by 3-position closed block instruments.

24. Staines is one of those places where the present difficulty can be overcome by placing an aspect indicator of the Up Inner Home signal near the centre of the platform. Since there is already an electrically worked repeater at the Windsor end, it should not be difficult to add an indicator to the same circuit, and I recommend that this work be done.
