MINISTRY OF TRANSPORT

RAILWAY ACCIDENT

Report on the Derailment that occurred on 21st January 1966 near Steventon

IN THE
WESTERN REGION
BRITISH RAILWAYS

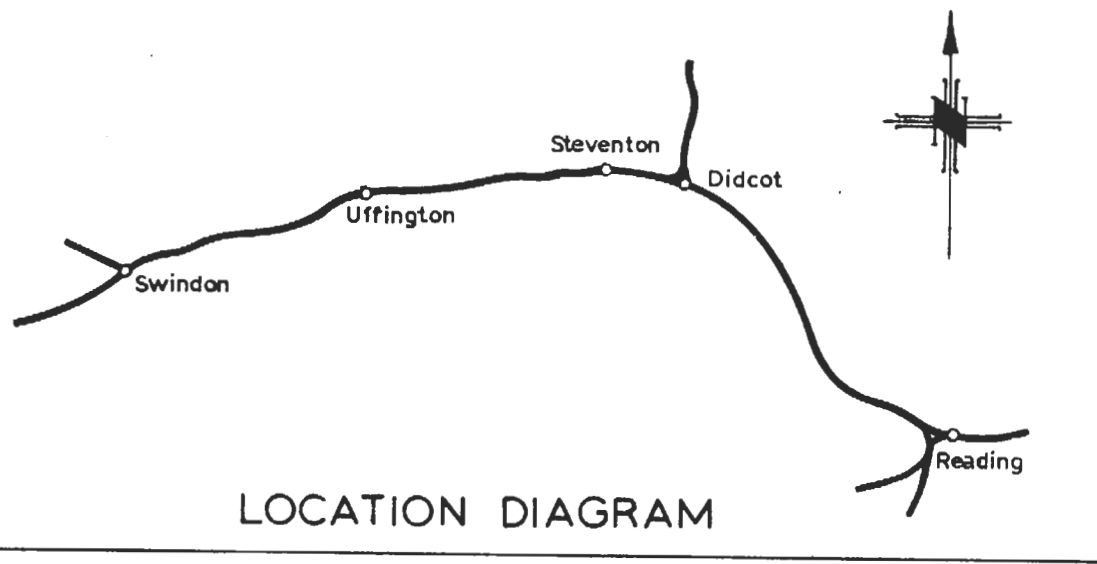
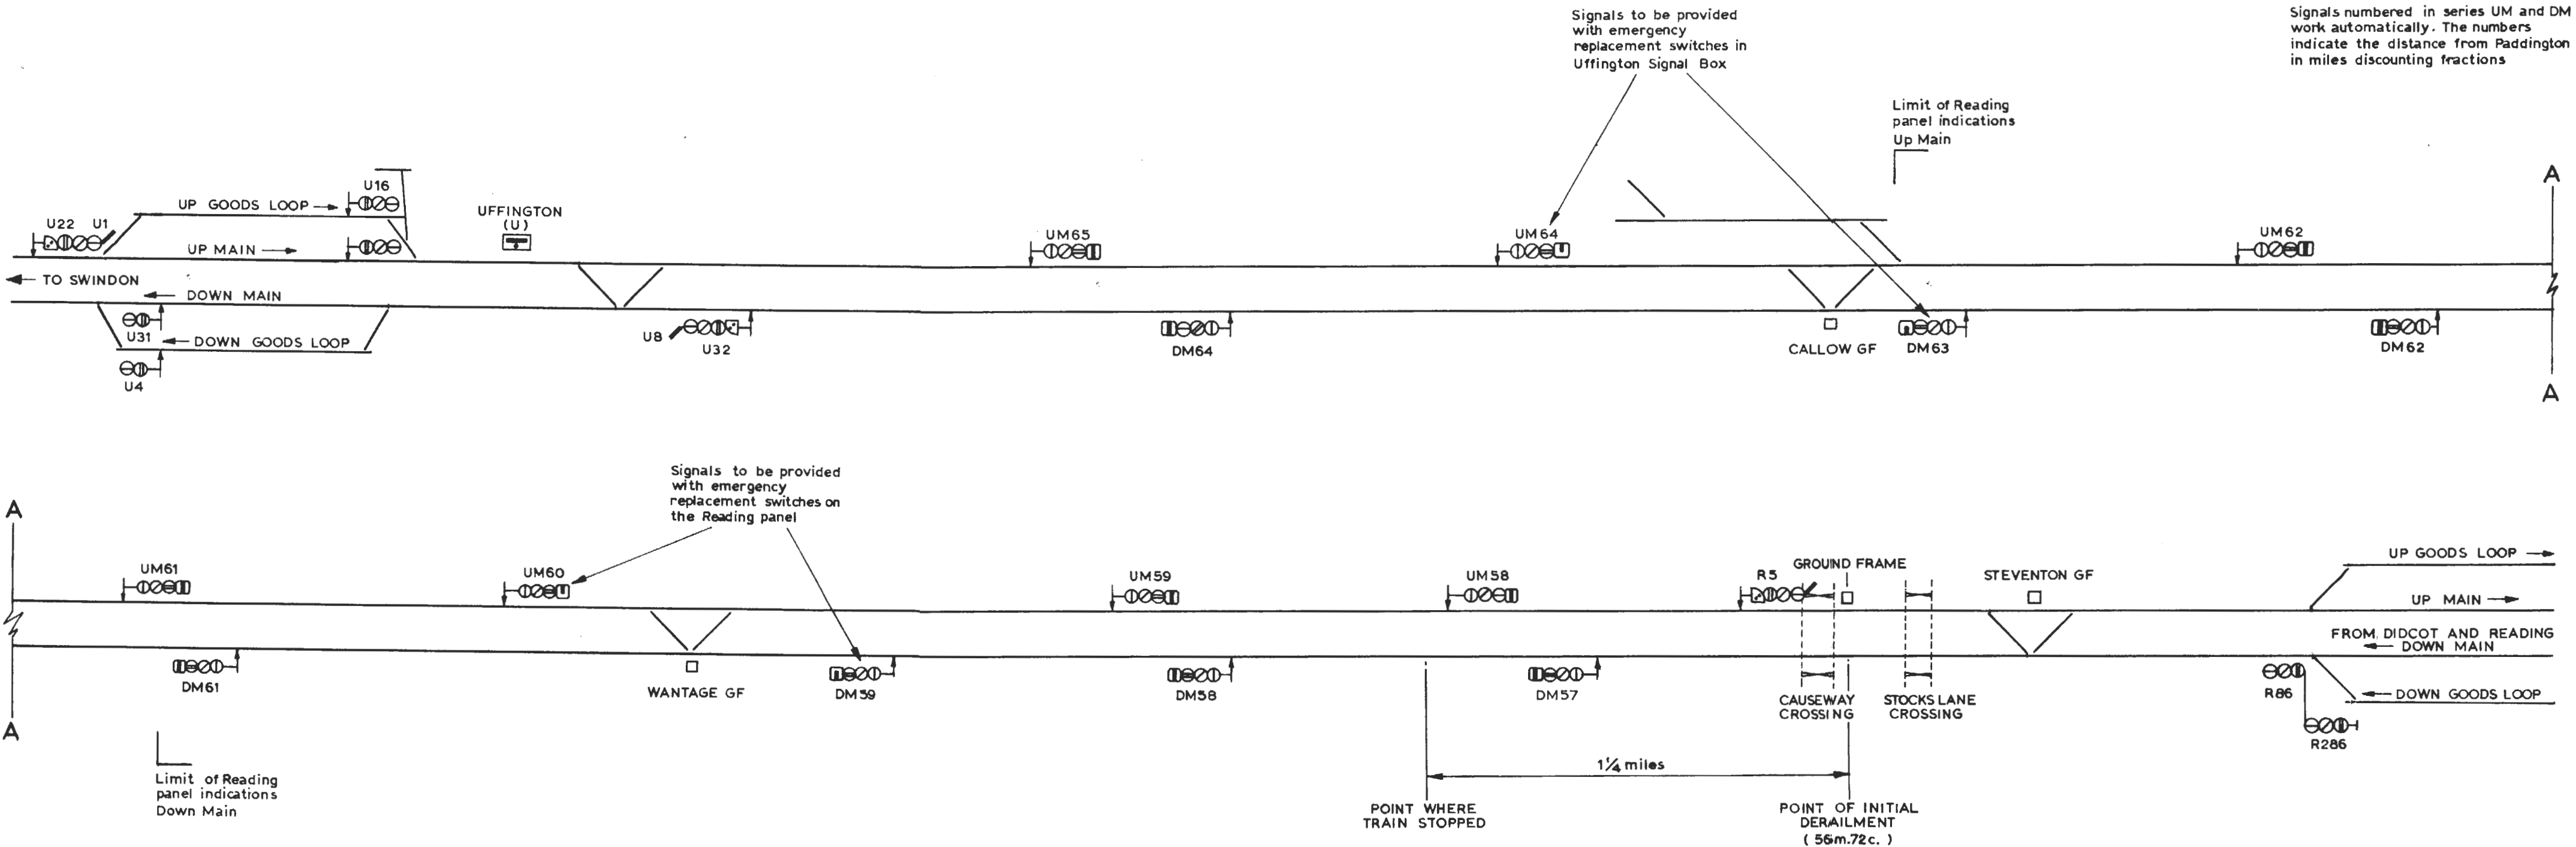
DERAILMENT OF A GOODS TRAIN AT STEVENTON, WESTERN REGION — 21st. JANUARY, 1966

1. As shown on the attached plan, Steventon lies $56\frac{1}{2}$ miles from Paddington on the Western Region Main line to Bristol and South Wales. As far as Didcot the line is four-tracked and between Didcot and Steventon there are Up and Down Goods loops. Beyond Steventon the line is double-tracked. The former wayside station is now closed and the area is remotely controlled from the new power-operated panel signalbox at Reading, 21 miles distant. The line is worked on the track circuit block system with 3-aspect colour light signals at an average spacing of 2200 yards. A telephone communicating directly with the Reading signalman is provided at every signal.

55. I have been assured by the Chief Signal and Telecommunications Engineer, Western Region, that this new policy is being implemented forthwith. In the case of the line between Steventon and Uffington I recommend that two of the intermediate automatic signals in each direction, those protecting the emergency crossovers at Challow and Wantage Road, are provided with replacement switches as indicated on the attached plan.
