RAILWAY ACCIDENT

**Report on the Derailment and
consequent Collision that occurred
on 4th July 1971 at Surbiton**

IN THE
SOUTHERN REGION
BRITISH RAILWAYS

DERAILMENT AND COLLISION AT SURBITON ON 4TH JULY 1971.

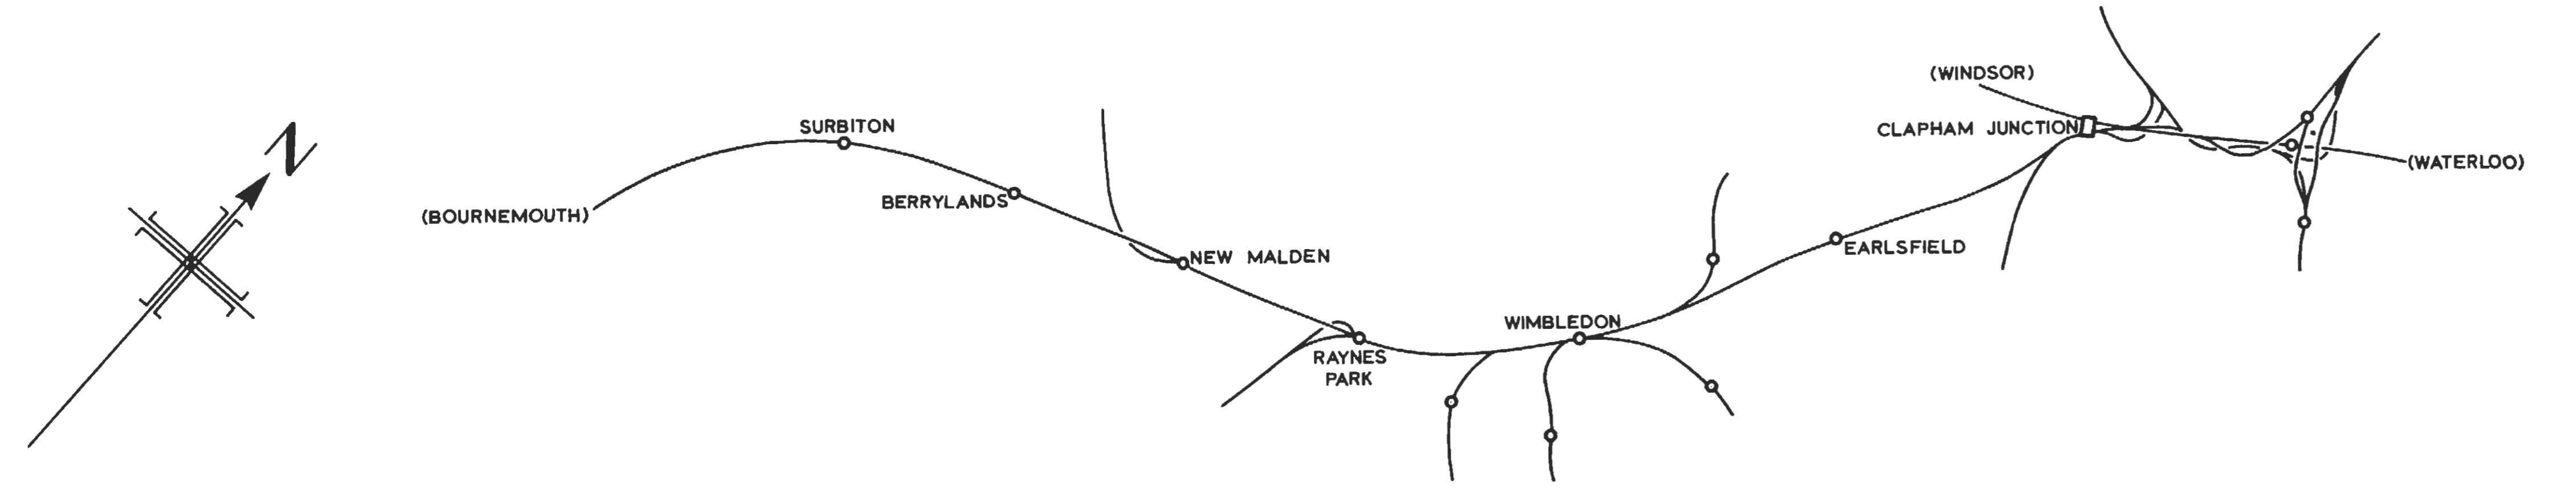
Fig. 1 Surbiton
Scale:- 100' to 1"

1. Surbiton Station lies on the Waterloo to Bournemouth main line some 8 miles south-west of Clapham Junction. The lines are electrified on the third rail system at 750 volts. The Down Slow and Fast lines lie to the east of the Up Fast and Slow lines as shown in the diagram at the end of this report. About 490 feet before the London end of Surbiton Station platforms, facing points No. 248 lead from the Down Slow to the Down Platform Loop line, which loop rejoins the Down Slow line at points No. 244 some 430 feet beyond the country end of the 860 foot long platform. There are also crossovers from the Down Fast to Down Slow line and Down Slow to Down Fast line parallel to the two connections. Some 230 yards beyond the platforms the lines cross the Brighton Road over a through-girder bridge, and between this bridge and the signalbox there is a trailing crossover from the Up Fast to the Down Slow with a diamond crossing in the Down Fast line.

29. *Mr. A. L. Headech* of the British Railways Board Research Department, Derby, in a written report described the marks he had found at the point of initial derailment near No. 248 points. The first mark of derailment was that of a wheel flange climbing over the left hand switch blade 4 feet beyond the tip of the blade, and another 17 feet beyond the tip of the right hand blade, by which point one axle had taken the divergent route to the Down Loop line. At about 100 feet from the tip of the right hand switch blade, where the switch rail is 19 inches from the stock rail he found rolling marks on the stock rail head which he thought had been made by the trailing wheel of a wagon, the leading axle of which had taken the wrong line. There were then signs that the point of contact of the right hand wheel transferred to the outside of the rail, indicating that the wagon was overturning to the offside, and the trailing wheels set having no lateral restraint to the left, derailed. Shortly afterwards the leading right wheel flange climbed over the rail and the wagon became totally derailed on the left hand side. The wagon was steered further to the left by the convergence of No. 247 crossover, and there were clear signs of this wagon striking and damaging the platform ramp, and of a further wagon, probably that following, derailing towards the offside and displacing the conductor rail. He also told me that the track alignment was good, although at the point of derailment the gauge, which was generally on the narrow side was $\frac{3}{8}$ inches less than the nominal 4 feet 8½ inches. Mr. Headech also described to me a continuous mark on the running edge of the left hand rail just below the head of the rail approaching points No. 248, which in his opinion had been caused by an unusual flange contact.

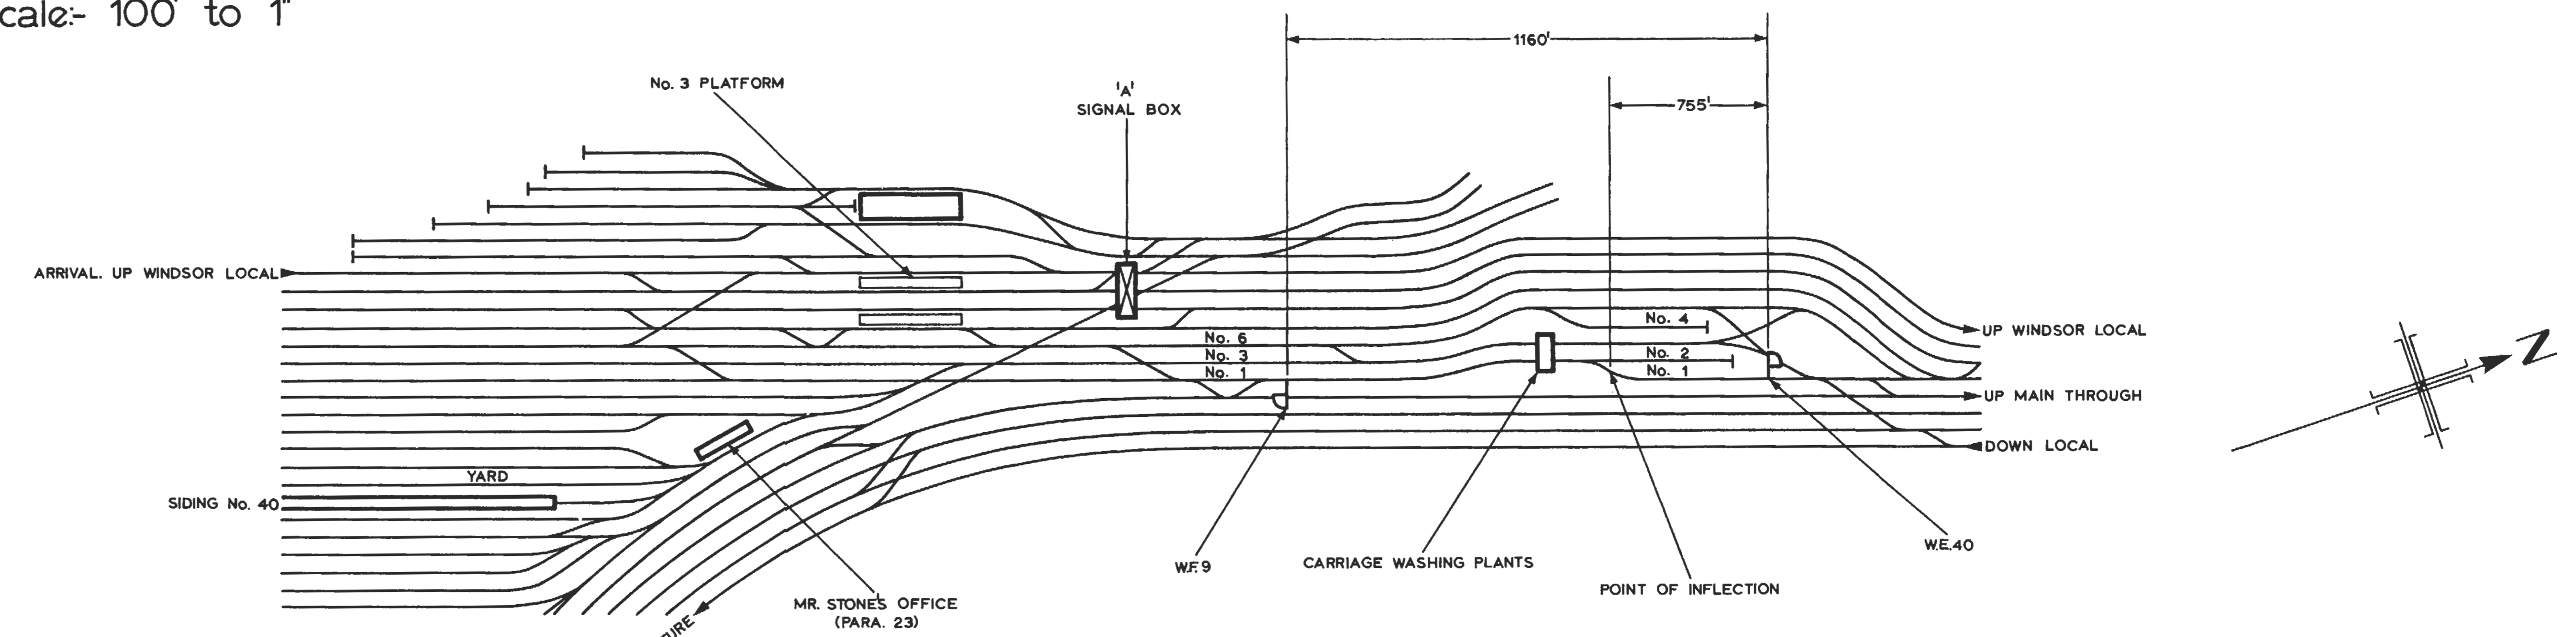
Fig. 2 Clapham Junction
(Not to Scale)

4. The ballast train began its journey from No. 1 Siding at Clapham Junction which lies beside the Up Main line on the London side of the station as shown in figure 2. No. 3 Siding lies on the west side of No. 1 Siding and both pass through carriage washing machines at about their mid points. From the south No. 1 Siding is straight for the first 50 yards and curves left and then right before passing through the machines. To the north of it the siding first curves right-handed at a radius of 13.8 chains (900 ft) from facing points which are clipped and padlocked reversed, and then left-handed at 11.8 chains (780 ft) to continue beside the Up Main line. The points lead to a spur known as No. 2 Siding. The gauge at the point of inflexion between the two latter curves (measured subsequent to the accident) was 4 ft 9 $\frac{3}{8}$ ins, and the point of inflexion is about 755 feet from the siding exit ground shunting signal No. WE 40 at its northern end. The siding is some 1,160 feet long overall between the two exit shunting signals Nos. WE 40 and WF 9 at its southern end.

36. To determine the likelihood of the two wagons becoming buffer locked in No. 1 siding at Clapham Junction I asked the Railway Officers to measure carefully the track where the buffer lock might have occurred, and to carry out certain tests on the two wagons involved. It is possible that the driver first applied his brakes when the leading locomotive was some 150 feet from the siding exit signal at which time the two wagons would have been negotiating the reverse curves of some 900 and 780 feet radii as shown in figure 2. The track on either side of the point of inflexion between these curves was from $\frac{3}{8}$ inch to $\frac{1}{4}$ inch wide to gauge.

41. The accident occurred because the buffers of an unladen wagon marshalled 24th in the ballast train became buffer locked over those of a laden wagon ahead of it and the wagon subsequently derailed at facing points approaching Surbiton station. It is not possible to be certain where this buffer lock occurred, but from the depth of the marks on the buffers and from the unusual mark on the rail it seems most likely that it happened at low speed as the locomotives were first braked after the train had been hauled back into No. 1 siding at Clapham Junction, and possibly when the two wagons were astride reverse curves in that siding.
