MINISTRY OF TRANSPORT

REPORT ON THE COLLISION

11th April 1961

WATERLOO

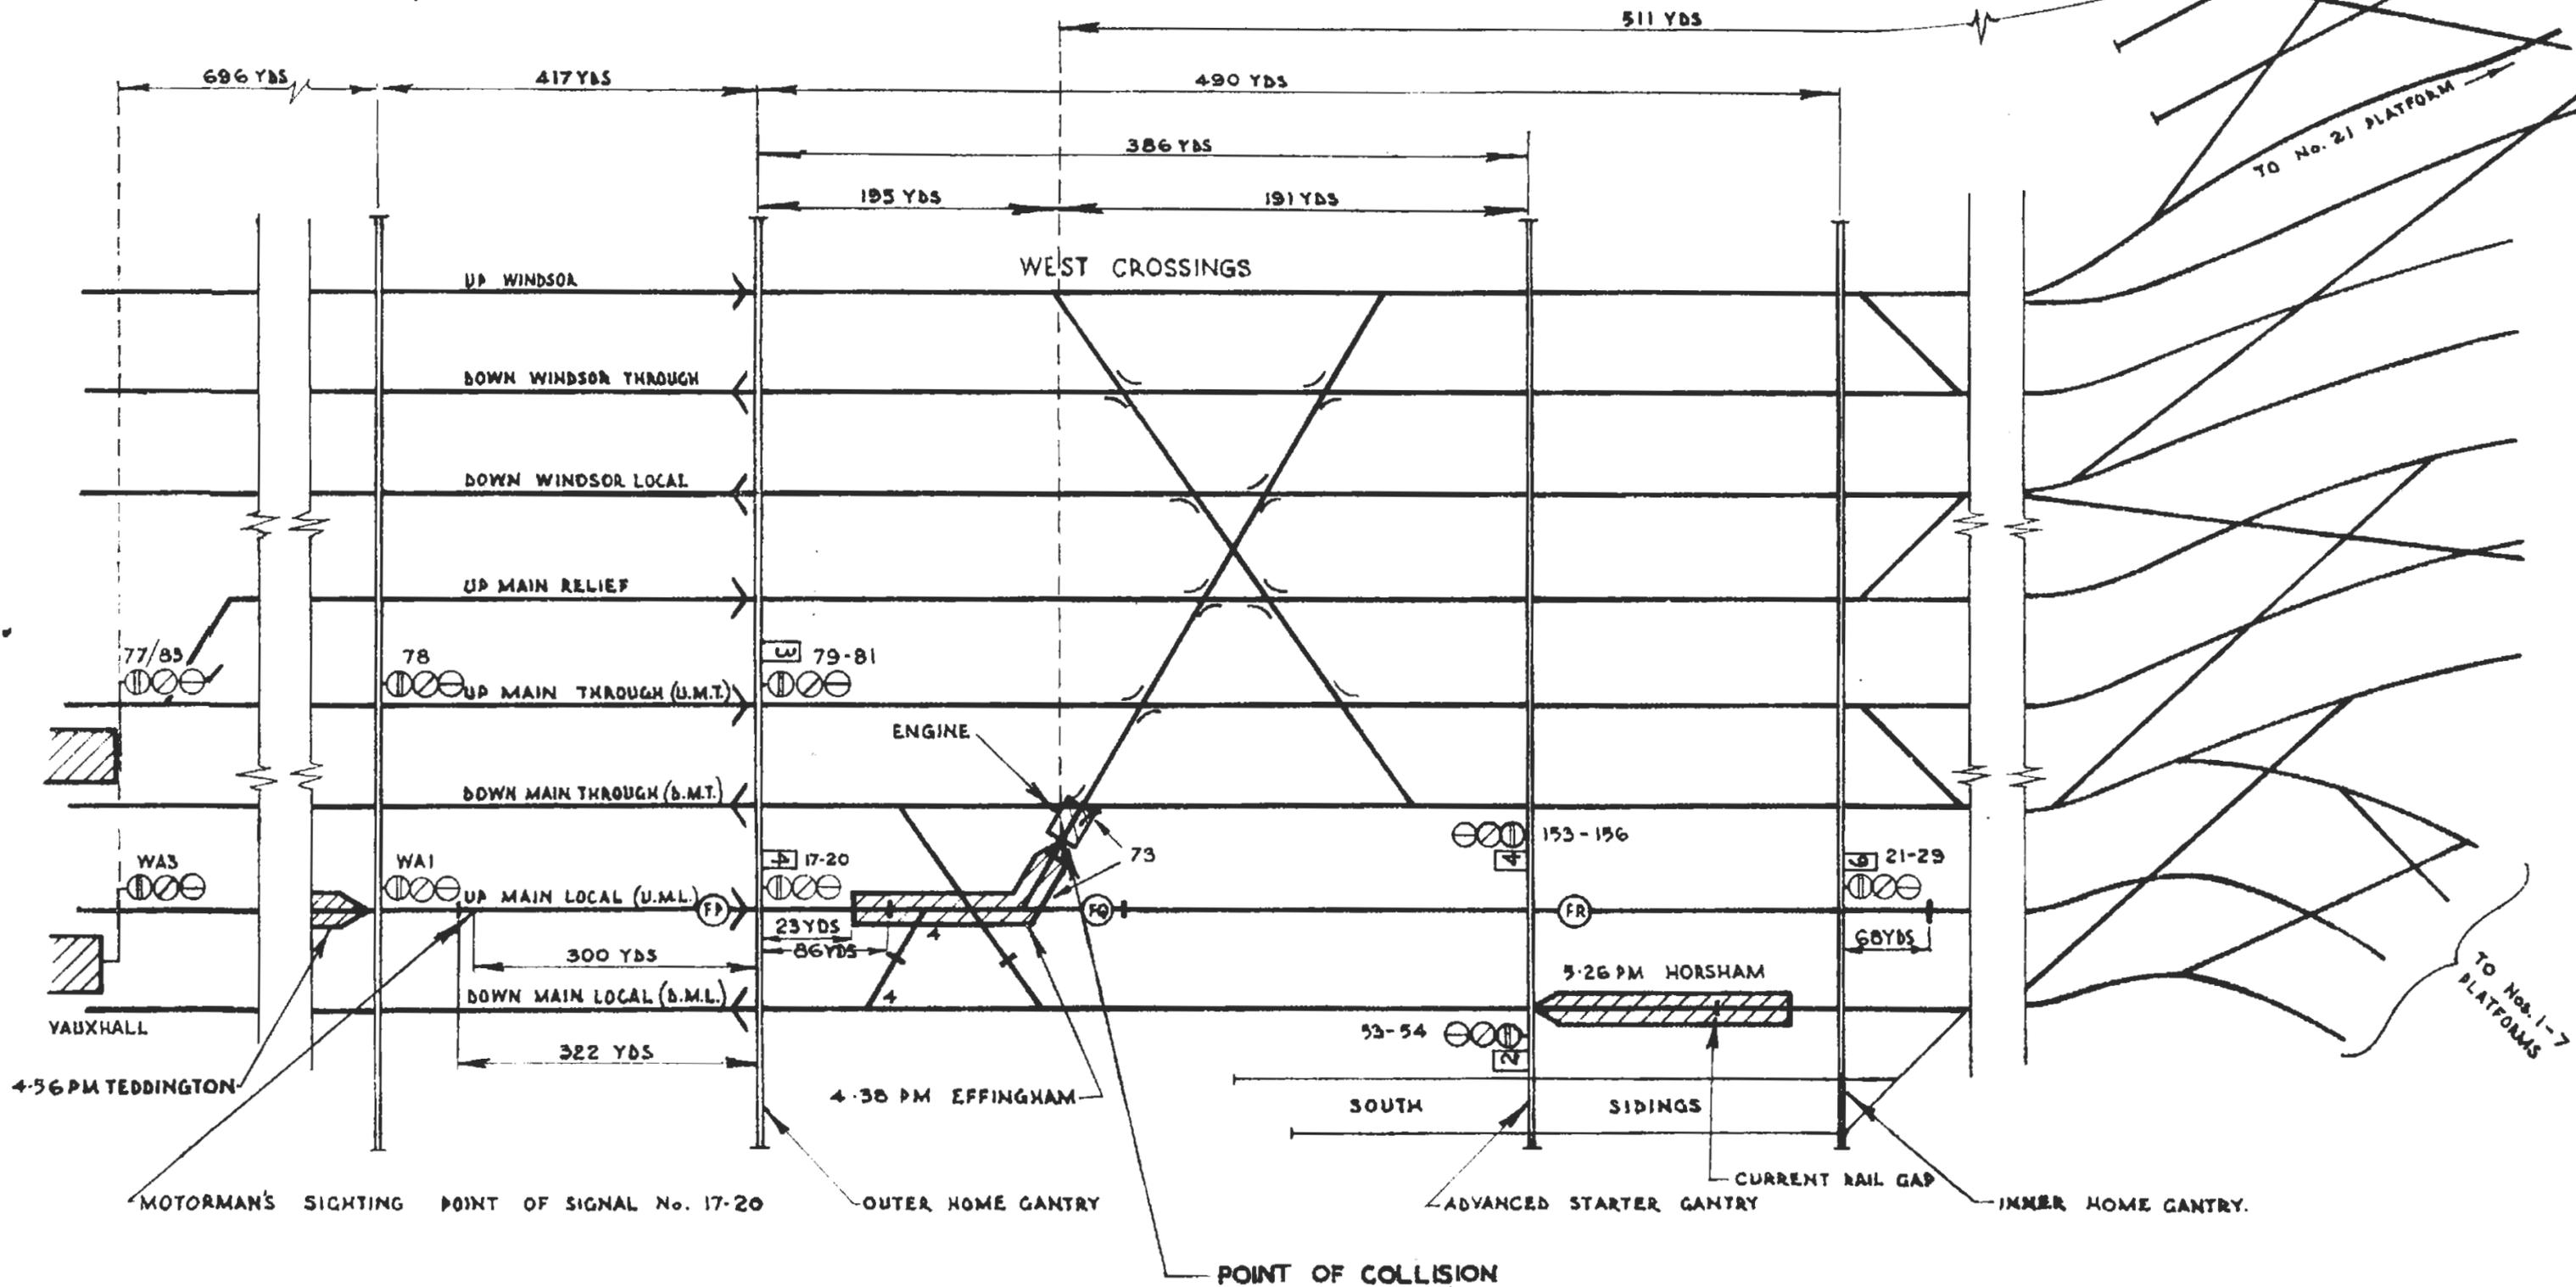
# SKETCH SHOWING PART OF THE LAYOUT AT WATERLOO

3. Waterloo is the London Terminus of the Western Section of the Southern Region and it has 21 platforms. Between Waterloo and Vauxhall Station, approximately one mile to the South, there are four Up and four Down lines. From West to East they are the Up Windsor, Down Windsor Through, Down Windsor Local, Up Main Relief, Up Main Through (U.M.T.), Down Main Through (D.M.T.), Up Main Local (U.M.L.), and Down Main Local (D.M.L.). For the sake of simplicity the above initials will be used in this report. Leaving Vauxhall the Up lines take a slight curve to the right, followed by a long curve to the right, which in turn is followed by a long left handed compound curve of easy radii which extends to the outer home signals. Details of the layout and of the position of the signals concerned are given in the sketch opposite page 3. The gradients are of no account.

4. The lines between Waterloo and Vauxhall are fully track circuited and the signals are 3-aspect multiple-lens colour lights. The signals and the electrically operated points are controlled from an electrically interlocked frame with 309 miniature levers, 272 of which are working levers, situated on the upper floor of the two-storey signal box at Waterloo; the relay room, battery room, transformers, rectifiers, etc., and the linemen's rooms are on the ground floor. The signalling installation was brought into use in 1936. The position of the box is shown on the sketch.
