RAILWAY ACCIDENT

REPORT ON THE COLLISION

16th October 1962

COLLISION BETWEEN ELECTRIC TRAINS NEAR WATFORD, 16 OCTOBER 1962

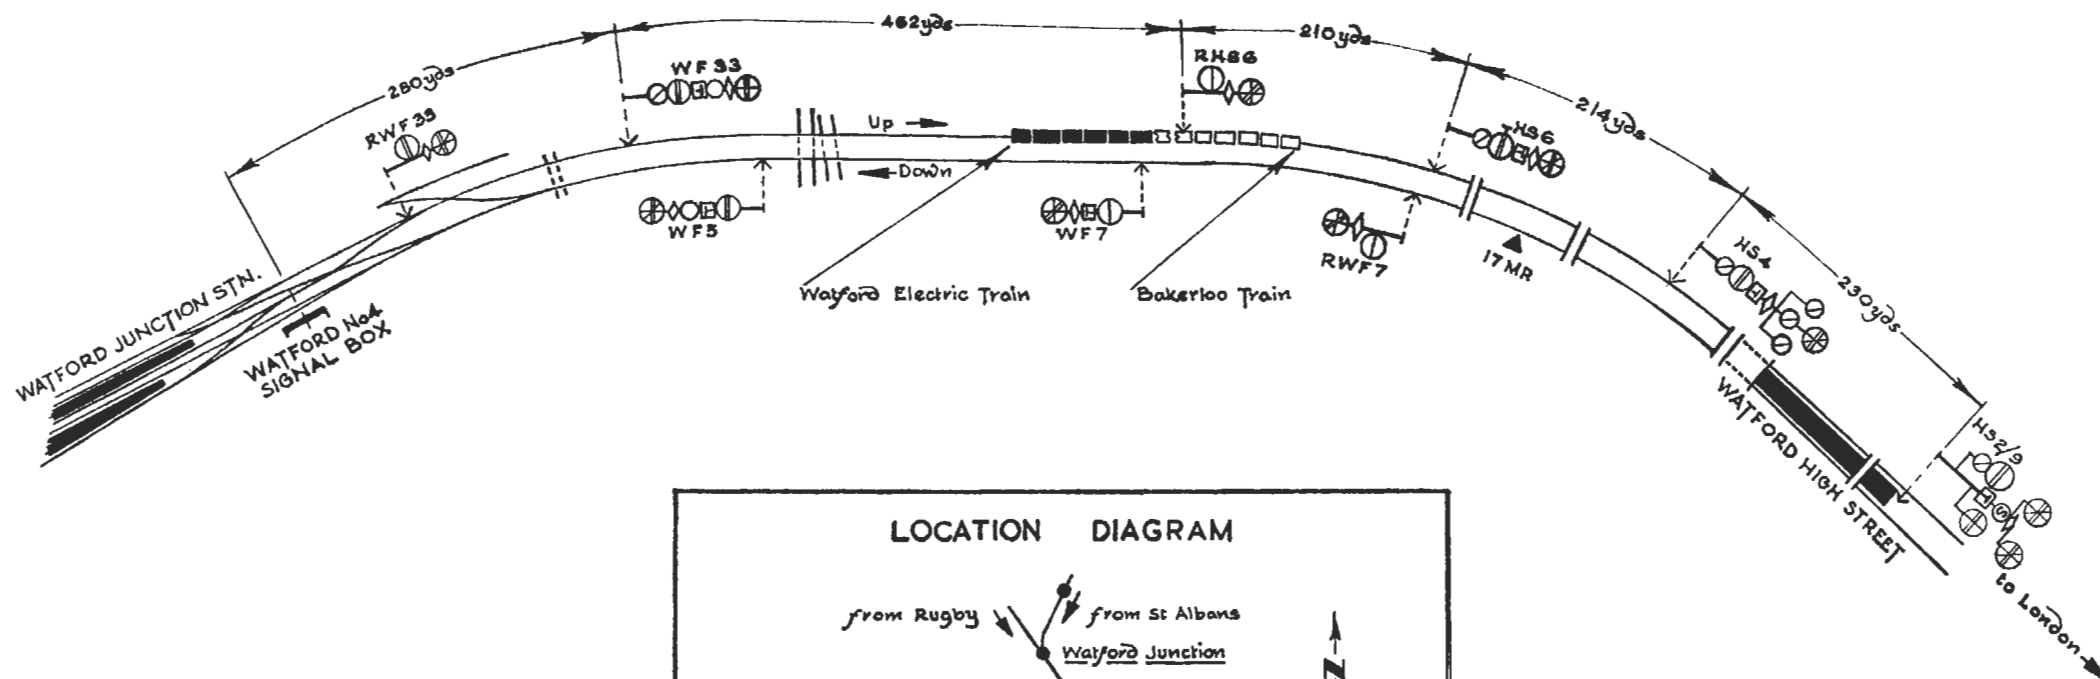
3. The signals on the Up line between Watford Junction No. 4 and Watford High Street signalboxes together with other relevant information are shown on the diagram on the facing page. All these signals are searchlight colour lights, and are on the left hand side of the line at a height of 10 to 11 feet above rail level. The relevant Up line signals are Watford Junction No. 4 advance starter (WF 33), 280 yards ahead of the signalbox which is in turn about 110 yards ahead of the platform starting signals: the repeater (RHS 6) for the High Street signal No. 6, 462 yards ahead of WF 33; HS 6, 210 yards ahead of RHS 6; HS 4, 214 yards ahead of HS 6; and HS 2/9, High Street Up platform starters for the routes to London and to Croxley Green, 230 yards ahead of HS 4. High Street box is 107 yards ahead of these signals. WF 7 is a Down line signal 30 yards on the Watford Junction side of RHS 6.
