MINISTRY OF TRANSPORT & CIVIL AVIATION

RAILWAY ACCIDENTS

REPORT ON THE DERAILMENT
which occurred on
13th February 1954 at
WINDMILL BRIDGE JUNCTION
in the
SOUTHERN REGION
BRITISH RAILWAYS

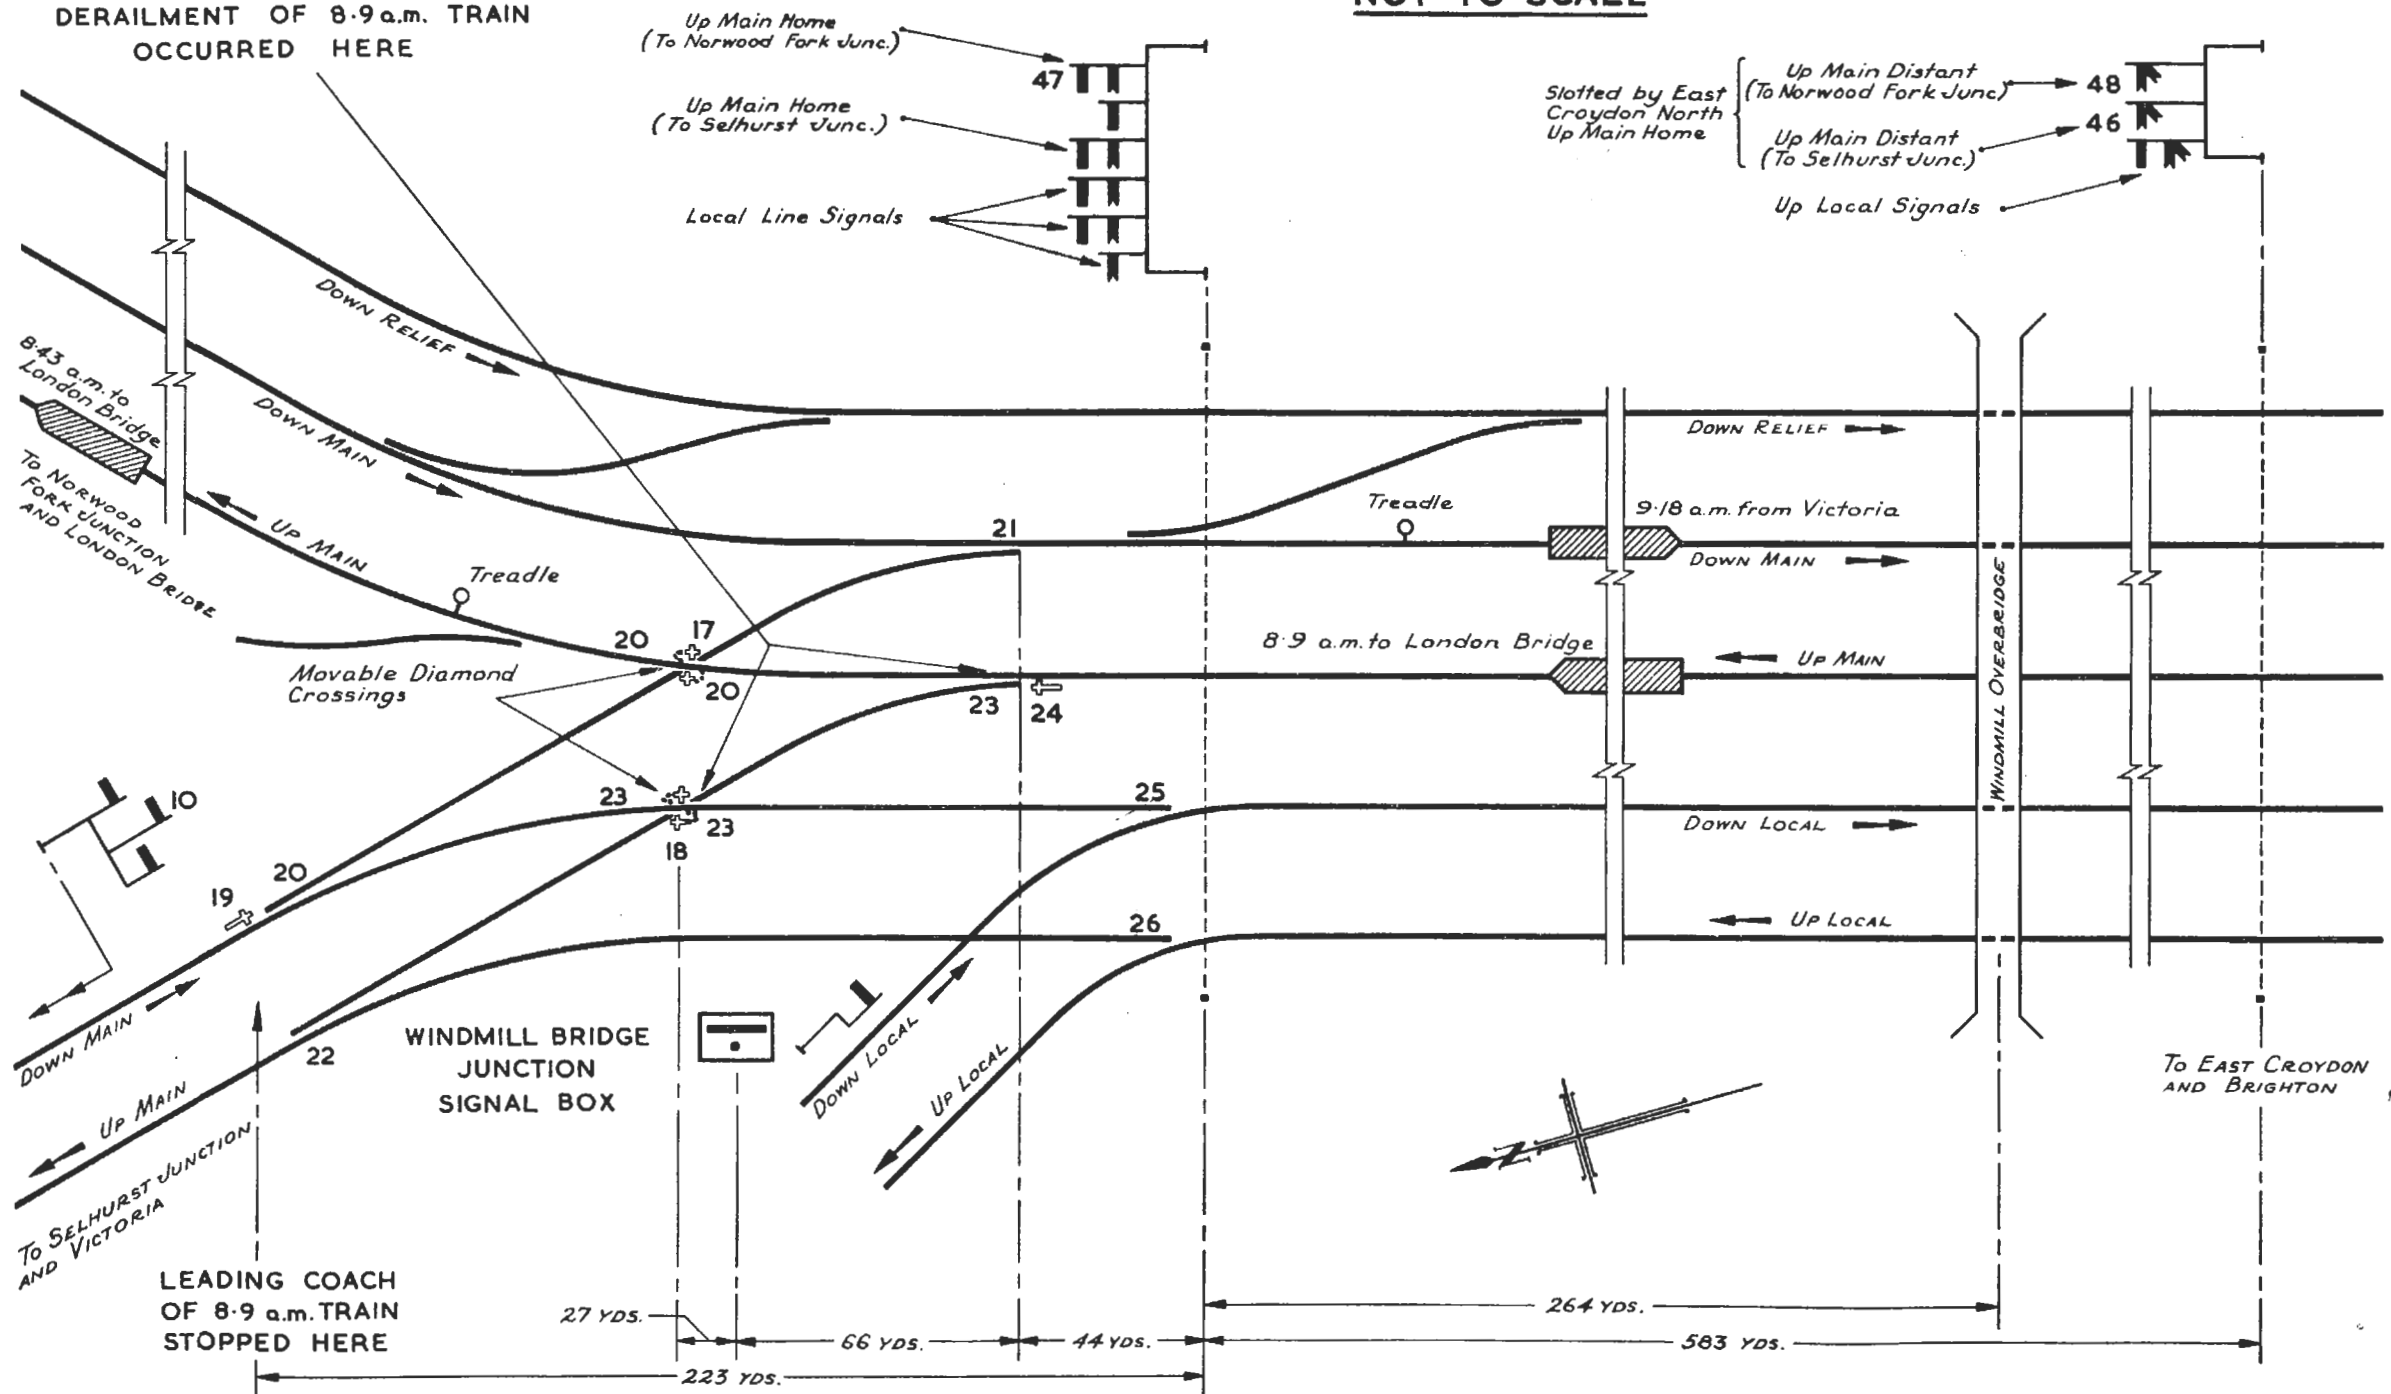
DERAILMENT OF 8.9 a.m. TRAIN
OCCURRED HERE

The sketch opposite shows the arrangement of the lines in the neighbourhood of the junction, the relevant signals and the numbers of the points to which reference will be made, as they existed at the time. Since the accident the lines have been re-signalled with colour lights and continuous track circuiting and all the points and signals are power operated from a new box.
