MINISTRY OF WAR TRANSPORT

RAILWAY ACCIDENTS

on the collision which
occurred on 10th November, 1945

at WOKING

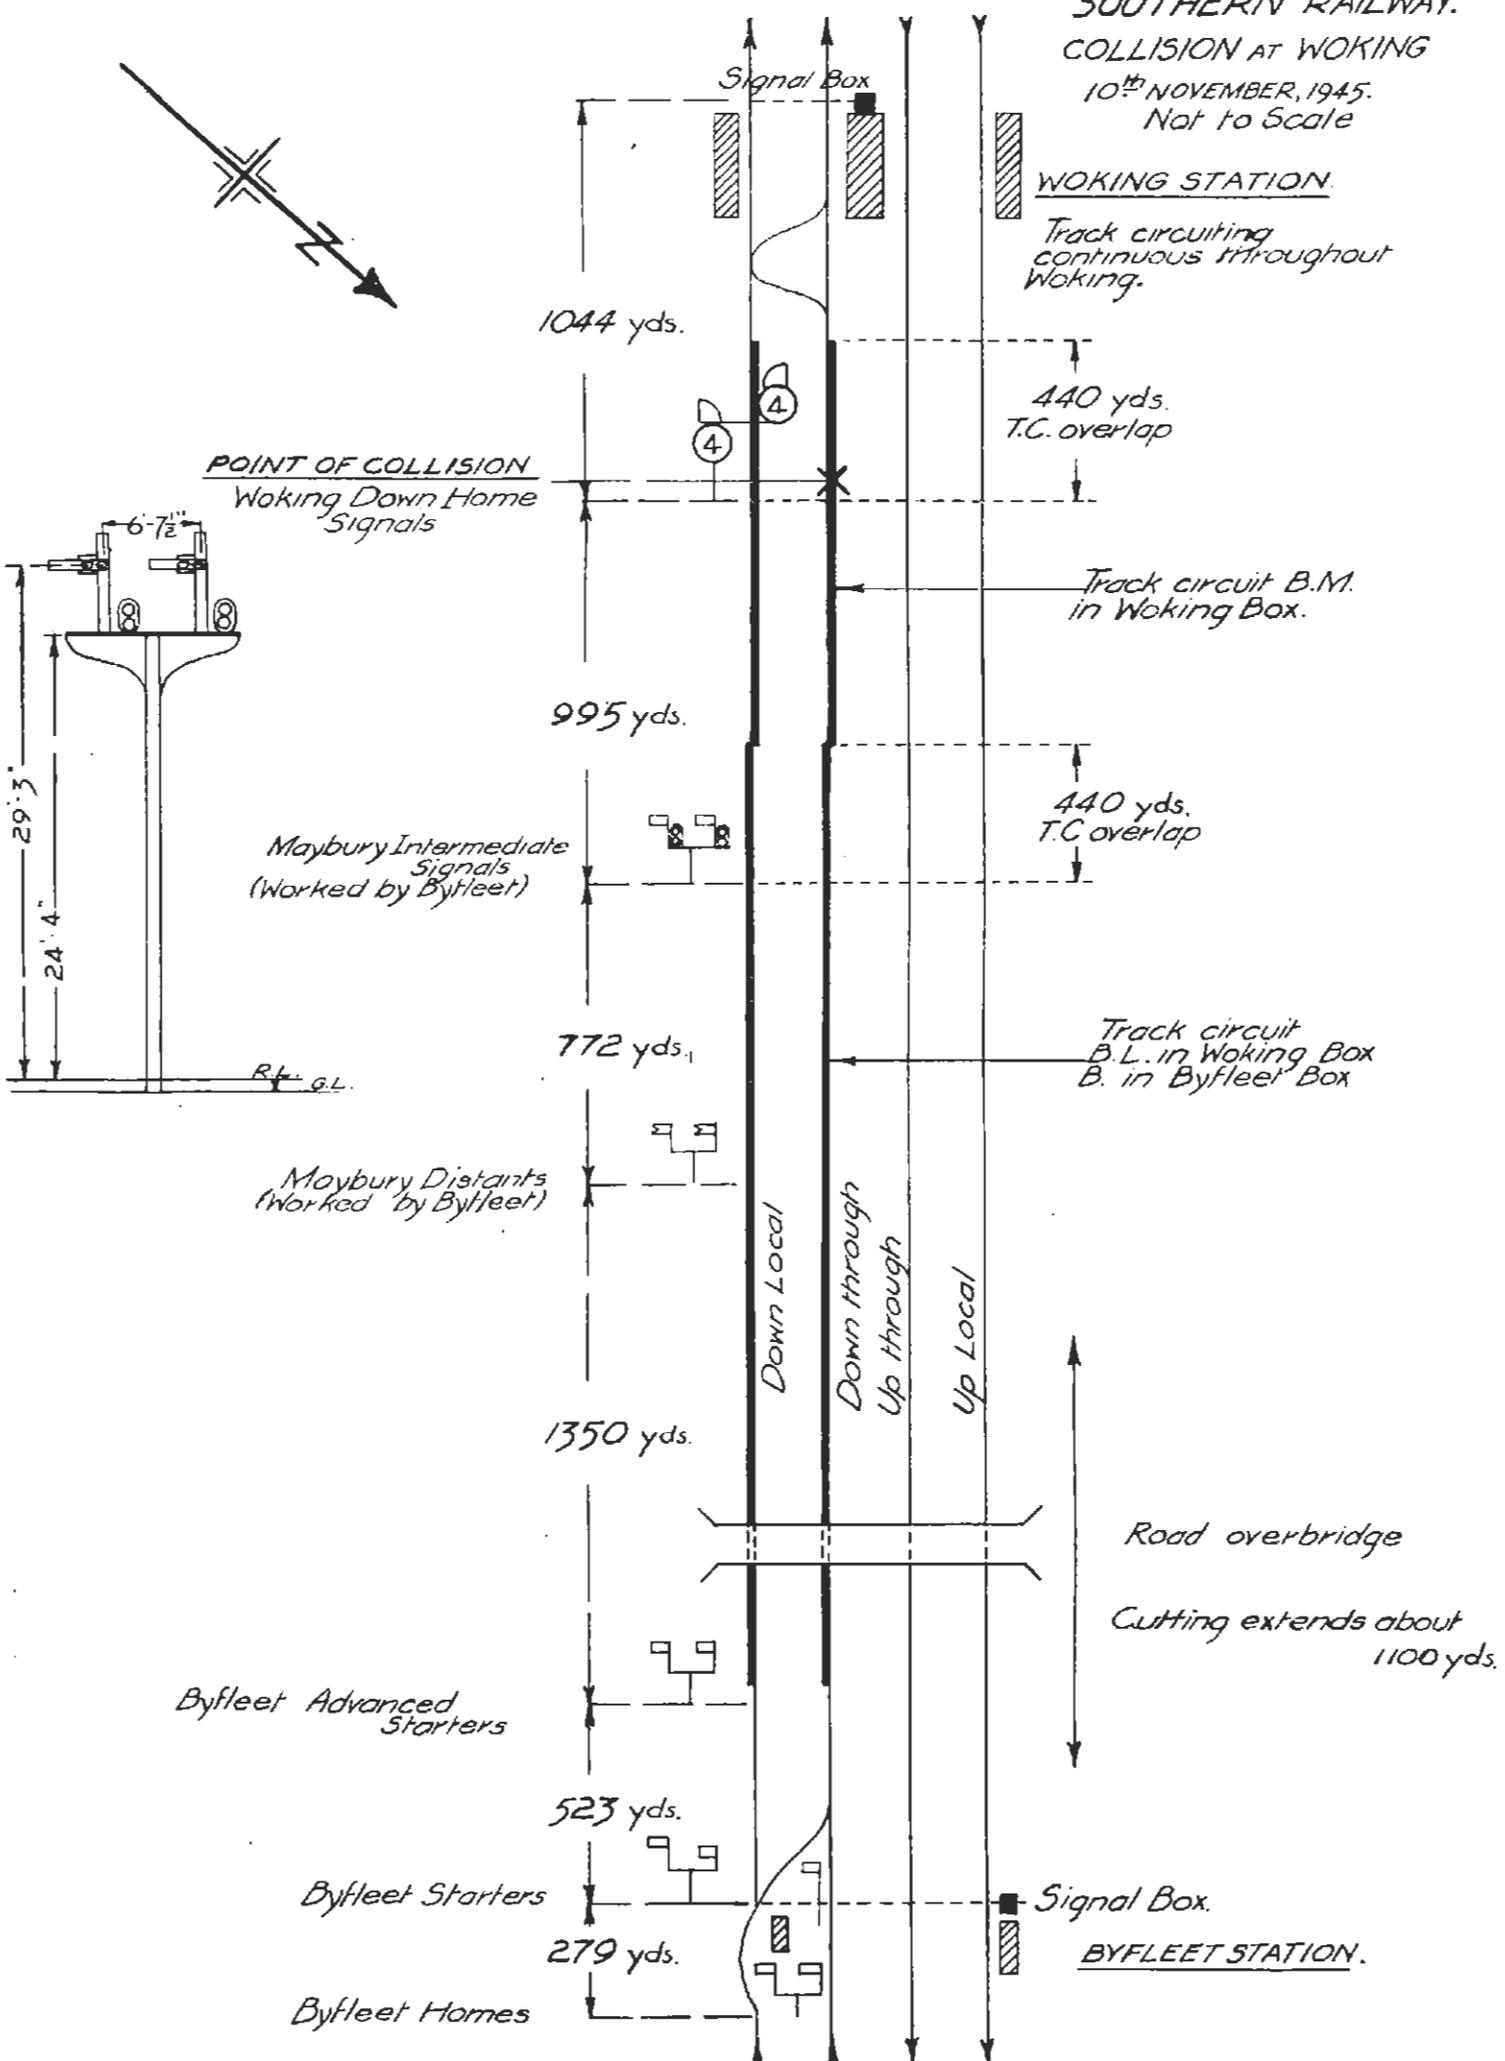
COLLISION AT WOKING

I think it may be accepted that the Maybury Intermediate Down Through semaphore was in the stop position and that its oil lamp was so much obscured by soot as to be invisible; further, that there was only one Yellow colour light displayed at that location, i.e. the light applicable to the Down Local line.

POINT OF COLLISION
Woking Down Home Signals

Maybury Intermediate Signals (Worked by Byfleet)
