Rail Accident Report

Collision at Plymouth station 3 April 2016

Report 02/2017
February 2017

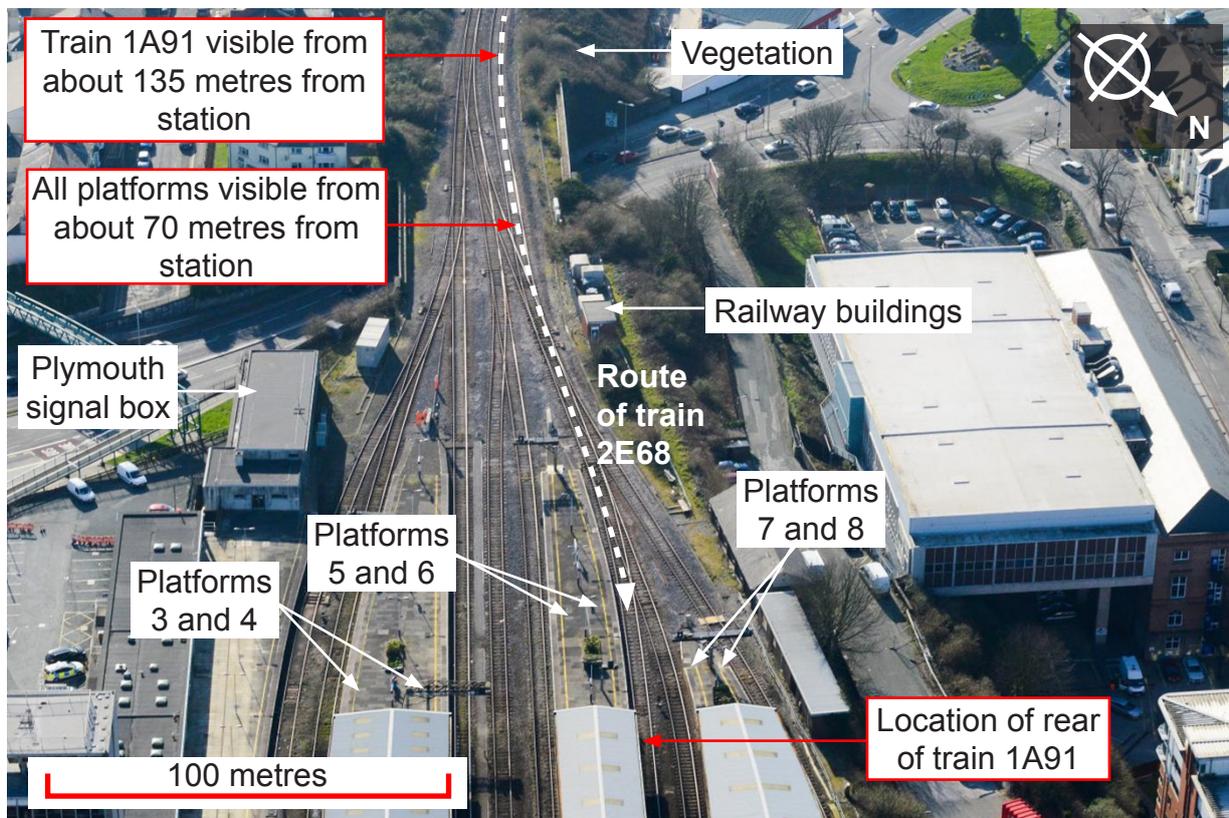
Figure 4: Features obscuring an approaching driver's view of platforms 6, 7 and 8 (image courtesy of Network Rail)

- 70 The presence of track curvature, vegetation and railway buildings (figures 3, 4 and 12) meant that the driver of 2E68 could not see platforms 7 and 8, and so could not establish the location of platform 6 by counting across from platform 8, until about 13 seconds (125 metres) before the collision. Counting at this stage would have revealed that train 1A91 was in platform 6 and would have given the driver sufficient time to stop his train safely. He did not count platforms at this stage because he had concluded that there was insufficient room for his train to share the platform occupied by train 1A91, and so had discounted the possibility of his train being routed into this platform. Although the driver of train 2E68 was competent to drive the route to Plymouth, he was still gaining practical experience driving it. It is possible that a more experienced driver would have recognised that train 1A91 was occupying platform 6 in time to prevent a collision (paragraphs 66 and 67).

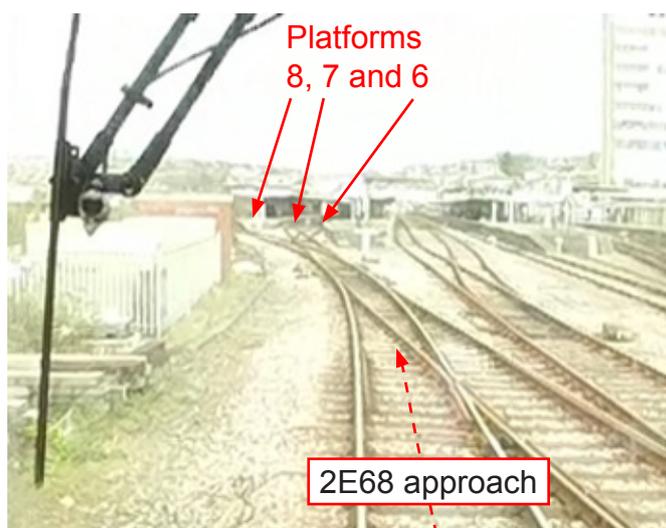
Figure 13: All platforms visible from about 70 metres from the station (image courtesy of GWR)

- 67 Train 2E68 continued towards Plymouth station with the driver's attention divided between looking forward, looking at the train's speedometer in the driving cab, and adjusting the power settings as the train negotiated the inclined and curved approach. When platforms 8 and 7 came into view to the left of train 1A91, the driver of train 2E68 continued to discount the possibility that his train was proceeding towards the same platform that train 1A91 was occupying because he firmly believed he was proceeding into one of the platforms to the left of train 1A91. His view along these platforms was partly obscured by train 1A91 and station buildings and so he could not see that there were no trains standing further along these platforms (paragraph 64, figure 13) where he would have expected a shorter train to be.

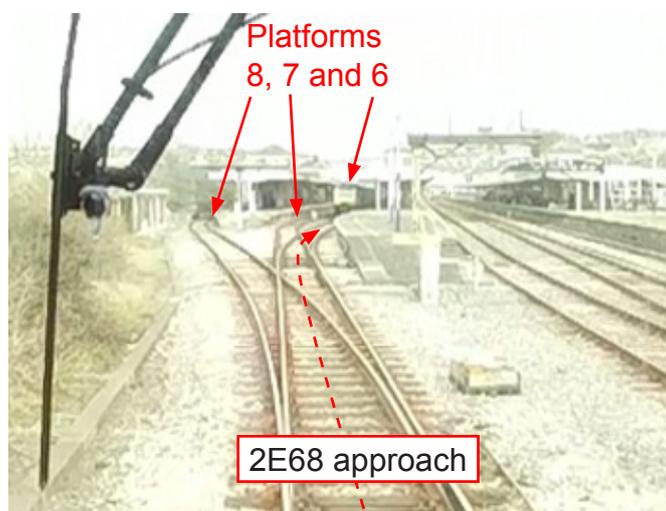
Figure 14: Approaching the points giving access to platform 8 about 91 metres from where train 1A91 was standing in platform 6 (image courtesy of GWR)

- 68 About 10 seconds (91 metres) before the collision, train 2E68 approached the points giving access to platform 8 (figures 6 and 14). The driver stated he looked at the points and saw that they were set for the straight ahead route, and continued to believe that his train was not going into the platform occupied by train 1A91.

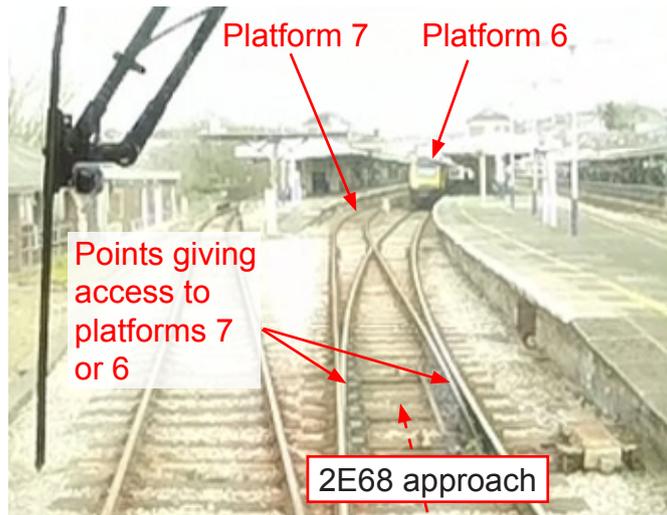
Figure 15: The points giving access to platforms 7 or 6 located near the start of platform 6 (image courtesy of GWR)

- 69 About 7 seconds (62 metres) before the collision, the train approached the start of platform 6 and the driver shut off power in preparation to stop in the station. At about the same time the driver looked at the final set of points which are located at the start of platform 6. This set of points permits a straight ahead movement into platform 7, or a route to the right into platform 6 (figure 15). On the final approach to this set of points the driver saw they were set towards train 1A91. The driver stated that, in disbelief, he counted the platforms across from 8 to 6, and on realising train 1A91 was in platform 6, he made an emergency brake application. The OTDR shows that the emergency brake was applied about 4 seconds (31 metres) before the collision.

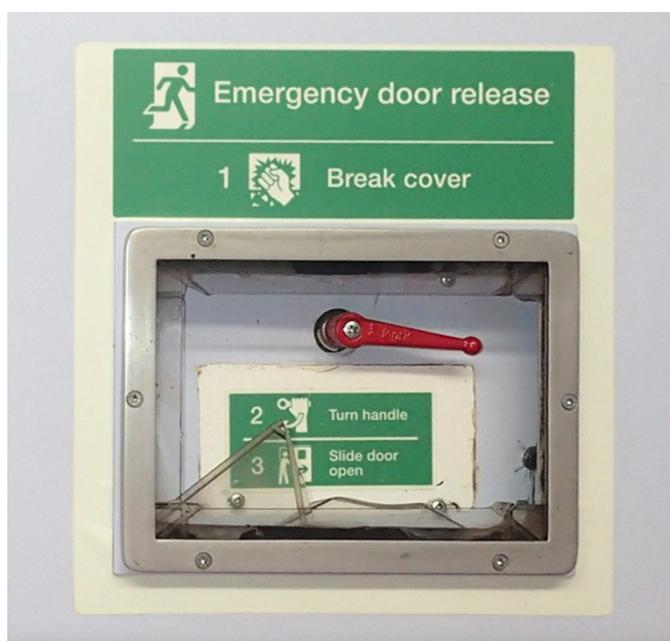
Figure 17: Emergency door release

107 One passenger and a member of GWR staff were injured when they broke the protective covers in order to operate the emergency door release handles. Other passengers said they were afraid to break the covers in case they injured themselves.

109 One passenger and one member of GWR staff reported cutting themselves when breaking the covers while attempting to open the doors to enable evacuation of the train following the accident. Some passengers told RAIB they were afraid to break the covers because they thought the cover was glass and would cause them injury. Figure 17 shows that, even though they are not made of glass, the hard plastic cover can leave sharp edges when broken.
