Rail Accident Report

Wrong side signalling failure and derailment at Dalwhinnie, Badenoch and Strathspey 10 April 2021

Report 10/2022
September 2022

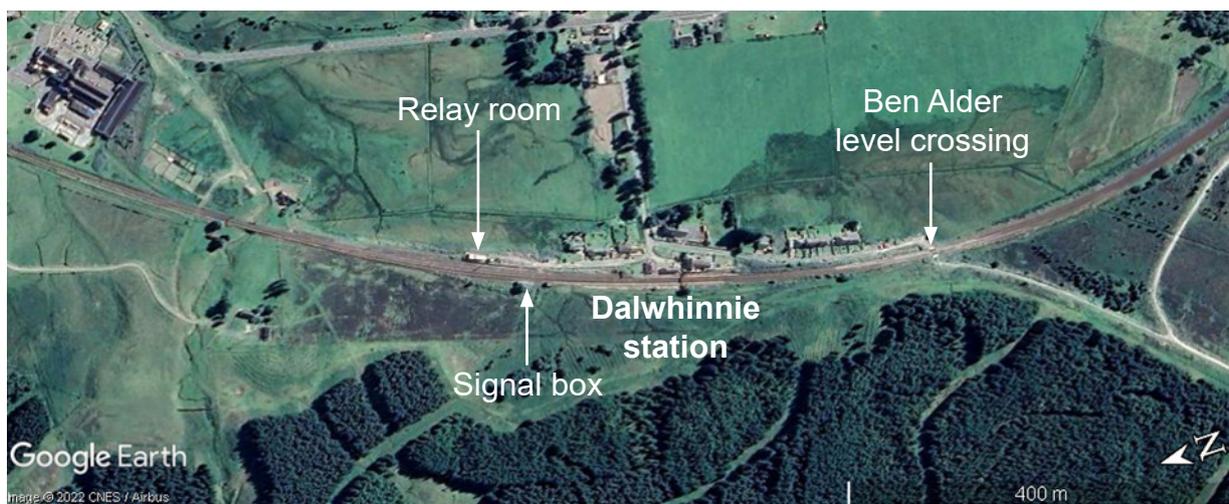
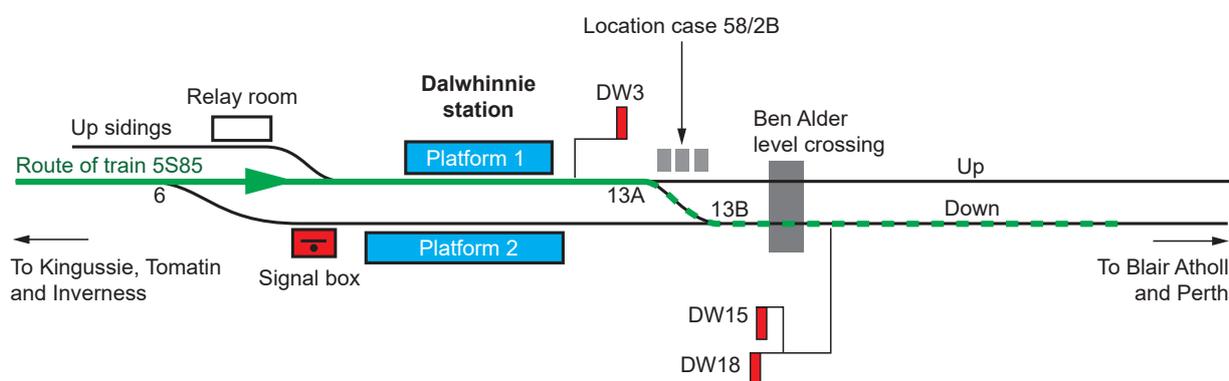
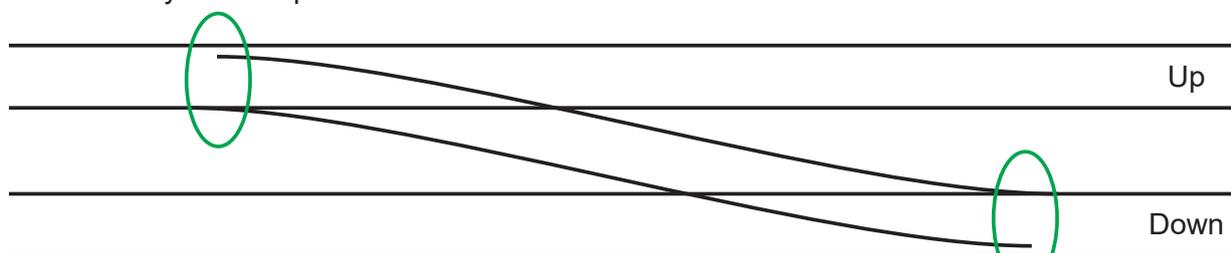
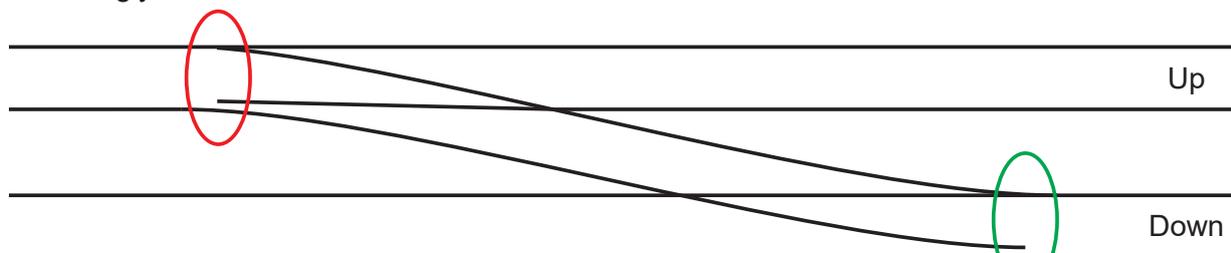
13A point end wrongly set for crossover

13 points wrongly set (out-of-correspondence)

Figure 2: Layout of the railway at Dalwhinnie station showing the route of the train. The lower diagrams shows 13 points in the correct and incorrect (as encountered by the train) positions.

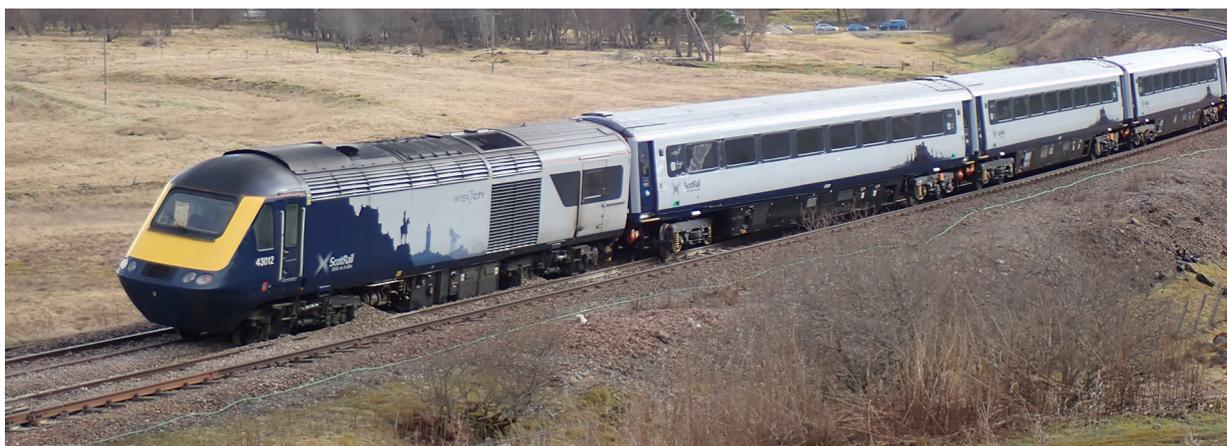
Figure 3: Derailed train – trailing power car and coaches

- 7 The derailment resulted in damage to both the train and the railway infrastructure, mainly the track and signalling equipment at 13 points and the deck of the nearby Ben Alder level crossing. Although no one was injured, trains are permitted to travel at up to 70 mph (113 km/h) through Dalwhinnie station on the up line, while movements over the crossover are restricted to 15 mph (24 km/h) (see paragraph 10). This means that the train could have been travelling at a much higher speed when the derailment occurred; it could also have been carrying passengers. The train could also have encountered a train travelling northbound on the down line.

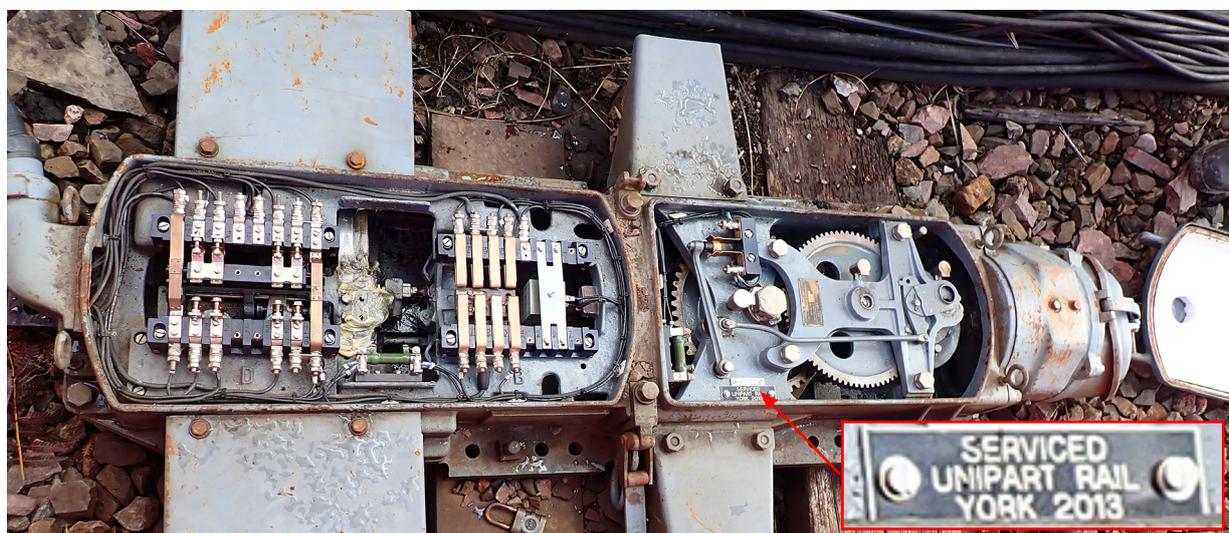
Figure 5: GRS 5E type point machine installed at 13A point end, with covers removed. Inset shows the plate fitted when it was last reserviced

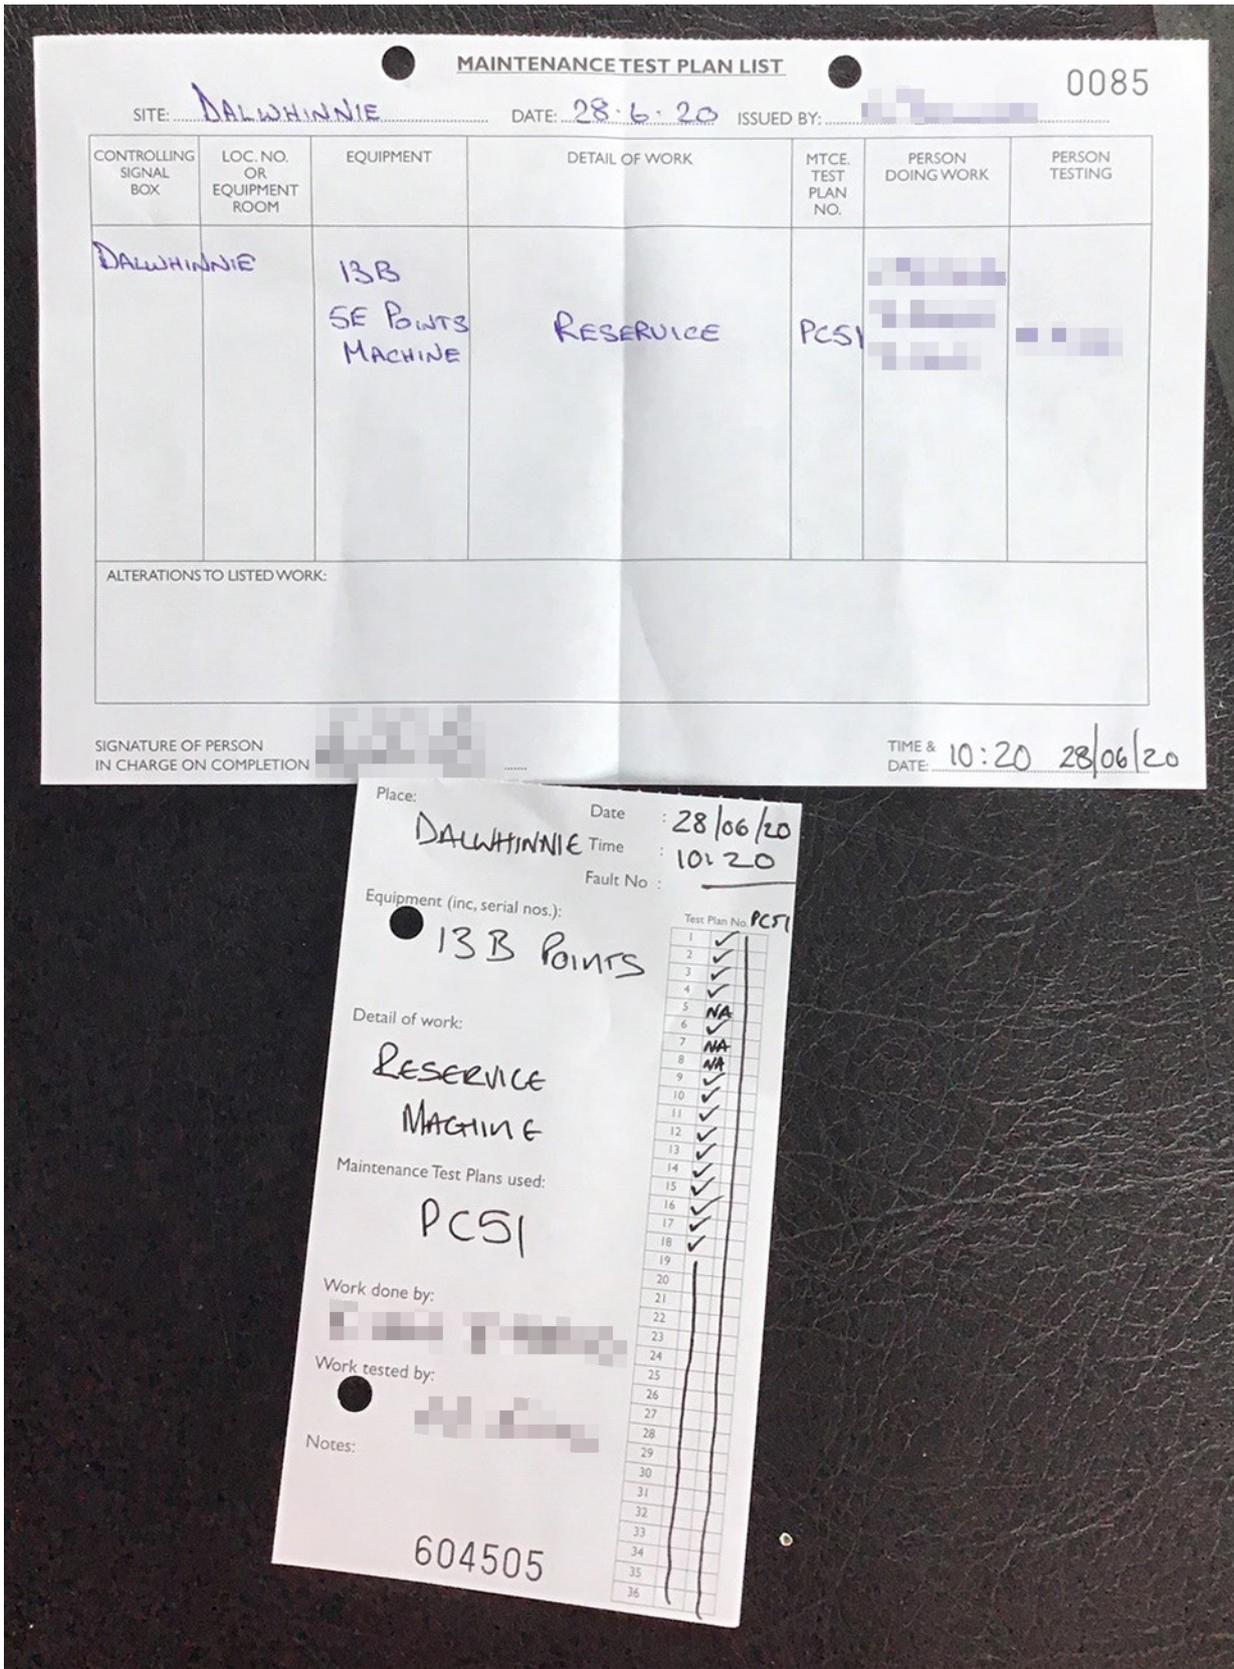
Figure 6: Completed SMTH log sheet and maintenance test plan list (photograph courtesy of Network Rail)

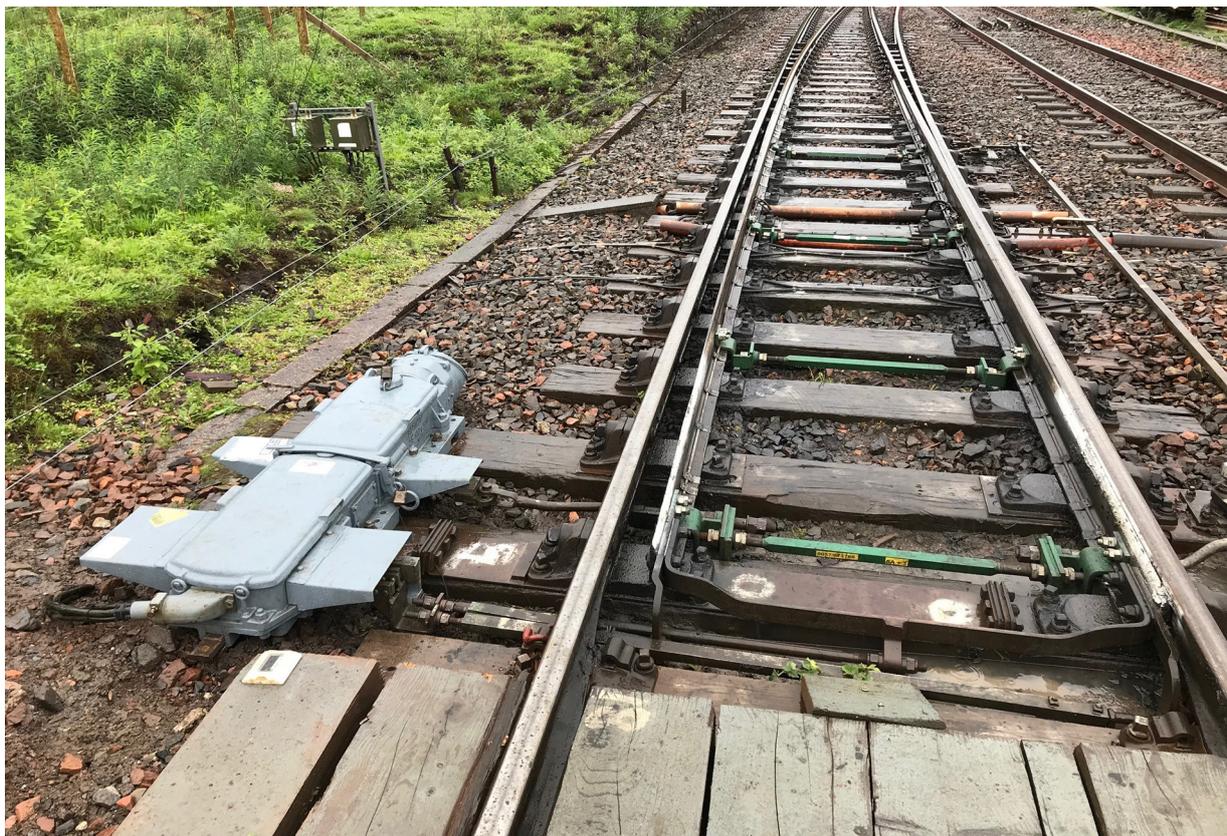
Figure 7: The newly-installed point machine at 13B point end (photograph courtesy of Network Rail)

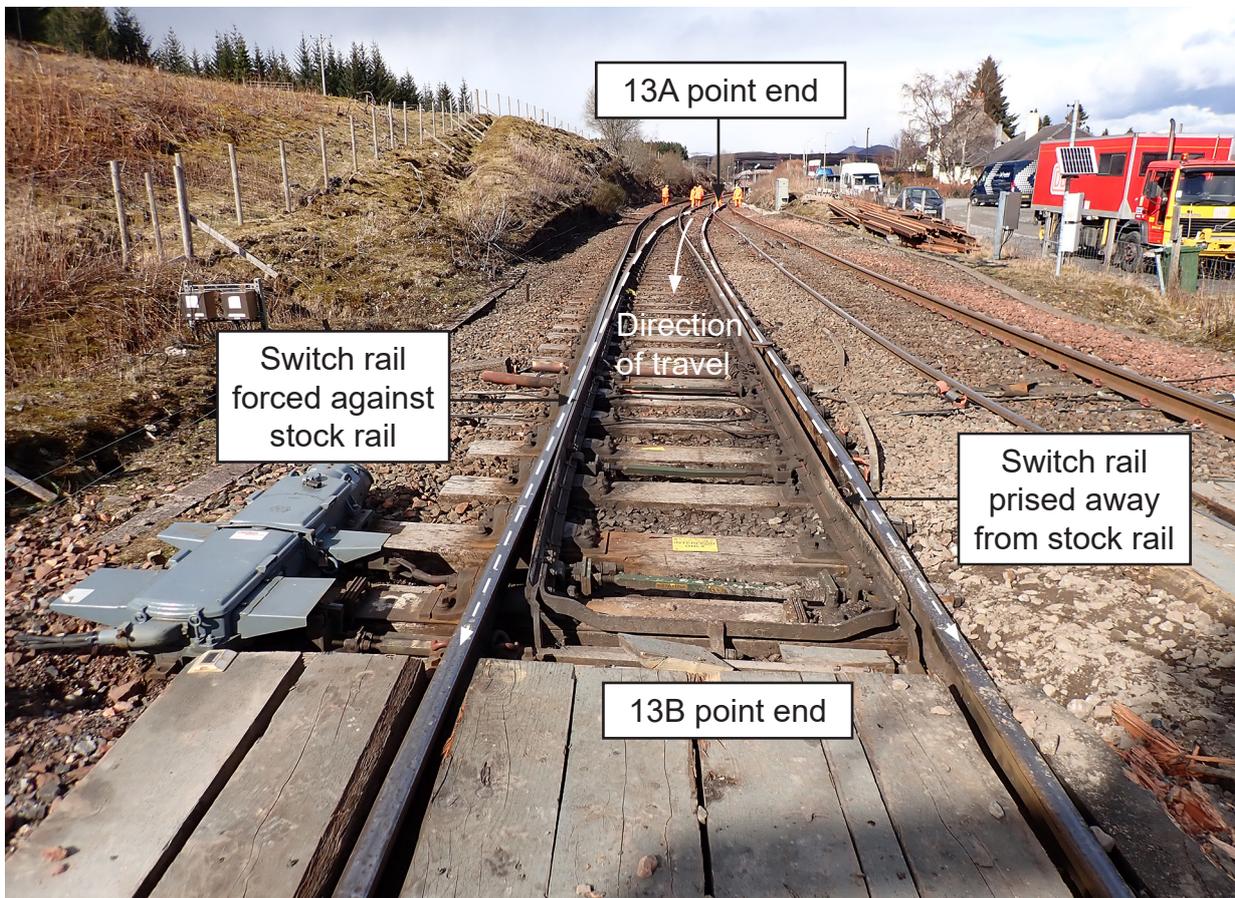
47 RAIB inspected the track and the derailed train at Dalwhinnie finding marks and damage at 13B point end indicating that:

- The left-hand wheels initially encountered the switch rail closed against the stock rail (the fixed rail section within a set of points), and that the train's wheels had prised the switch rail away from the stock rail as they passed.
- The right-hand wheels had forced, and deformed, the opposite switch rail against its stock rail.

Both are consistent with the leading wheelsets being diverted onto the crossover after encountering 13A point end (incorrectly set) in the reverse position, and then encountering 13B point end (correctly set) in the normal position and running through onto the down line in the trailing direction¹⁴ (figures 2 and 8).

Figure 8: Track damage at 13B point end, showing paths of the wheels that ran through

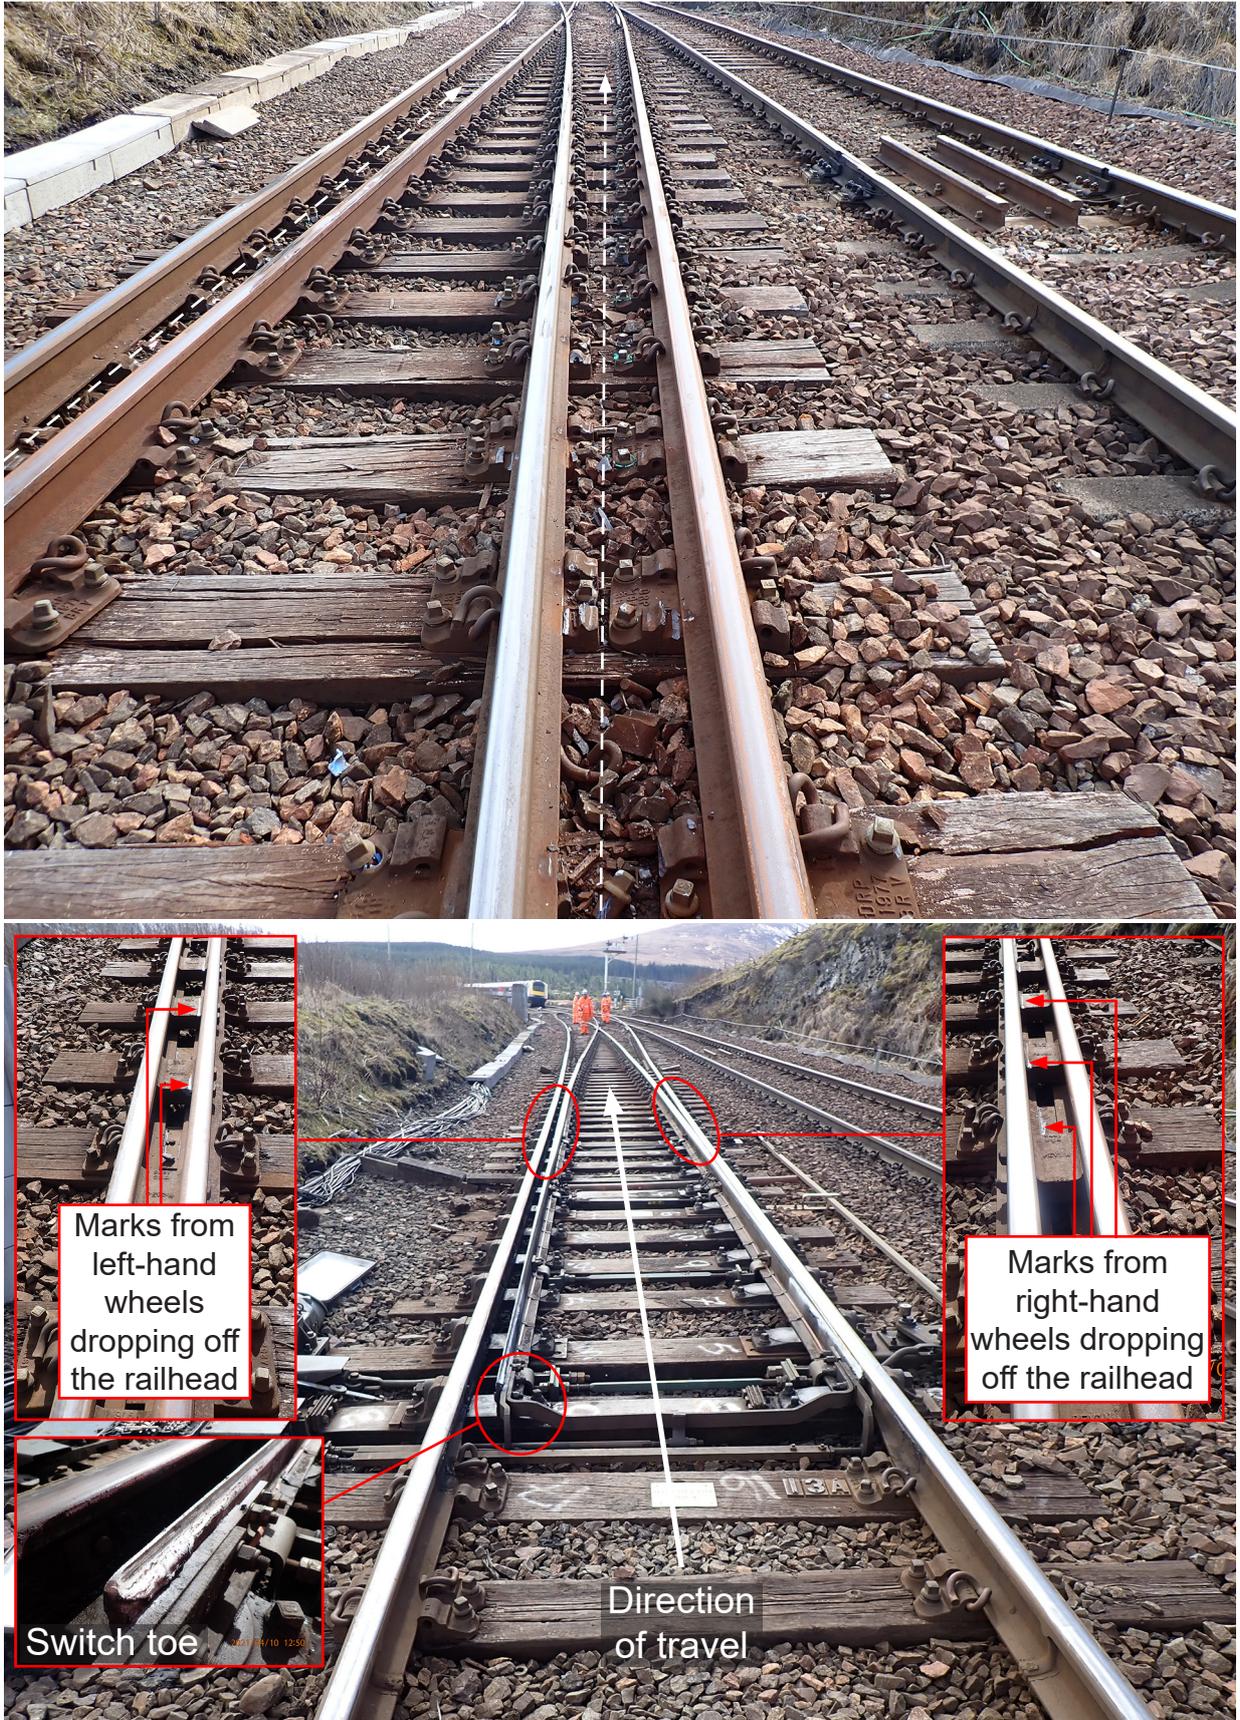
Figure 9: Derailment marks at 13A point end, switch rails in the normal position (as found after the derailment)

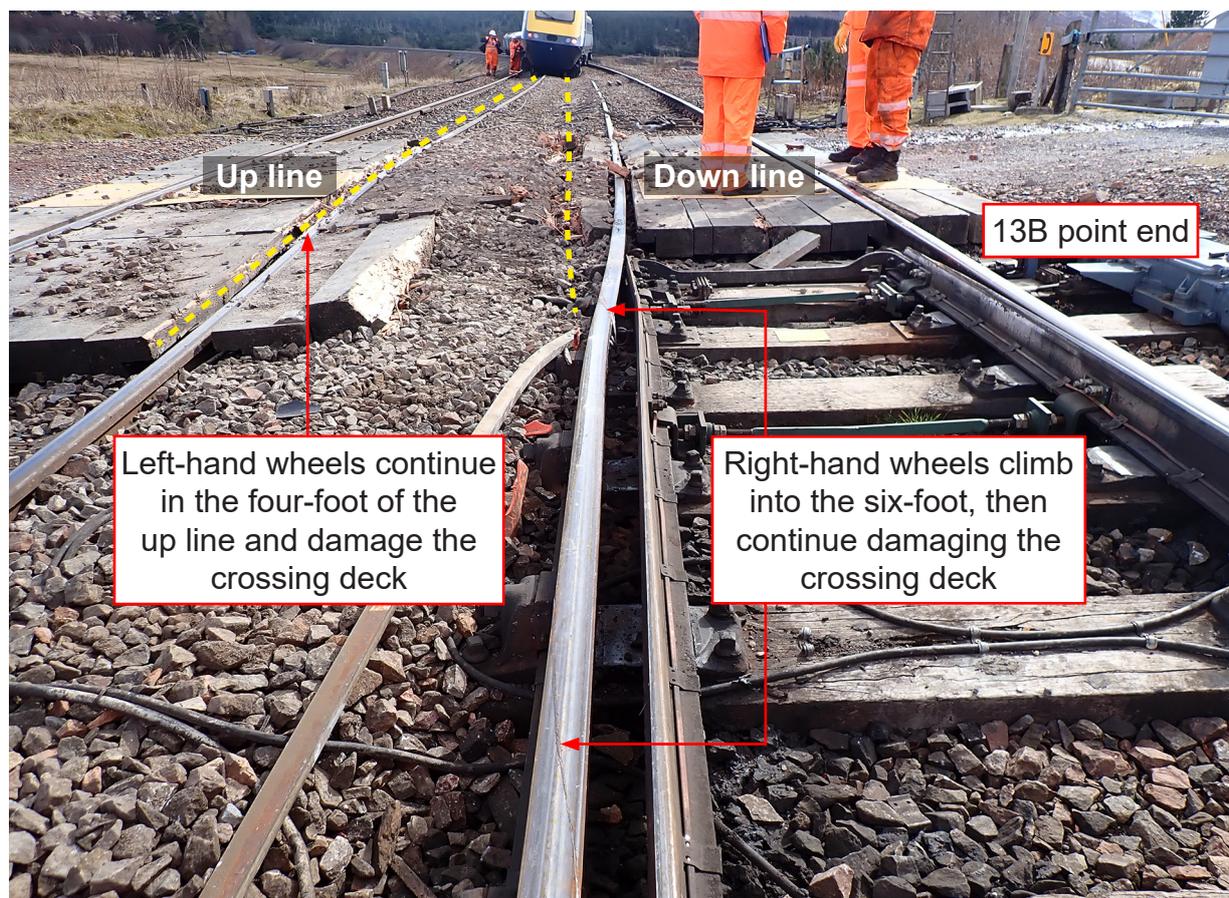
Figure 10: Marks and damage from the last three bogies on the train

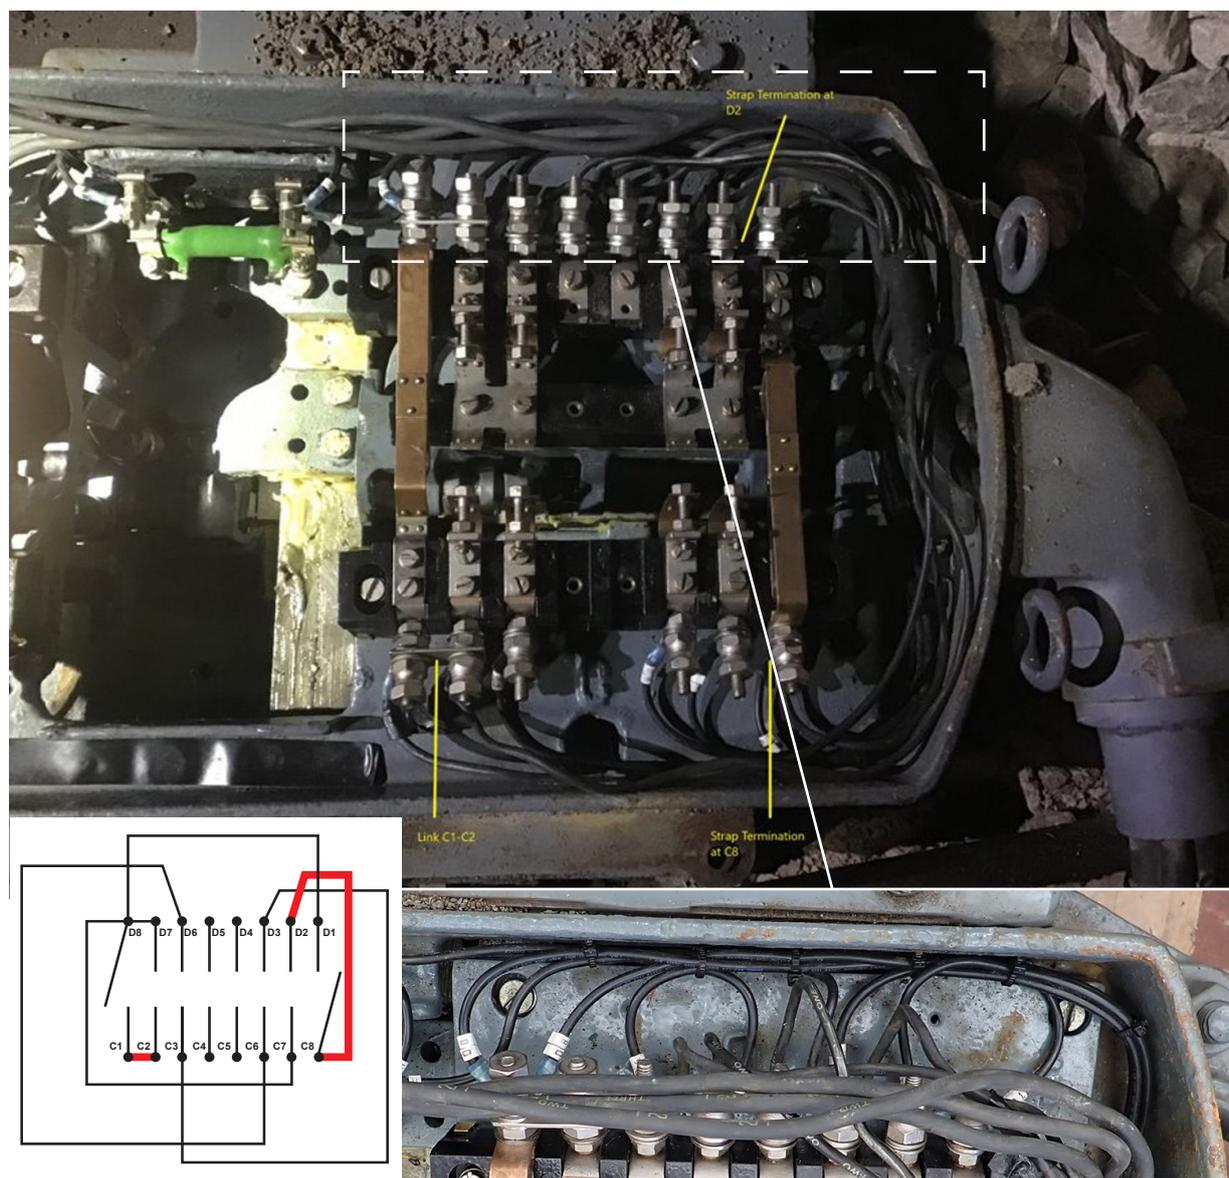
The wiring error was the result of two unwanted conductors, a wire strap and a metal link, within the replacement trailing end point machine. These conductors were only required when this type of point machine was installed at single-ended point locations. The local signalling maintenance team was responsible for installing and testing the replacement point machine. The team did not appreciate that the crossover at Dalwhinnie was unique to the area and that, because of the design of the point position detection circuit that the two point machines shared, these conductors needed to be removed from the point machine when it was installed.

- 82 RAIB has concluded that the additional conductors (the link and the strap) were a part of the internal wiring of the reserviced point machine that was supplied to the depot in Inverness. These conductors are needed so that the detection circuitry functions correctly when GRS 5E type point machines are installed at single-ended point locations. Apart from Dalwhinnie, GRS 5E type point machines are only installed at single-ended point locations on the Highland main line, and witness evidence from staff in Inverness depot was that all recently reserviced GRS 5E type point machines had been supplied with wiring that was compatible with single-ended usage.

- 83 The internal detection circuit wiring in the installed point machine directly matched that on the wiring diagram for a single-ended point location on the Highland main line that was considered typical (Tomatin passing loop), and that the only other wires connected to the detection terminals were the cores of the external tail cables. RAIB found no evidence of any routine maintenance or other work that would have altered detection circuit wiring after the 13B point machine was installed and before the derailment.

Figure 12: Additional link and wire strap (red) found in point machine at 13B point end (main photograph courtesy of Network Rail – annotation Network Rail). Inset photograph below shows example of use of cable ties to bind wires

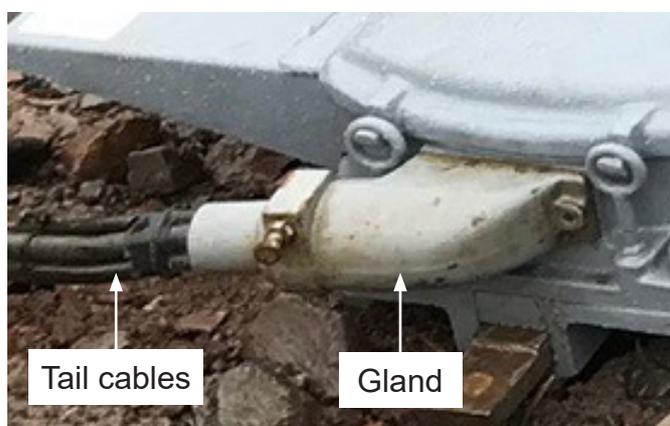
127 The condition of the gland shown on the photograph of the newly-installed point machine is consistent with the tail cables having been transferred in this way (figure 14). Witness evidence supports both this, and that installer A’s focus did not extend to considering the internal detection circuit wiring. He had not considered this necessary because of the pre-installation checking work that he had done (paragraph 106).

Figure 14: Enlargement of figure 8 showing the tail cables and gland. Paint discolouration is evidence that the gland is from the point machine that was replaced (photograph courtesy of Network Rail)

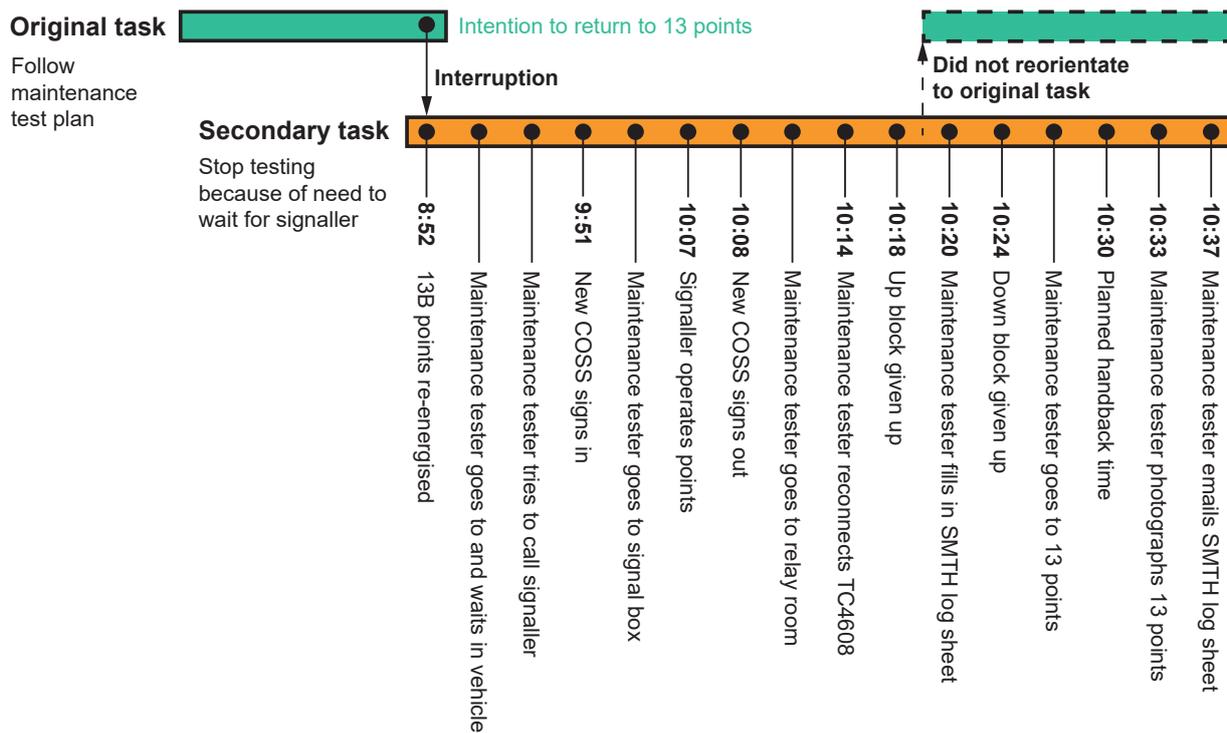
Figure 15: Timeline of events relating to the renewal of the 13B point machine and the interruption resulting from the need to wait for the signaller to book on duty

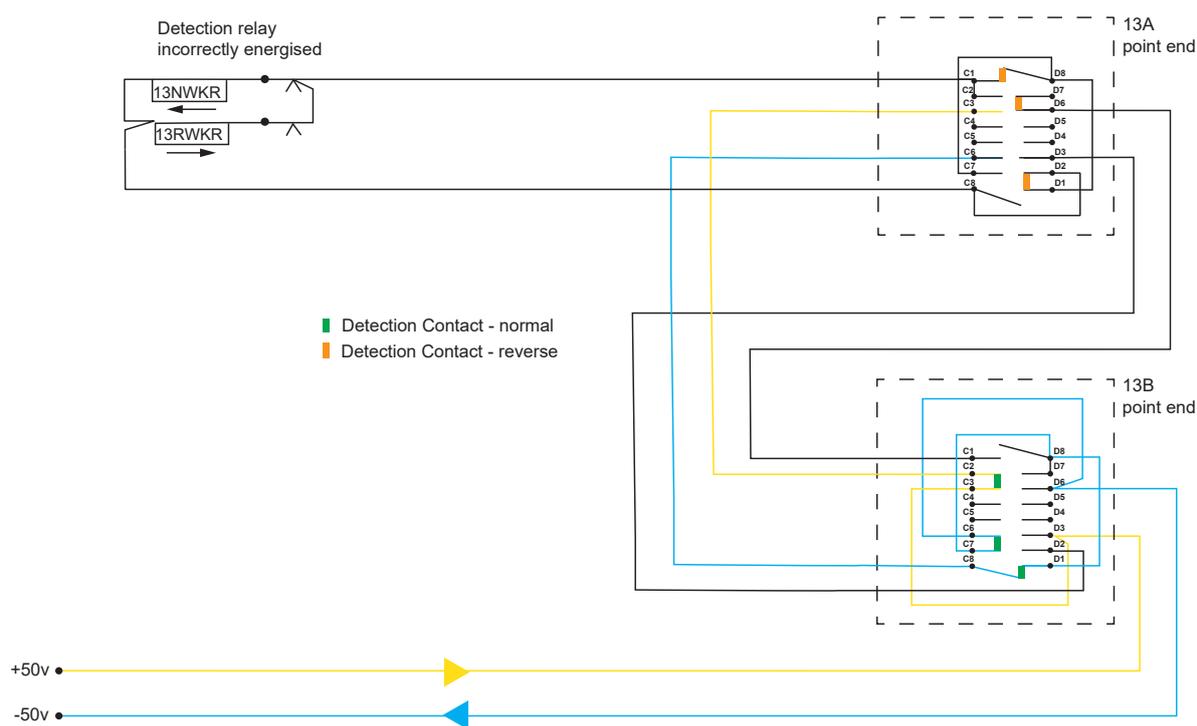
Figure B3: As-designed detection circuit for 13 points showing 13A point end reverse and 13B point end normal – neither detection relays energise

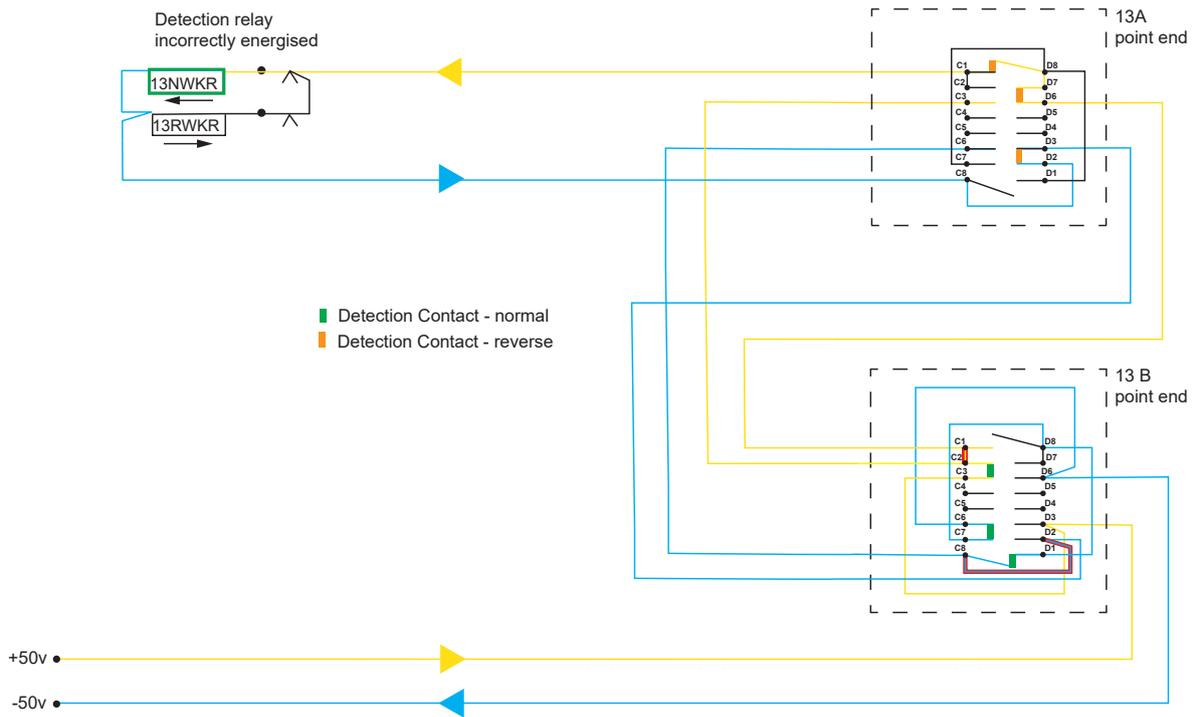
- B9 With the switch rails at 13A point end in the reverse position, and those at the 13B point end in the normal position (paragraph 81), 13 points were out-of-correspondence. For this condition, analysis of the as-designed circuit shows that neither of the detection relays should have energised (figure B3). However, with the two additional conductors in the point machine at 13B point end (between terminals C1 and C2; and C8 and D2) detection relay 13NWKR is incorrectly energised (figure B4).

Figure B4: Detection circuit for 13 points with additional conductors (red) showing 13A point end reverse and 13B point end normal – detection relay 13NWKR is incorrectly energised
