Rail Accident Investigation Branch

Rail Accident Report

**Two trains in the same signal section at South
Wingfield, Derbyshire
26 October 2022**

Report 11/2023
October 2023

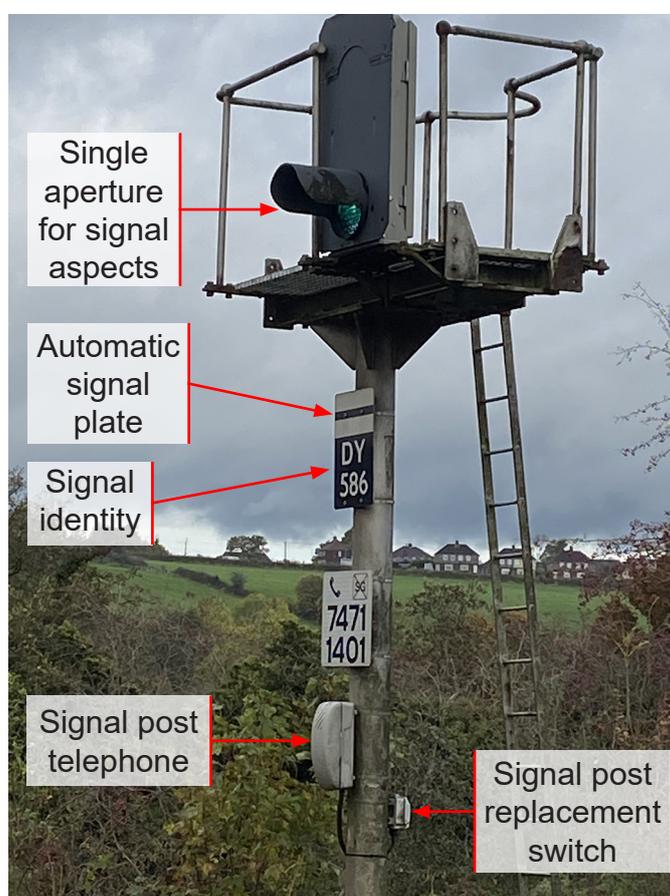
Figure 5: Signal DY586.

- 15 Signal DY586 is a three aspect, colour light signal (figure 5), meaning it can display a red, yellow or green aspect. It has a light emitting diode (LED) signal head so it can display all three colours through a common single aperture.

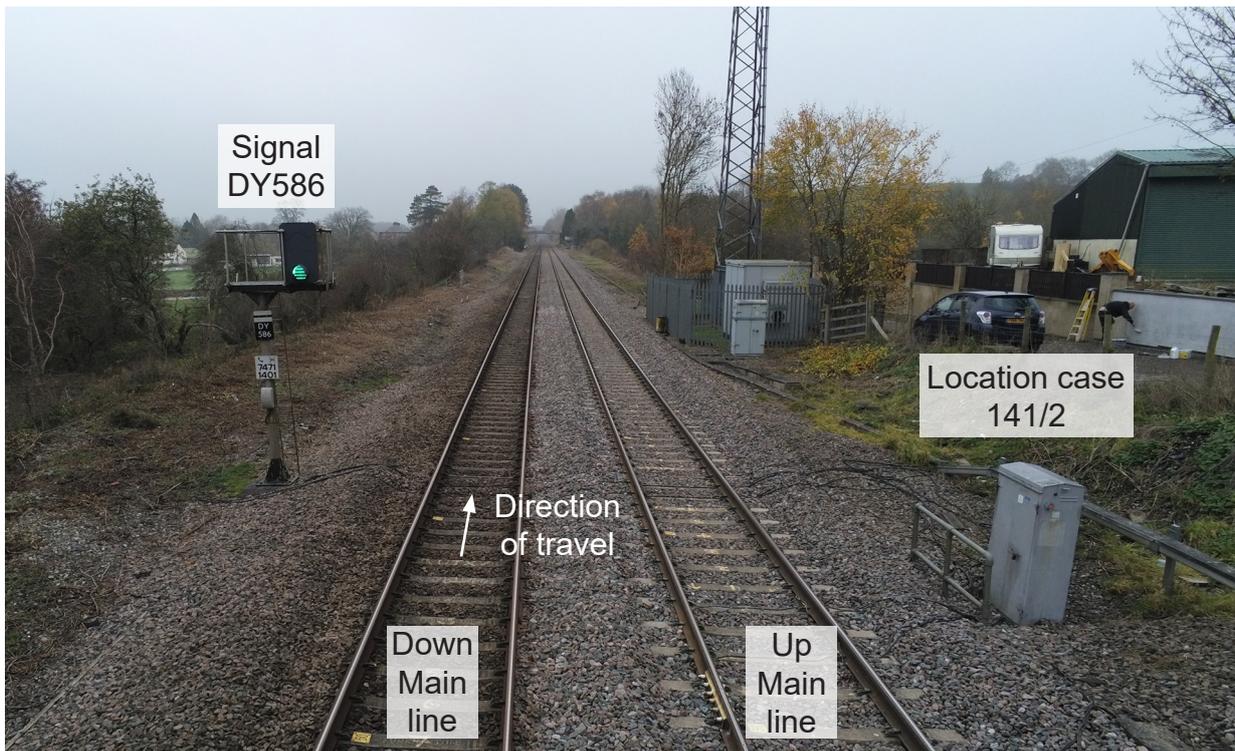
Figure 6: Location case 141/2 in relation to signal DY586.

- 16 Signal DY586 is located next to the Down Main line. The cabling for the signal runs under both tracks to an equipment cabinet, known as a location case. It is numbered 141/2 and is on the opposite side of the railway to the signal (figure 6). The location case contains terminal bars that the external cables running to and from trackside signalling equipment and other location cases further along the railway are connected to. Also connected to the terminal bars is the wiring inside the case, going to equipment such as relays, transformers, power supply busbars and fuses.

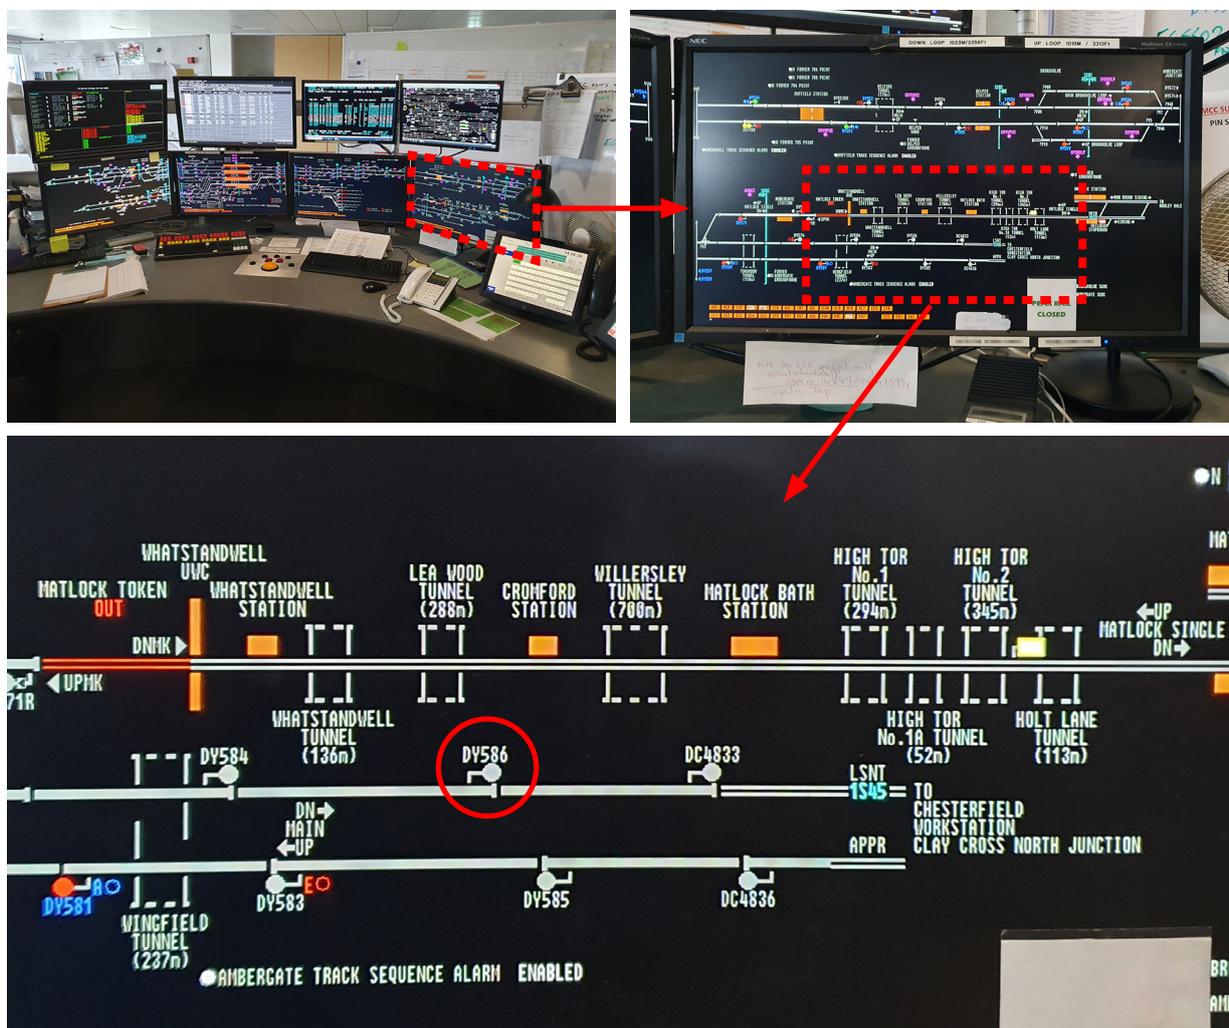
- 21 Signalling design practices in 1969, around the time the Ambergate interlocking was commissioned, did not require signallers to have any controls to change the aspect displayed by automatic signals. Therefore, the Derby workstation signaller was not able to command signal DY586 to display a red aspect. These practices also limited what information the signalling system needed to provide to signallers, so information about what aspect the signal is displaying is not passed back to either the Derby or Chesterfield workstations. On the workstations, the signallers can see a symbol providing the location of signal DY586 but, while other signals might indicate the aspect being displayed, this is greyed out for signal DY586 (figure 7). It is the same on the Chesterfield workstation.

Figure 7: The Derby workstation (top left image), a workstation display screen showing the Wingfield area (top right image), and a closeup of signal DY586 greyed out on the workstation display.

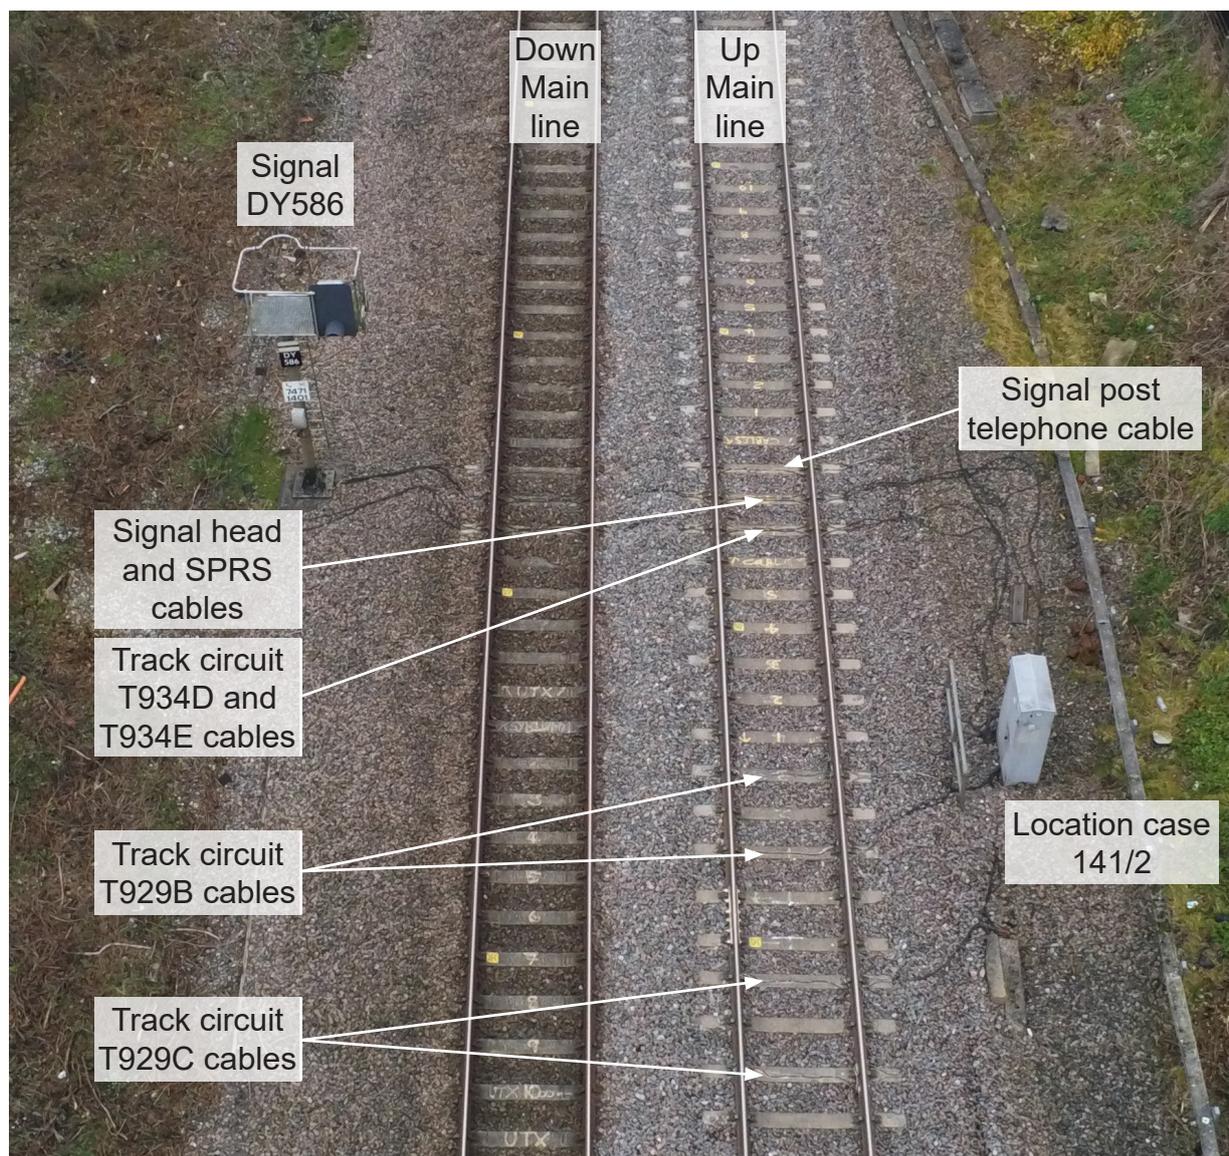
Figure 8: The cables disconnected by the signalling group.

- 47 At about 04:15 hrs, once the on-track machines were clear of the area in the vicinity of signal DY586, the signalling group started reconnecting the signalling cables. The on-track machines completed the second pass at 04:40 hrs and then headed north on the Up Main line, moving clear of where the signalling related work was taking place by 05:04 hrs.

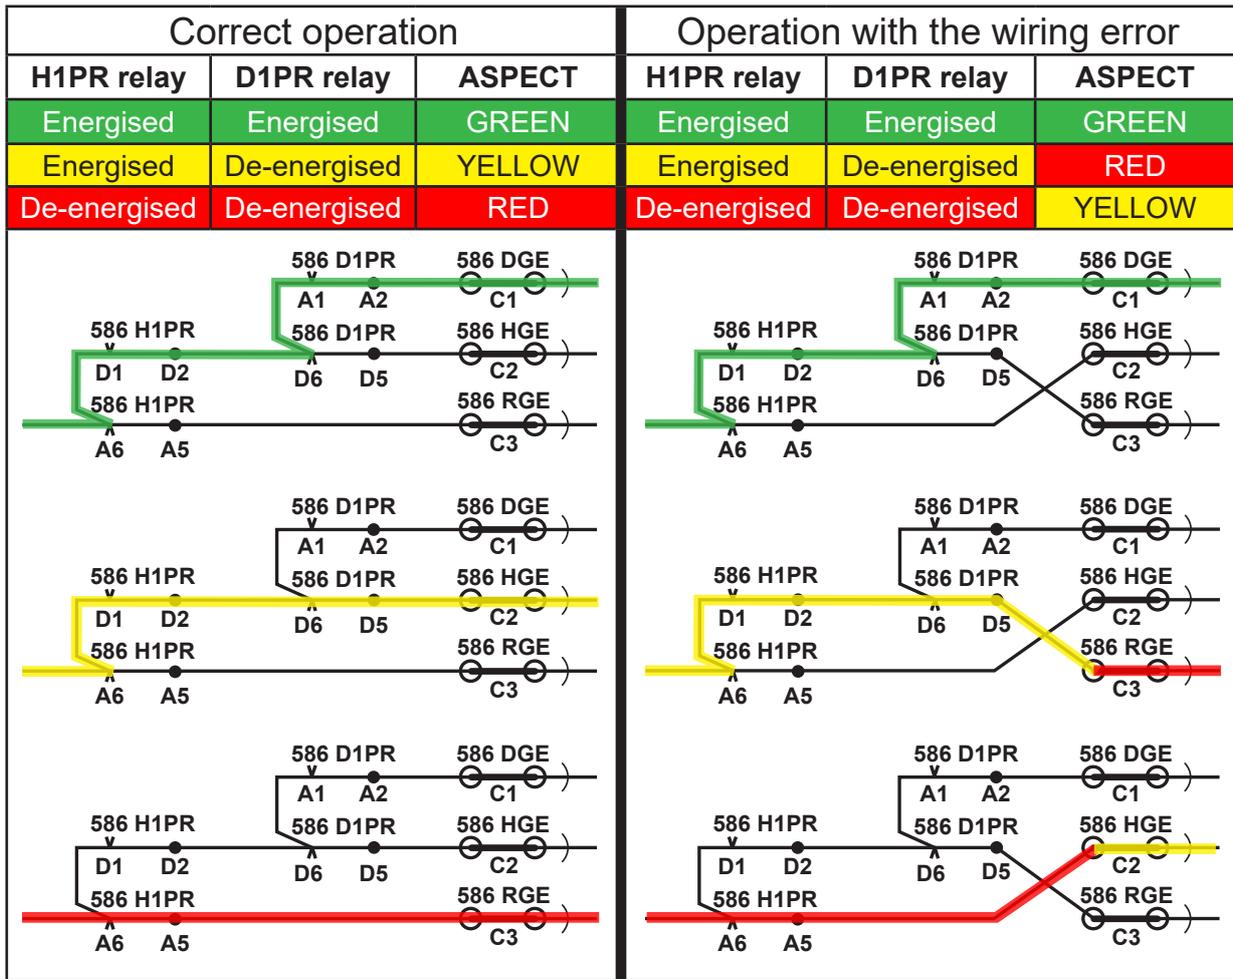
Figure 10: The operation of the relays and the aspect displayed by the signal.

- 64 With the internal wiring to links C2 and C3 transposed, when the 586D1PR and 586H1PR relays were energised, the signal correctly displayed a green aspect (figure 10). With only the 586H1PR relay energised, the signal incorrectly displayed a red aspect instead of a yellow aspect. With neither relay energised, the signal incorrectly displayed a yellow aspect instead of a red aspect.

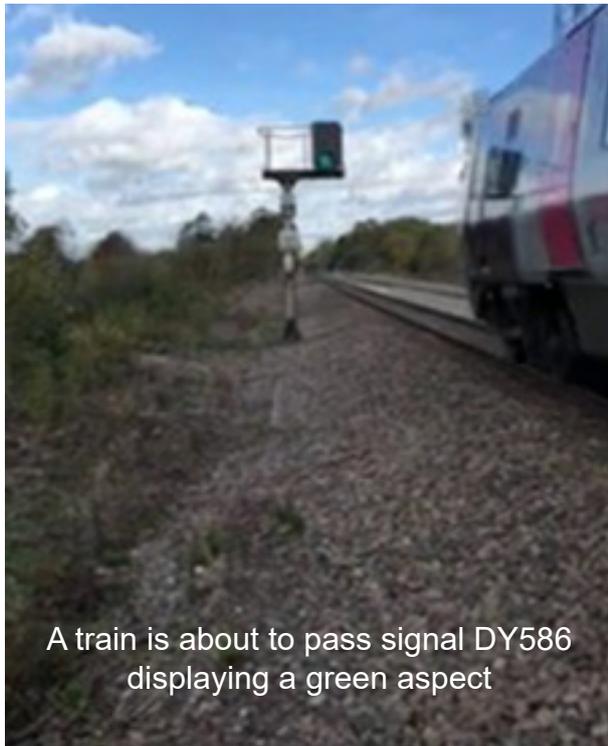
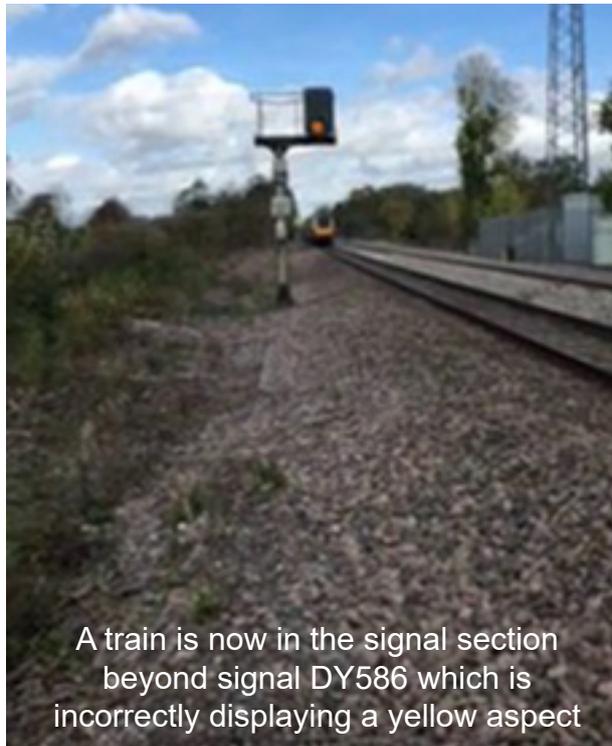
- 60 The local signalling maintenance team who attended afterwards (paragraph 6) found the internal wire for the signal's red aspect was connected to terminal C2, the yellow aspect output, whereas it should have been connected to terminal C3, which corresponds to the red aspect output (figure 9). Conversely, the team found the internal wire for the signal's yellow aspect was connected to terminal C3 instead of terminal C2. This wiring configuration meant the signal's red and yellow aspects were transposed.

- 65 The forward-facing CCTV footage from the two trains supported the accounts given by both drivers as to what aspects the signal displayed when each train approached. A data logger in location case 141/2, which recorded the state of the two relays, evidenced what aspect the signal should have displayed to each train driver. The local signalling maintenance team who attended (paragraph 58) recorded a video of the signal incorrectly displaying its red and yellow aspects as a train was passing it (figure 11). The team also recorded the incorrect wiring when it diagnosed the problem with the signal.

Figure 11: Stills from the video footage recorded by the local signalling maintenance team showing signal DY586 displaying the incorrect aspect (courtesy of Network Rail).

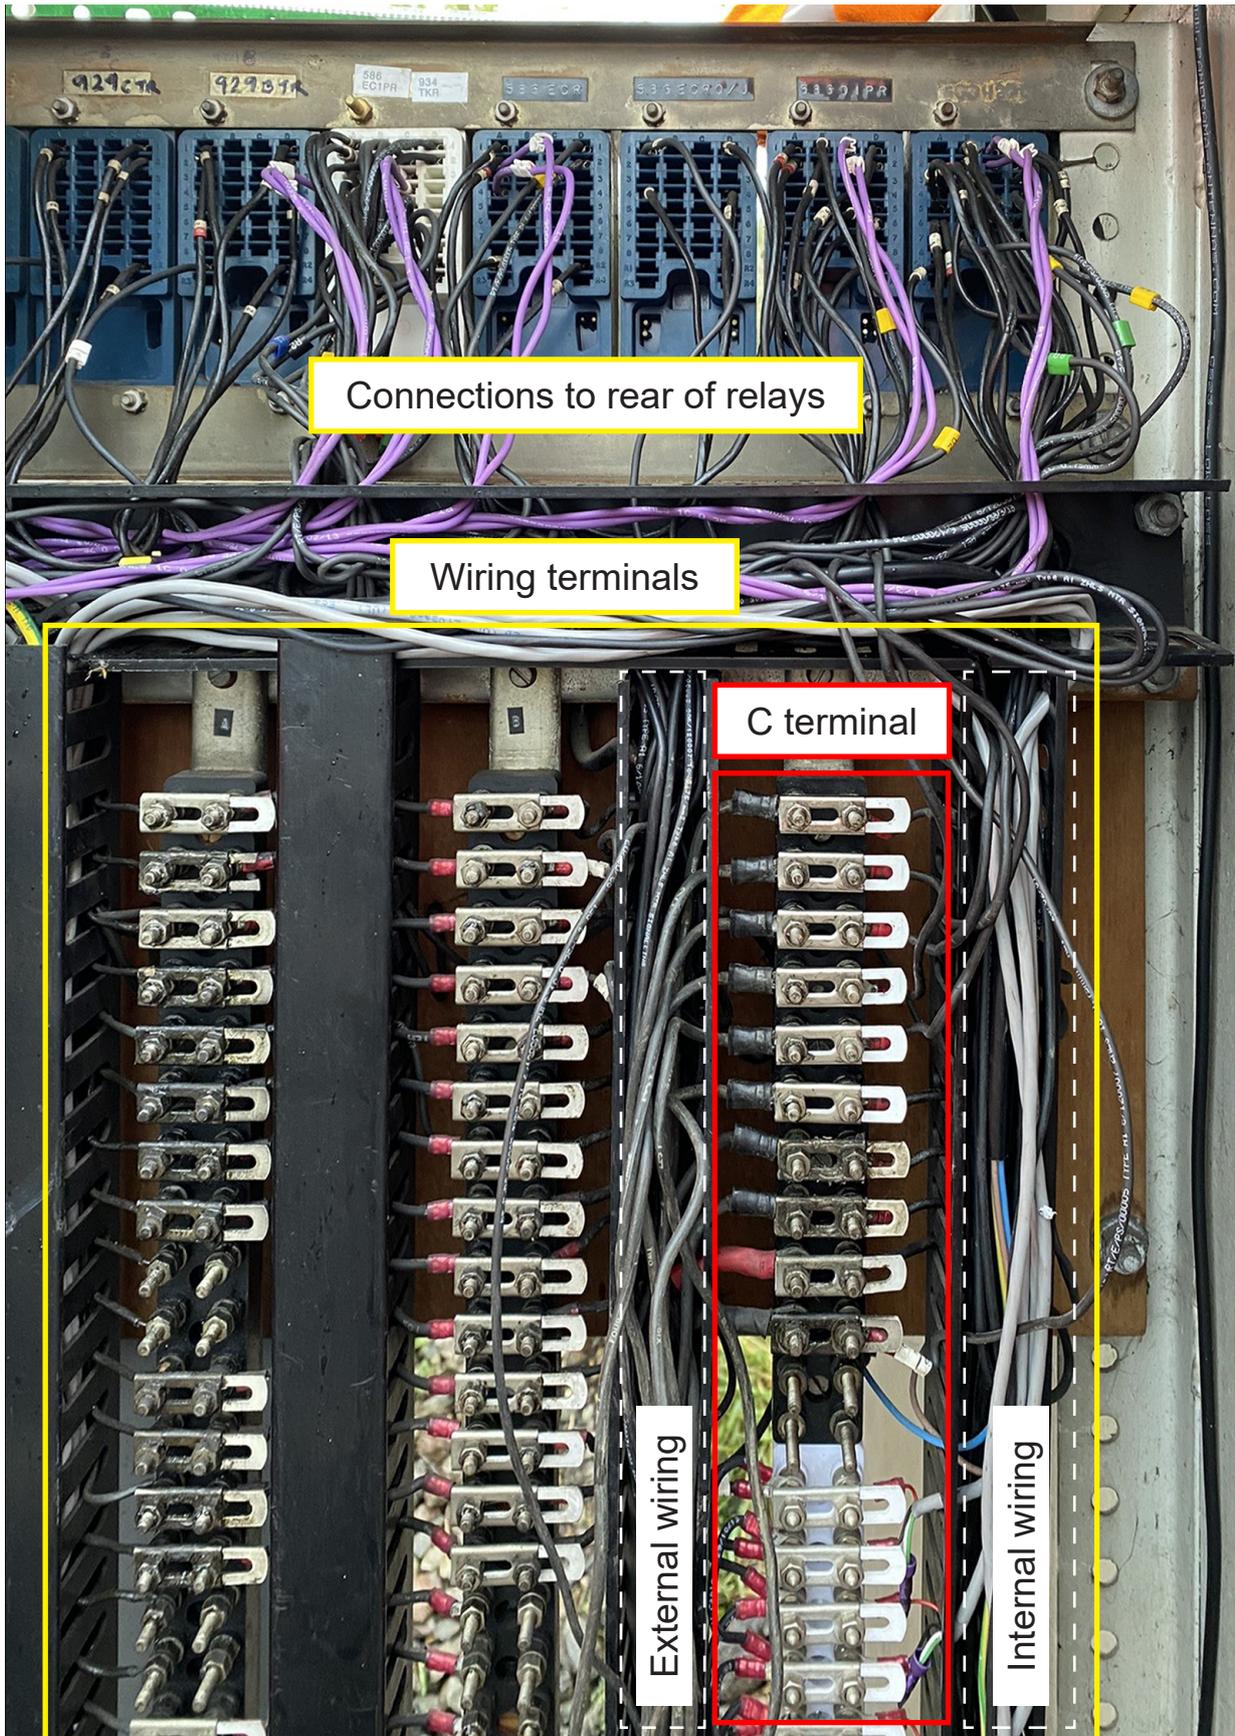
Figure 12: The wiring terminals within location case 141/2.

- 71 Before SMT2 disconnected any wiring, they were required by SMTH test plan NR/SMTH/Part04/CA12,¹⁵ 'Remove and Refit a Multi-core Cable', to carry out a pre-disconnection wire count. A wire count is a visual examination to check that the number of wires on each termination point corresponds to the applicable signalling circuit diagram. SMT2 did not have the drawings at the time but called out to SMT1 their observations that core one of the cable to the signal was connected to terminal C1, core two to terminal C2 and so on. SMT1 later recorded this information on a wire count sheet at the end of the night. To see which of the external cable's cores were which, SMT2 began disconnecting the wiring for the signal at the same time as they carried out the wire count.

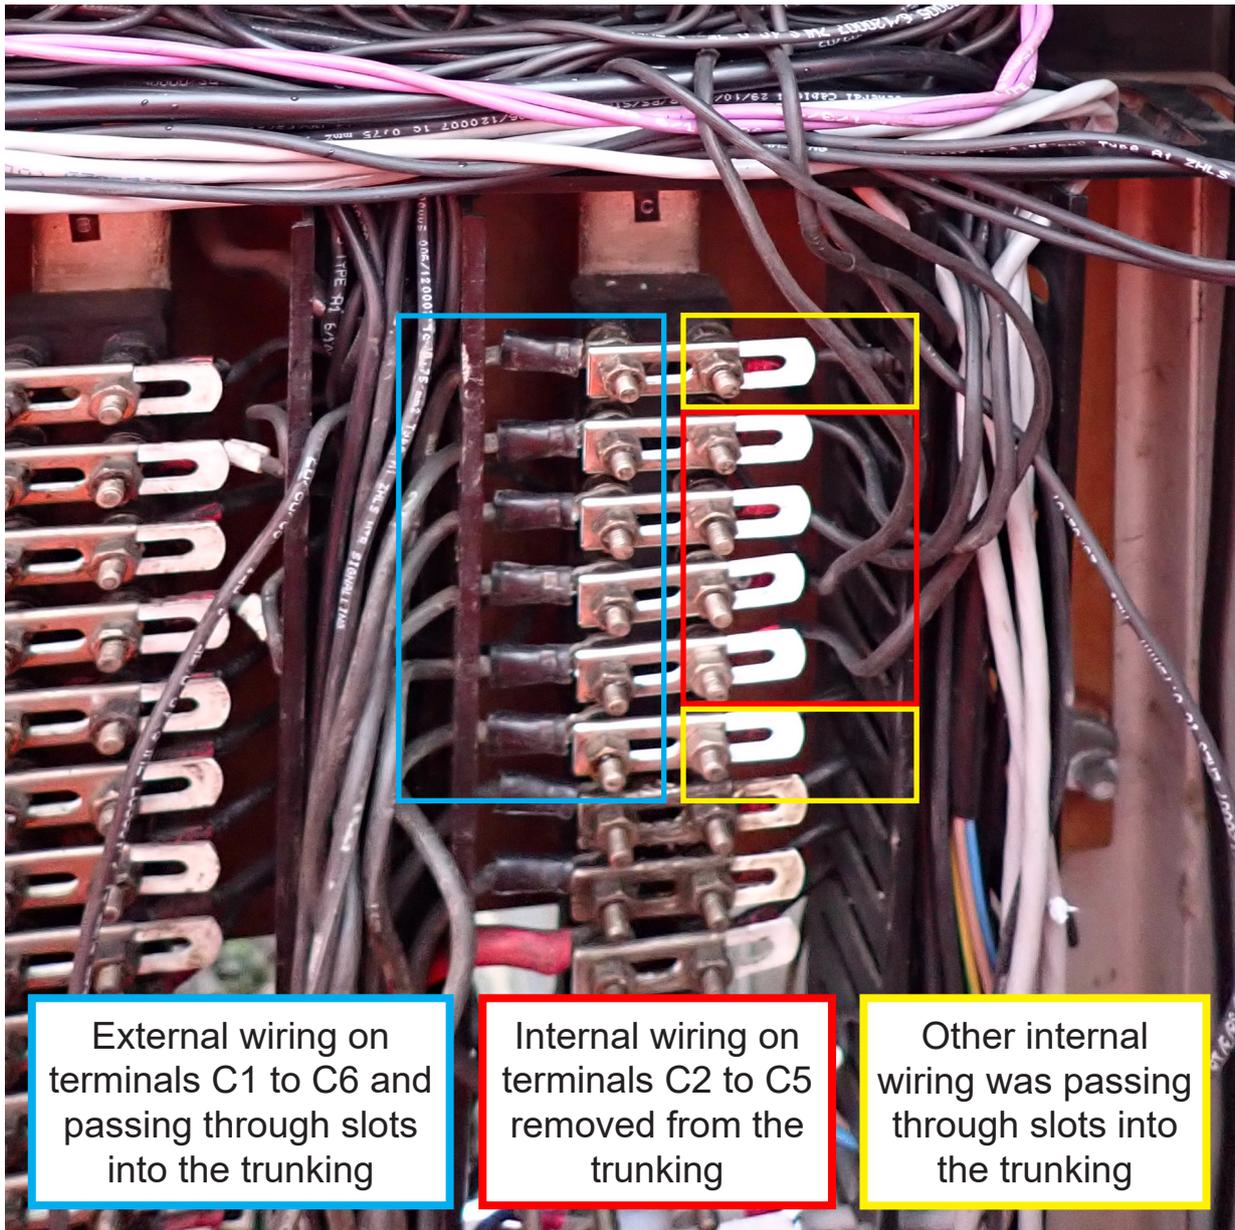
Figure 14: Close-up of the internal wiring on terminals C1 to C6.

- 72 Photographs and videos taken after the incident by the local signalling maintenance team, with the fault still present, showed the internal wiring on the right-hand side of terminals C2, C3, C4 and C5 had been removed from the wiring loom and cabling trunking at some point (figure 14). None of these wires ran through the slots in the side of the trunking and into the wiring loom, whereas the other internal wires on this terminal bar did. This suggests that the internal wires on the right-hand side of terminals C2, C3, C4 and C5 had been disturbed since they had been installed.

- 73 RAIB has concluded from witness evidence that it was probably SMT2 who mistakenly disconnected the wiring on the wrong side of the terminals. This included disconnecting the internal wiring on terminals C2 and C3 for the signal's red and yellow aspects.

- 74 SMT2 stated that they cannot remember disconnecting the internal wiring. No one monitored what SMT2 was doing when they disconnected the external cable because they were certified, and held an authority to work issued by their employer, which allowed them to undertake these installer activities unsupervised (see paragraphs 139 and 140). Consequently, there is no witness evidence from anyone else who was present to confirm whether it was SMT2 who had disconnected the internal wiring.

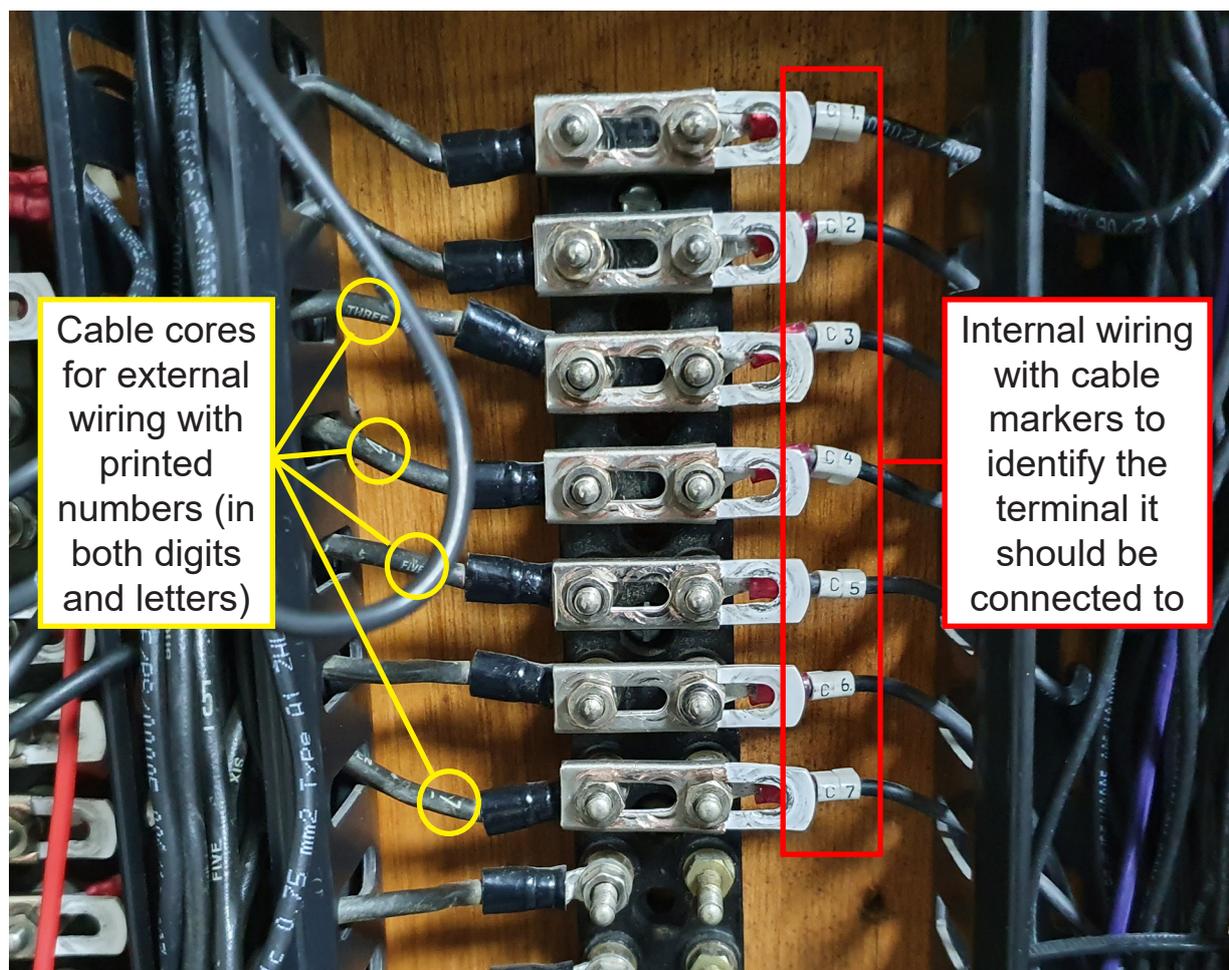
Figure 15: Example of how cables can be identified.

75 Due to its age (paragraph 21), there was no requirement to fit labels to the wiring either side of terminals C1 to C6 when this wiring was first installed or retrospectively. That meant there were no labels fitted to this wiring to identify it as either internal or external wiring, although the external cable wiring could be identified from its thickness and the cores having their respective core number printed on them (figure 15). However, it was dark when SMT2 was identifying what wiring to disconnect, with the only source of light coming from their headtorch, so picking out these subtle differences in the wire types would have been challenging. The location case was not fitted with any internal lighting, none of the signalling group used portable lighting to illuminate where they were working, and there were no nearby external light sources (paragraph 30).

- 76 Although it was common for members of the signalling group to work only by the light from their headtorch, it is possible that this lack of lighting, a lack of cable markers, and SMT2 not directly referring to a correctly annotated drawing, led SMT2 into mistakenly disconnecting the wiring on the wrong side of the terminal bar. RAIB has also concluded that SMT2 probably reconnected the internal wiring onto the terminals after realising their error, but that they inadvertently crossed the two internal wires going to the C2 and C3 terminals as they did so.

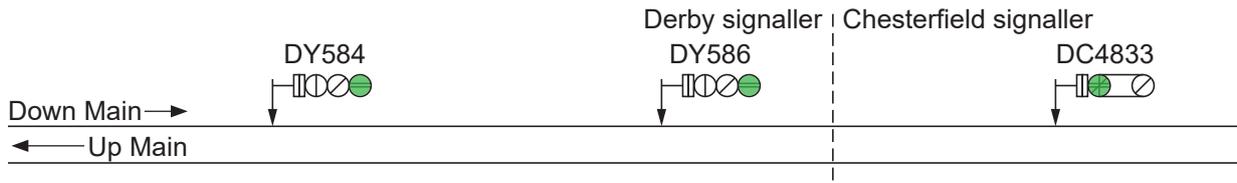
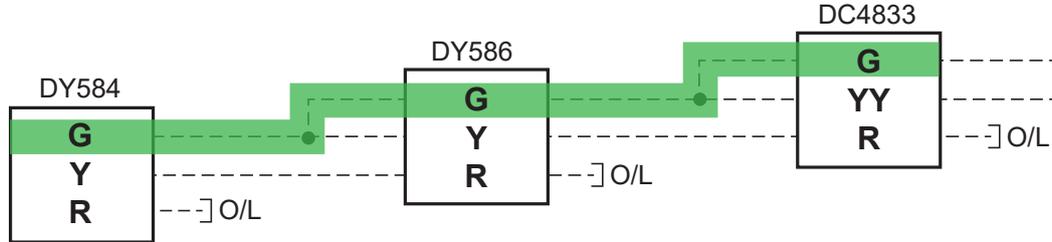
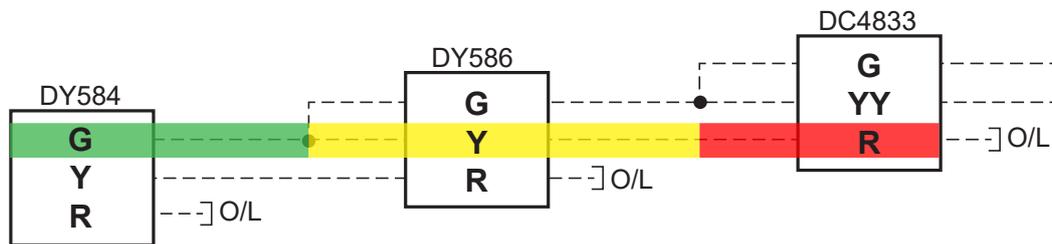
Figure 17: The aspects shown by signal DY586 through the actions taken by the Chesterfield signaller.

- 94 When SMT1 started to test signal DY586 it was displaying a red aspect. Instead of slipping links in the location case, SMT1 initially tried asking the signaller to change the signal's aspect. SMT3 called the Chesterfield signaller on behalf of SMT1 and asked the signaller to provide a green aspect on signal DY586. To do this, the Chesterfield signaller removed controls applied to two track sections beyond the first signal under their control, signal DC4833. This caused signal DC4833 to change from a red to a green aspect. This in turn caused signal DY586 to change from a red to a green aspect (figure 17). In their call to the signaller, SMT3 confirmed that signal DY586 was now displaying a green aspect.

- 95 About three minutes later, after the testers had completed their tests for the green aspect, SMT3 called the Chesterfield signaller again and asked if they could get signal DY586 to display a yellow aspect. The signaller reapplied controls to the two track sections which caused signal DC4833 to show a red aspect. As soon as this was done, SMT3 reported that signal DY586 had changed but was now also displaying a red aspect (figure 17). The signaller was confused as they expected with signal DC4833 at red, that signal DY586 would be showing a yellow aspect. The signaller then removed the controls from the track sections and instead operated an emergency replacement control for signal DC4833 which caused the signal to again display a red aspect. As soon as this was done, SMT3 reported to the signaller that signal DY586 was again displaying a red aspect. At this point, the signaller concluded that perhaps it was not possible to get signal DY586 to display a yellow aspect from that workstation and the call ended.
