Rail Accident Investigation Branch

# Rail Accident Report

**Two signal passed at danger incidents, at Reading Westbury Line Junction, 28 March 2015, and Ruscombe Junction, 3 November 2015**

Report 18/2016  
September 2016

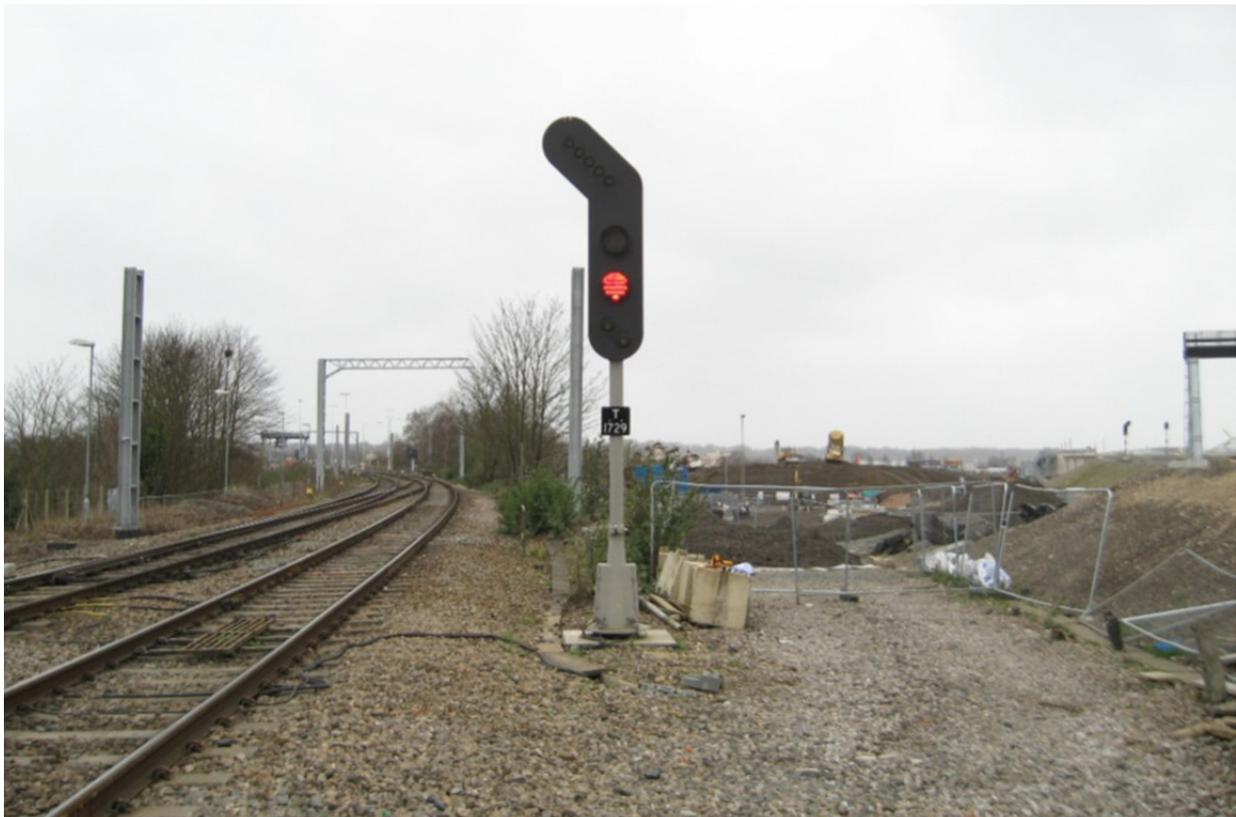
- 7 T1729 is a four-aspect LED signal located on the right-hand side of the *bidirectional* Up Westbury line at 36 miles 29 *chains*, approaching Reading Westbury Line Junction to the west of Reading station (figure 2). For the path that train 7C29 took on 28 March 2015, this signal is preceded by two similar four-aspect signals. Permissible speed at this location is 40 mph (64 km/h).
- 8 On the morning of 28 March 2015, signal T1729 was being held at danger because the parallel signal (T1727) was showing a proceed aspect to allow for the passage of passenger train 2K32 (figure 3).

Figure 2: Signal T1729 at Reading Westbury Line Junction (image courtesy of DB Cargo (UK) Ltd)

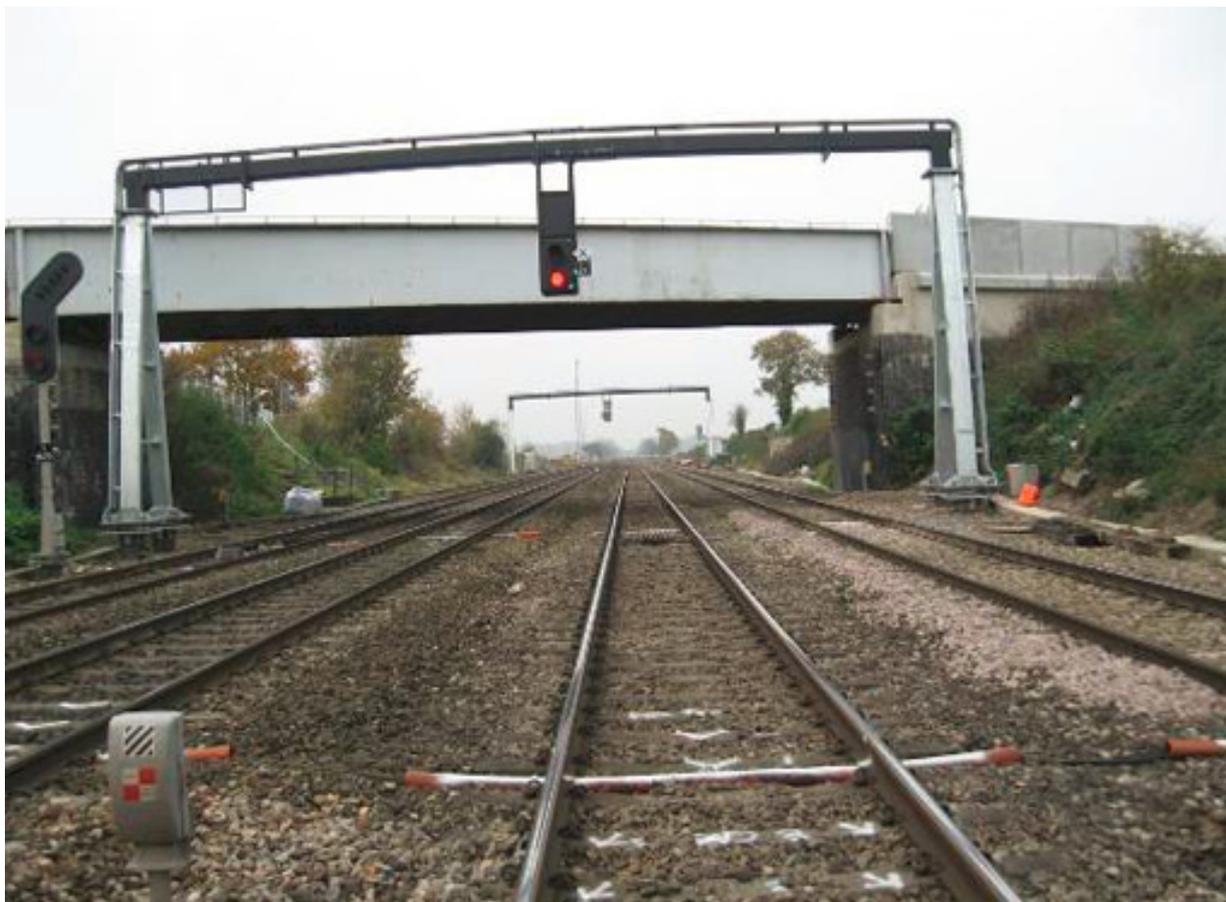
- 9 T1627 is a gantry-mounted four-aspect LED signal protecting Ruscombe Junction on the Down Relief line at 29 miles 16 chains, to the east of Twyford station (figure 4). Its preceding signals are T1623 (four-aspect) and T1611 (three-aspect), meaning that when T1627 is at danger the two signals on the approach to it show green and single yellow respectively. Permissible speed at this location is 60 mph (97 km/h) for freight trains and 90 mph (145 km/h) for passenger trains, although the maximum permitted speed for the train concerned was 45 mph (72 km/h) (see paragraph 15).

Figure 4: Signal T1627 at Ruscombe Junction (image courtesy of DB Cargo (UK) Ltd)

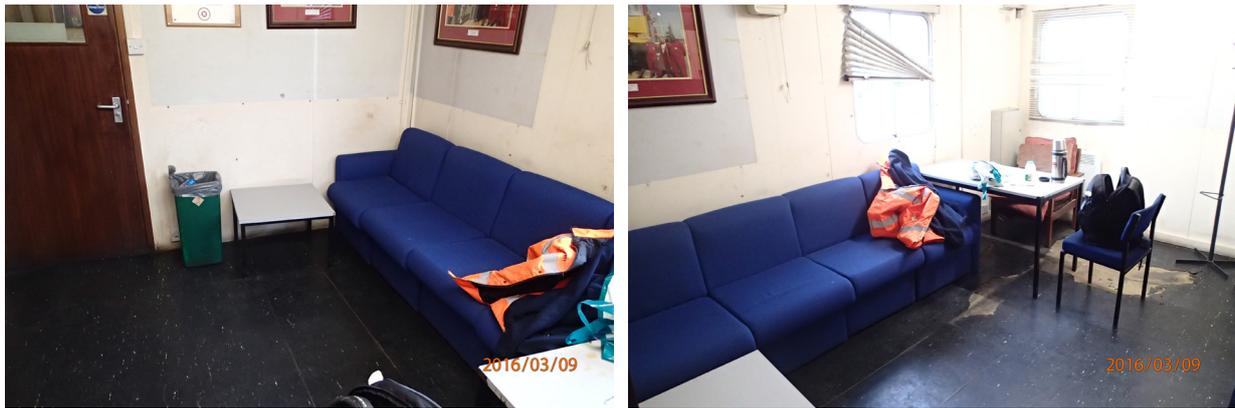
- 72 Evidence gathered during the current investigation found widespread dissatisfaction with the standard of the drivers' facilities at Acton train crew depot relative to equivalent facilities at other depots. The RAIB's inspection confirmed that the designated rest facility at Acton was not conducive to napping because of the amount of noise, its location (being on a through route between other rooms), and the unsuitability of the furniture for napping (see figure 6).

Figure 6: The rest facility at Acton train crew depot

123 Although DB's current position largely meets the requirements of these recommendations, RAIB notes that the facilities provided for napping at Acton depot were not fit for purpose (paragraph 68).
