Rail Accident Investigation Branch

Rail Accident Report

Autumn Adhesion Investigation Part 2: Signal LW9 Passed at Danger at Lewes 30 November 2005

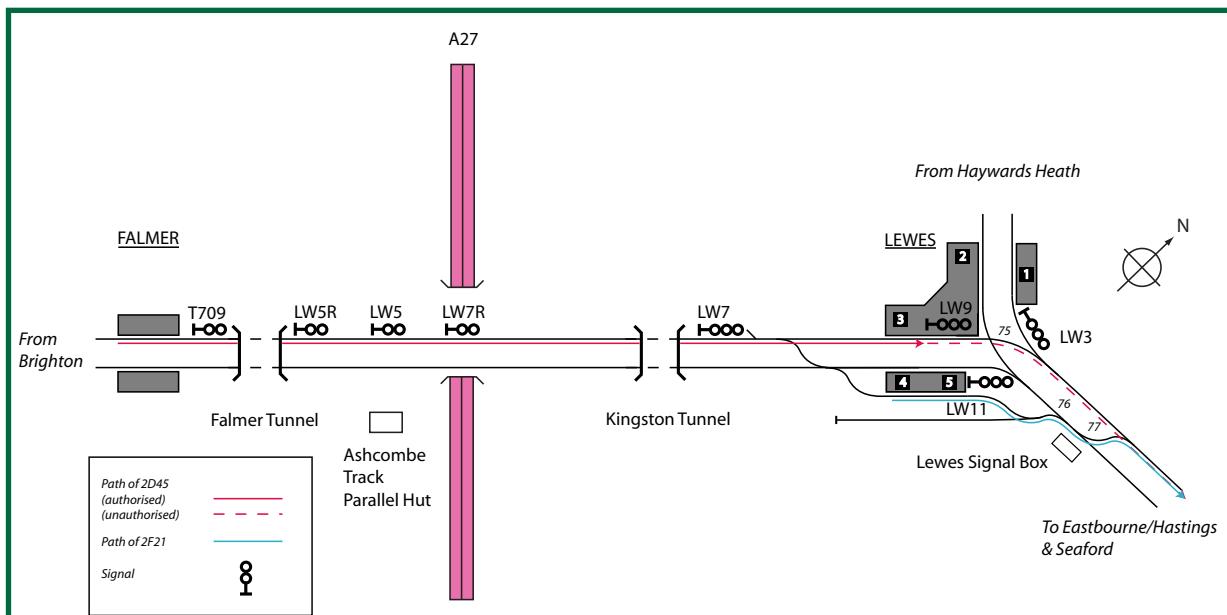
Figure 2: Track layout showing location of incident.

- 24 Figure 2 shows the general layout of the area where the incident occurred. Lewes is located at the junction of two routes, one from London via Haywards Heath and the other from Brighton. The two routes have their own platforms at Lewes, the junction being located to the east of Lewes station.
- 25 Lewes station has 5 platforms, with Platforms 1 and 2 being used by trains from and to London respectively and Platforms 3 and 4 being used by trains from and to Brighton respectively. Platform 5 can be used by trains running to and from Brighton but is also used by trains approaching from the east that terminate at Lewes.

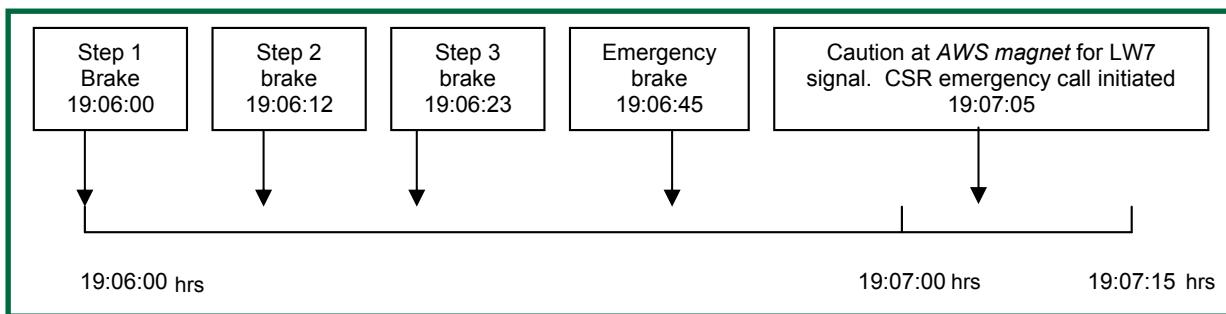
Figure 3: Timeline of key events before driver of 2D45 made CSR emergency call to signaller.

- 61 On realising that there was a possibility that signal LW9 could be passed at danger, the driver made an emergency call to the signaller via the CSR. The RAIB has considered whether the CSR emergency message could have been sent earlier, which might have allowed the signaller to stop train 2F21 before it departed from Lewes. Figure 3, shows a timeline of the key events leading up to this incident:

- 62 As signalling between Falmer and Lewes is of the three aspect variety, it was not until the signal preceding LW9 (signal LW7) was sighted that the driver knew whether there was a possibility of passing Signal LW9 at danger. The timeline in Figure 3 shows that within 20 seconds of selecting emergency braking, and at the same time as the train passed the *AWS magnet* located 183 metres from Signal LW7, the driver initiated the emergency call. But it was only within this period of 20 seconds that two key facts would have become apparent to the driver:

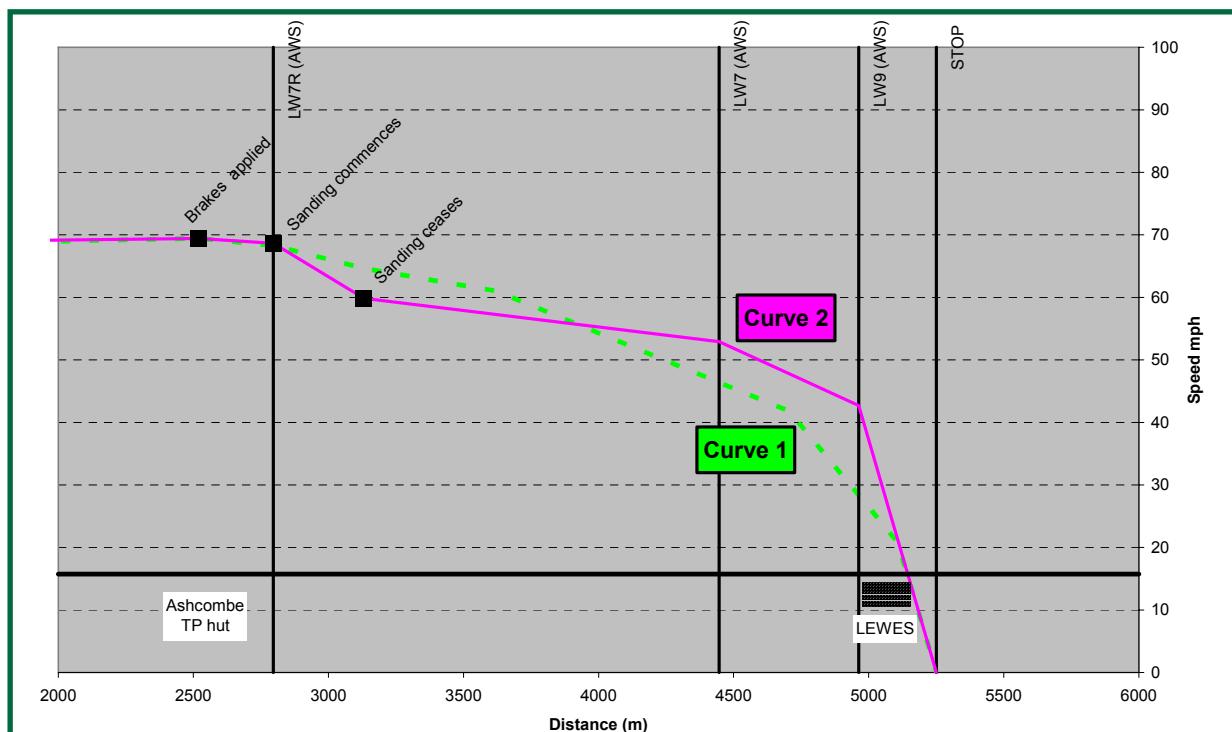
Figure 4: Distance speed graph depicting the events at Lewes on 30 November 2005.

81 Figure 4 shows estimated train speeds during the incident derived from the following sources:

- Calculated speeds based on the times at which the train passed the AWS magnets, which are located on the approach to the signal (Curve 1, green). This has been used as a measure of train speed that is independent of the figures estimated by the WSP system and reflected in the OTMR data.
- ‘Actual’ train speed derived from the OTMR (Curve 2, purple). In practice, this value is an estimate of ground speed based on information about the performance of the reference wheelset (see paragraph 79) obtained from the *brake control unit* (BCU).

82 Figure 4 shows that:

- Rail head conditioning occurred when the extent of the slide was being controlled by the WSP system. In particular, the level of adhesion encountered by each wheel set was increased by the passage of previous wheelsets on the same train. Southern Railway's analysis shows that adhesion levels encountered by the last wheelset were higher than those of the leading wheelset, based on the individual readings of train braking performance at different ends of the train.
