***Federal Railroad Administration
Office of Safety
Headquarters Assigned
Accident Investigation Report
HQ-2006-48***

***Burlington Northern Santa Fe
Kismet, CA
June 14, 2006***

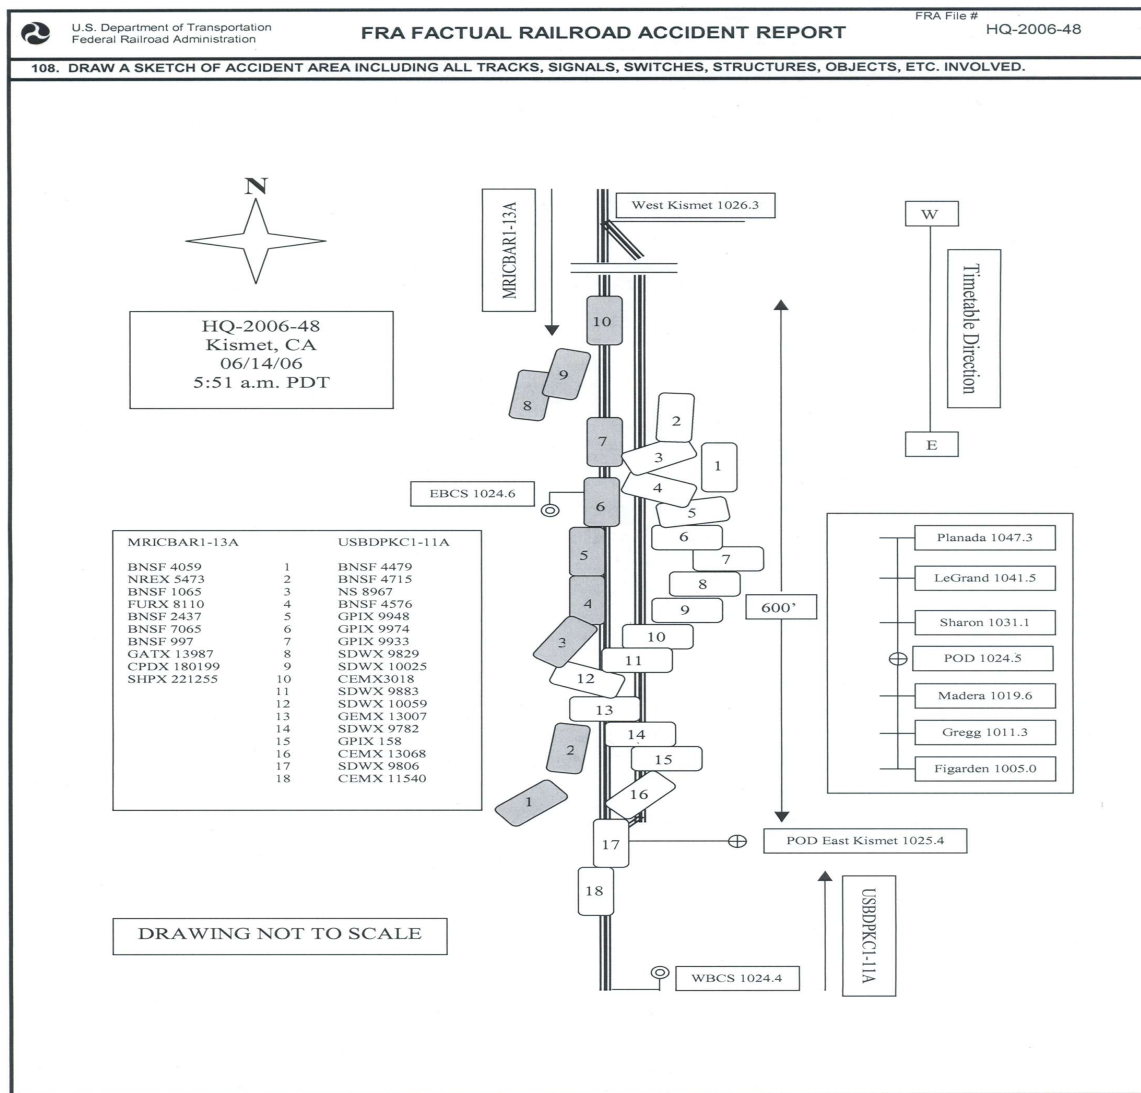
108. DRAW A SKETCH OF ACCIDENT AREA INCLUDING ALL TRACKS, SIGNALS, SWITCHES, STRUCTURES, OBJECTS, ETC., INVOLVED.
new kismet
drawing.jpg

At approximately 5:51 a.m. PDT, June 14, 2006, an eastbound BNSF freight train M-RICBAR1-13 (Train #1) struck a westbound BNSF unit train U-SBDPKC1-11 (Train #2) head-on at the East Kismet Siding, Kismet (Madera County), California, Stockton Subdivision, milepost 1024.5. Track speed in the area is 55 mph for freight and 40 mph at both ends of the Kismet Siding. The method of operation is Traffic Control System/Centralized Traffic Control and is controlled by a dispatcher in San Bernardino, California.

Speed of Train #1 at impact was 22 mph, while Train #2's speed was 38 mph. Three of the seven locomotives on Train #1 derailed along with two tank cars (one non-placarded, one placarded FLAMMABLE); one placarded tank car with FLAMMABLE GAS was knocked off its center pin but did not derail. No hazardous materials were released and there was no evacuation ordered. All four of the locomotives on Train #2 derailed as did 14 loaded hopper cars of cement. Train speeds were verified from event recorder downloads of the lead locomotives.
