***Federal Railroad Administration
Office of Safety
Headquarters Assigned
Accident Investigation Report
HQ-2008-77***

***Burlington Northern Santa Fe/Union Pacific (BNSF/UP)
Bond, CO
October 6, 2008***

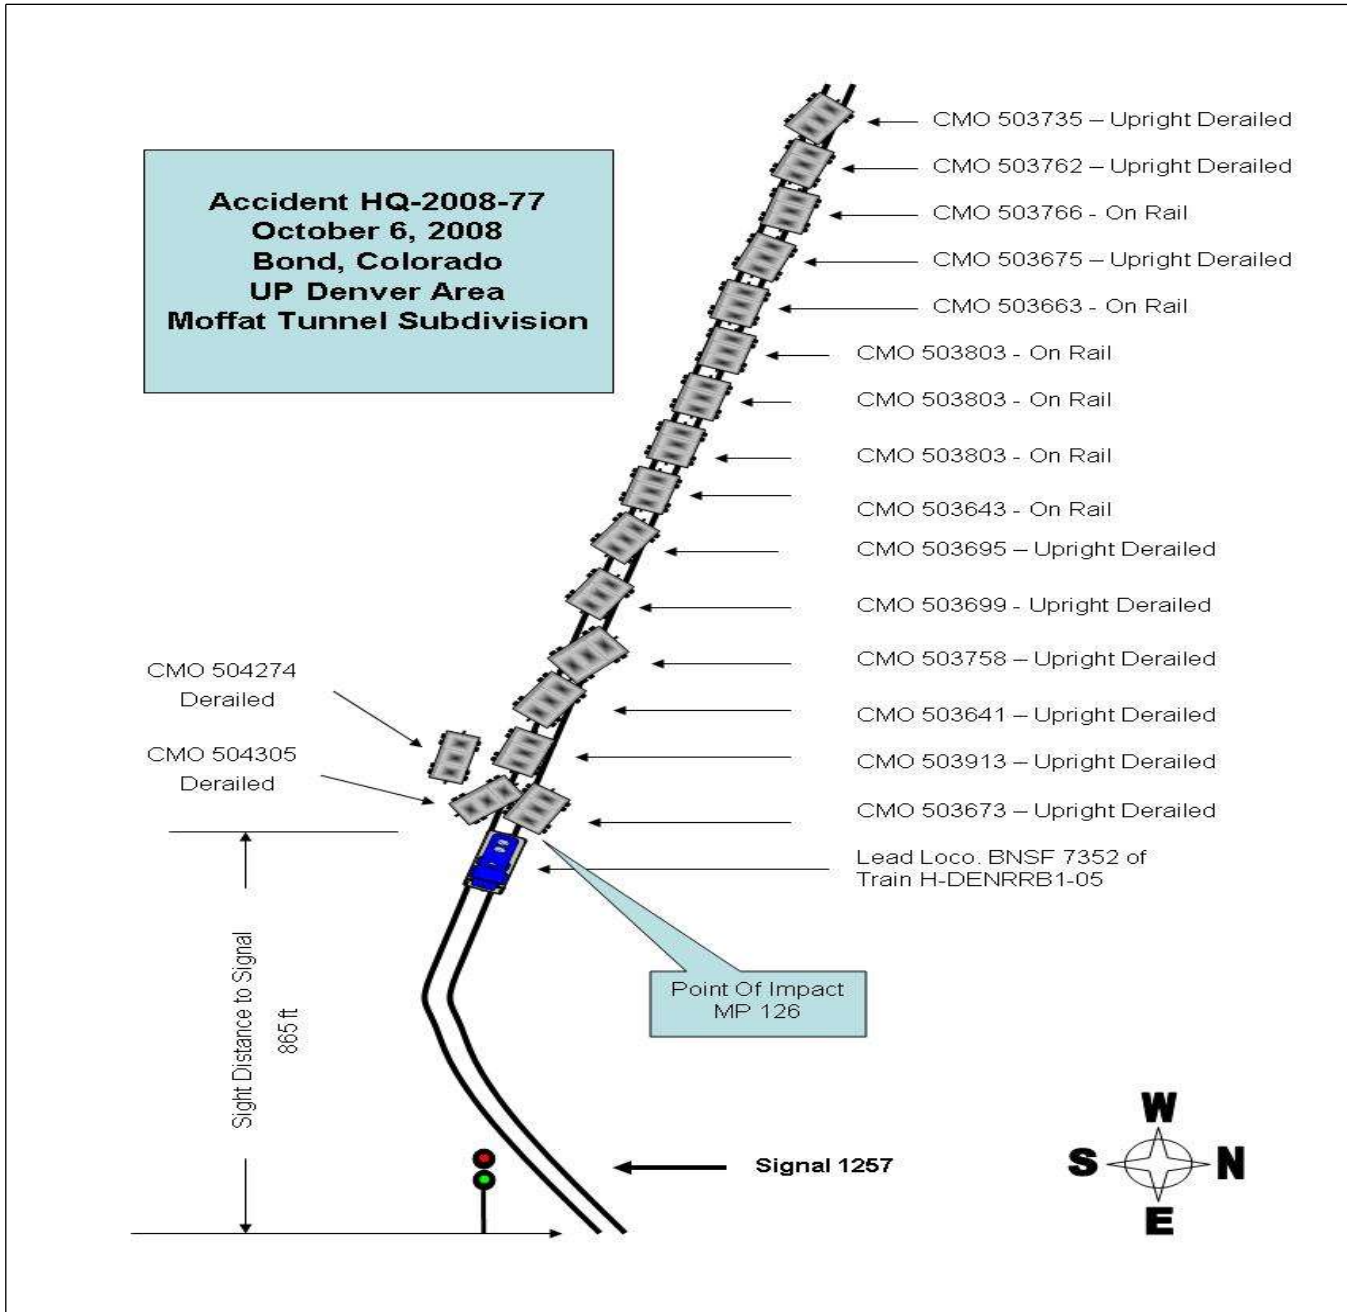
136. DRAW A SKETCH OF ACCIDENT AREA INCLUDING ALL TRACKS, SIGNALS, SWITCHES, STRUCTURES, OBJECTS, ETC., INVOLVED.

In this area of the railroad sight distance from Intermediate Signal 1257 to the end of the train marker on UP Train CDYBR-01 stopped ahead was approximately 650 feet. There is a 0.4-percent descending grade with a 4-degree right-hand curve.
