RAILROAD ACCIDENT INVESTIGATION

REPORT NO. 4149

ILLINOIS CENTRAL RAILROAD COMPANY

INDIAN OAKS, ILLINOIS

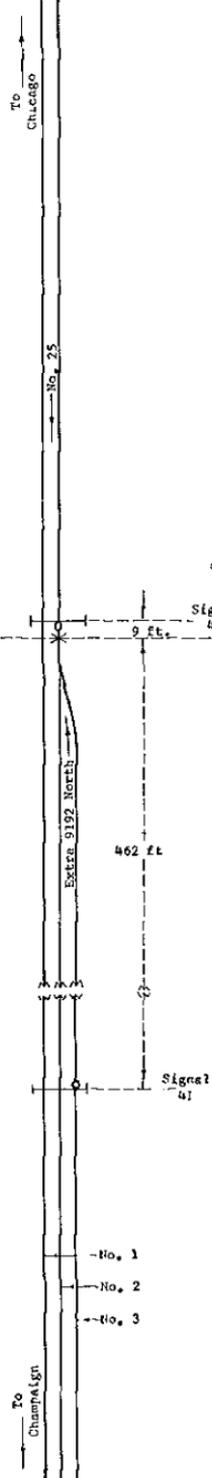
Illinois Central Railroad
Indian Oaks, Ill
January 17, 1969

The entire train derailed. It stopped with the front of the second diesel-electric unit 480 feet south of the collision point. The first diesel-electric unit overturned and stopped on its right side 439 feet south of the collision point, in a field on the west side of the track structure

The remaining train equipment stopped upright in various positions as shown in the sketch at the end of this report

Derailed cars of No. 25
