RAILROAD ACCIDENT INVESTIGATION.

REPORT NO. 4168 LIBRARY

CHICAGO, ROCK ISLAND AND PACIFIC RAILROAD COMPANY

UNION, MISSOURI

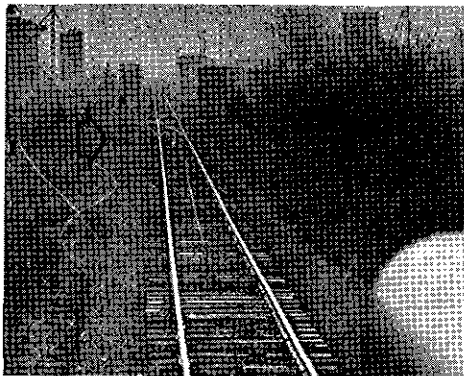
The west switch of the siding at Union is part of a No. 10 left-hand turnout The switch stand is on the north side of the main track. It is of the column-throw type, about seven feet in height

A circular non-reflectorized target, approximately 15 inches in diameter, was attached to the top of the switch stand. It was displayed when the switch was in reverse position, lined for movement from the main track to the siding or vice versa The switch stand had no lamp See photo below for west siding-switch, in reverse position, with switch target displayed

West siding-switch at Union, from distance of 310 feet.

At the time of the collision, the switch stand for the west switch of the siding at Union had neither a switch lamp nor a reflectorized target. This condition was brought to the attention of the Missouri Public Service Commission two days after the accident, the State agency initiated action to ensure the CRI&P's compliance with the order of September 10, 1968.

8 The absence of a switch lamp or a reflectorized target on the switch stand for the west siding-switch at Union appears to have been a causal factor in the accident. Had such lamp or target been provided, there is a possibility the engineer of No. 74 would have been alerted to the fact that the switch was not properly lined in sufficient time to avert the collision.

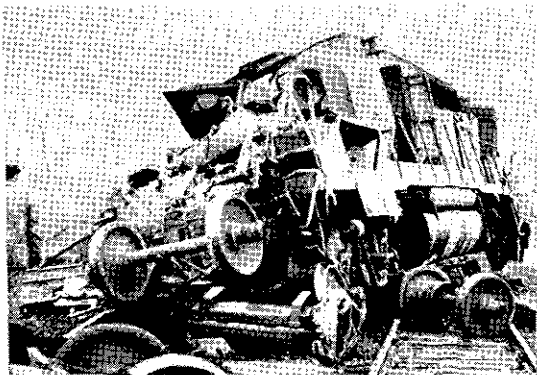
This train stopped with the front end 40 feet east of the collision point. Both trucks of the first diesel-electric unit derailed. This unit stopped upright with its rear truck on the siding structure, and with the front end on the north side of the main track structure and against the overturned caboose of the preceding train. Its control compartment was demolished by the caboose (see photo below) and other appurtenances were heavily damaged. The second unit was slightly damaged.

Leading, or control compartment, end of first locomotive unit of No. 74.

9 The incident at Union was another slow-speed collision resulting in fatal injury to a crew member in the control compartment at the front of a road-switcher type diesel-electric unit, due to a struck caboose or other car overriding the underframe of the unit and telescoping the

control compartment The aforesaid fatal injury and casualties from similar slow-speed collisions investigated by the FRA appear to have been caused by control compartments lacking the structural strength to withstand impacts of overriding equipment, and/or being insufficiently protected by structural components of that part of diesel-electric units in front of the control compartments
