✓
RAILROAD ACCIDENT INVESTIGATION

✓
REPORT NO. 4170

PENN CENTRAL TRANSPORTATION COMPANY

MASSILLON, OHIO

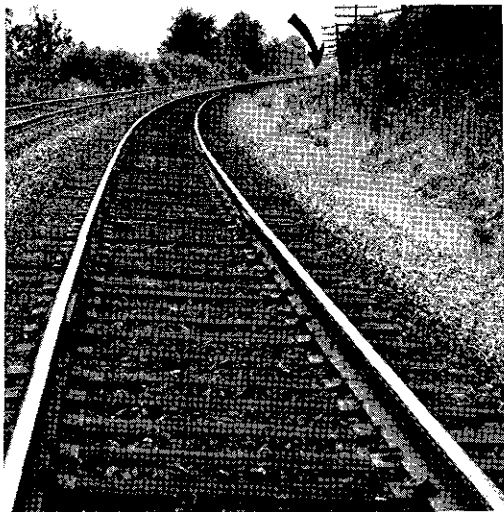
Because of track curvature and trees alongside the railroad, a caboose standing on track No 2 at the collision point cannot be seen from an approaching westbound train at a distance greater than about 2400 feet (see photo below).

Westward view from point on track No. 2 about 2400 feet from collision point (arrow).

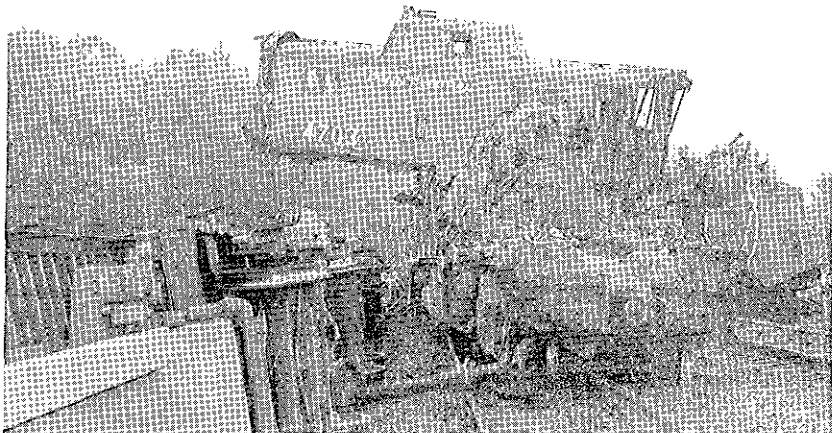
The impact moved No. 9 about 40 feet westward, and caused its caboose and last six cars to derail. The six derailed cars overturned onto their right sides and stopped in line along the north shoulder of the track No. 2 structure. The caboose rose from its trucks; overrode the underframe of the first locomotive unit of Extra 2253 West and struck the control and engine compartments of that unit. It stopped crosswise on top of the rear, or east, end of the first unit, and with one side against the control compartment at the front of the second locomotive unit of Extra 2253 West. The derailed cars and caboose were damaged considerably (see photograph on the following page).

This train stopped with the front end 258 feet west of the collision point. Only the front truck of the first locomotive unit derailed. This unit stopped upright on and in line with the structure of track No. 2, alongside the derailed cars of No. 9. The control compartment at the front of the first unit was completely demolished, and the long engine hood was torn loose, as a result of being struck by the caboose of No. 9.

The first locomotive unit was destroyed; the second unit was damaged moderately.

Front of first diesel-electric unit of Extra 2253 West (control-compartment end). Torn off control-compartment shown at right. Caboose of No. 9 at top, and derailed cars of that train at left.
