RAILROAD ACCIDENT INVESTIGATION

REPORT NO 4173

UNION PACIFIC RAILROAD COMPANY

ATCHISON, TOPEKA AND SANTA FE RAILWAY COMPANY

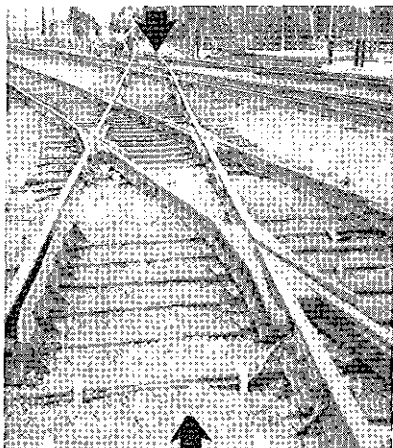
The 173-foot dead section of the UP main track extended across the ATSF tracks at the crossing, as indicated in the photograph below:

View eastward on UP main track. Jumpered-out section shown between arrows.

2. At the UP - ATSF railroad crossing in Fullerton interlocking, there was a 173-foot section of UP dead track. A trap circuit was installed to protect this dead section. Its function was to lock the interlocking during movements through the dead section. The UP crew, unaware of both the dead section and the resulting inability of the interlocking system to reflect track occupancy at that location, left their train standing in the railroad crossing and proceeded through the trap circuit and out of the interlocking.

3. Due to inability of the interlocking to detect occupancy of the UP main track in the dead section where the UP train was standing, track occupancy lights associated with the ATSF train dispatcher's traffic control machine appeared to indicate that the Fullerton interlocking was unoccupied and enabled the dispatcher to establish a route for another train to proceed through the interlocking whenever he so desired.

As a result of the accident, the ATSF installed an overlay track circuit on the existing UP trap circuit within the Fullerton interlocking. The installation of the overlay circuit reduced the 173-foot "dead" section of UP track at the crossing to a total length of 27 feet, broken into three 9-foot sections, and provides for the desired isolation of the UP track circuits from the ATSF track circuits at the crossing. Since the former "dead" section of the UP track has been reduced to three separate 9-foot sections, detection of occupancy of the UP track in the interlocking, including the railroad crossing, has been significantly expanded.
