INTERSTATE COMMERCE COMMISSION

**REPORT OF THE DIRECTOR OF THE BUREAU OF SAFETY IN RE
INVESTIGATION OF AN ACCIDENT WHICH OCCURRED ON THE
LINE OF THE KEY SYSTEM TRANSIT COMPANY AT OAKLAND,
CALIF, DECEMBER 4, 1924**

JANUARY 12, 1925

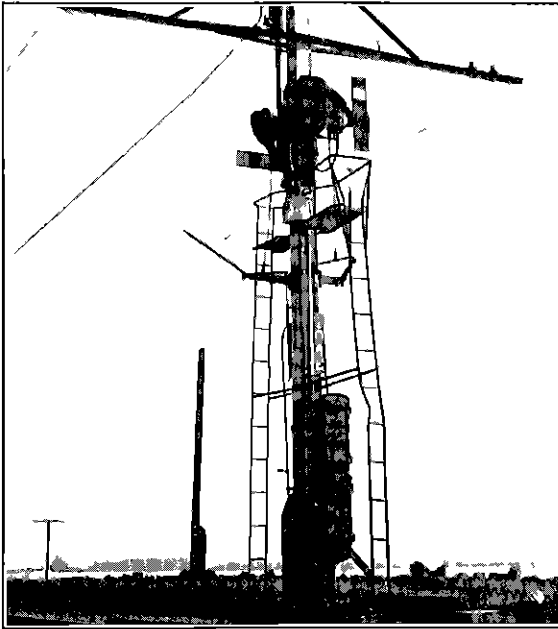
FIG 1 --Signal pole 104 looking eastward. Eastbound signal in clear position, west bound signal at stop, with automatic stop arm extended.

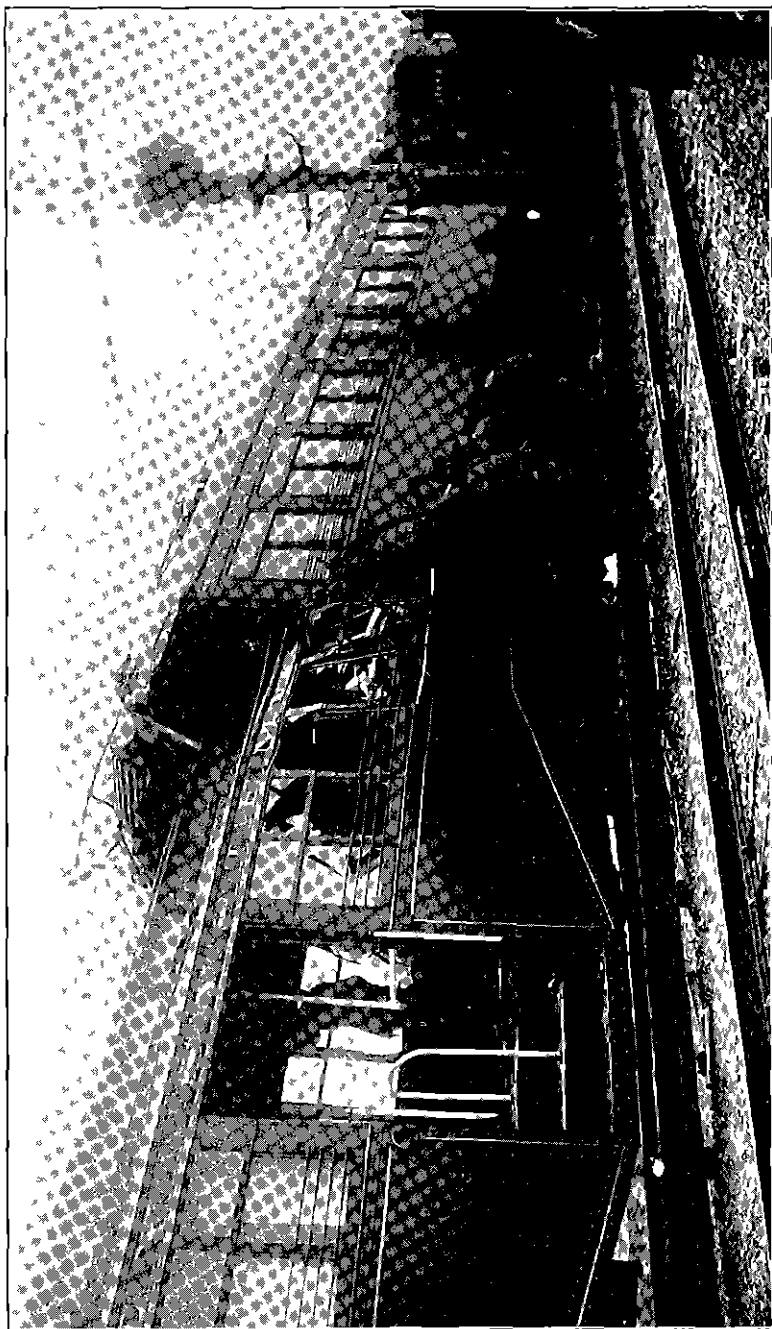
Motor car 1014 telescoped the rear car of train No 729 for a distance of 18½ feet. It came to a stop with the head end of car 1014 at a point 37 feet west of signal 104, and the rear end of car 665, the last car of train No 729 was 18 feet 6 inches west of signal 104.

FIG. 2.—Key System car 665 telescoped by car 1014, signal pole 104 opposite car 1014

48 inches. The rear portion of this car was practically demolished, the damage probably being due in part, at least, to the fact that the floor line and top of the body buffers were lower than the floor and buffers on the San Francisco-Sacramento car. Motor car 1014 was of steel-underframe construction, having wooden superstructure. It was 57 feet 10 inches long, weighed 93,260 pounds, and the distance from top of rail to top of 8-inch buffer beam was 53 inches. The platform of this car overlaid the floor of the Key System car. The forward end of car 1014 and a partition 7 feet from the head end were demolished, pipe connections and other equipment broken or torn from the car, and the truck on the damaged end was driven

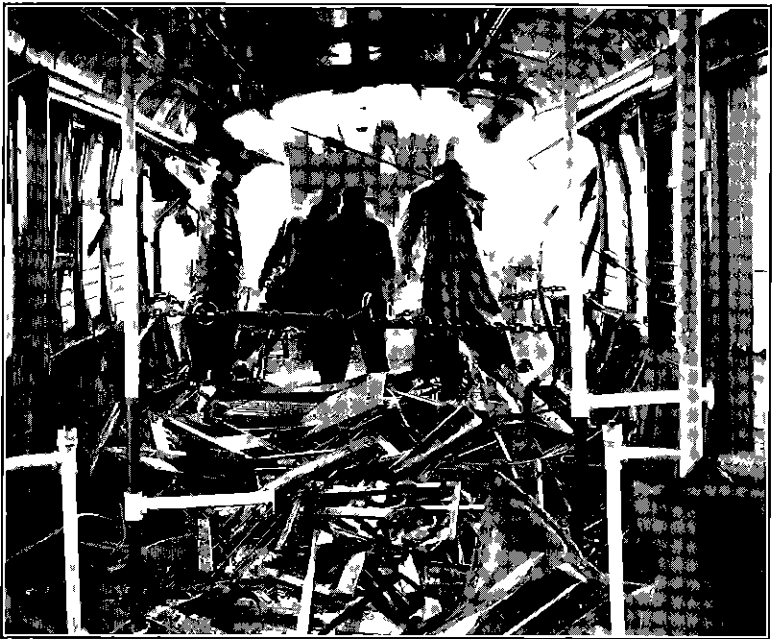
FIG. 3.—Interior of car 665 after separation from car 1014

overridden by the buffer on car 1014 but was driven back over the top of the center sills, at the same time pulling in the side angle-iron sills which prevented the sides of the car from being fanned outward by the telescoping action.
