## INTERSTATE COMMERCE COMMISSION

### REPORT OF THE DIRECTOR OF THE BUREAU OF SAFETY IN RE INVESTIGATION OF AN ACCIDENT WHICH OCCURRED ON THE WABASH RAILWAY NEAR TOLONO, ILL., ON JULY 29, 1925

MARCH 16, 1926

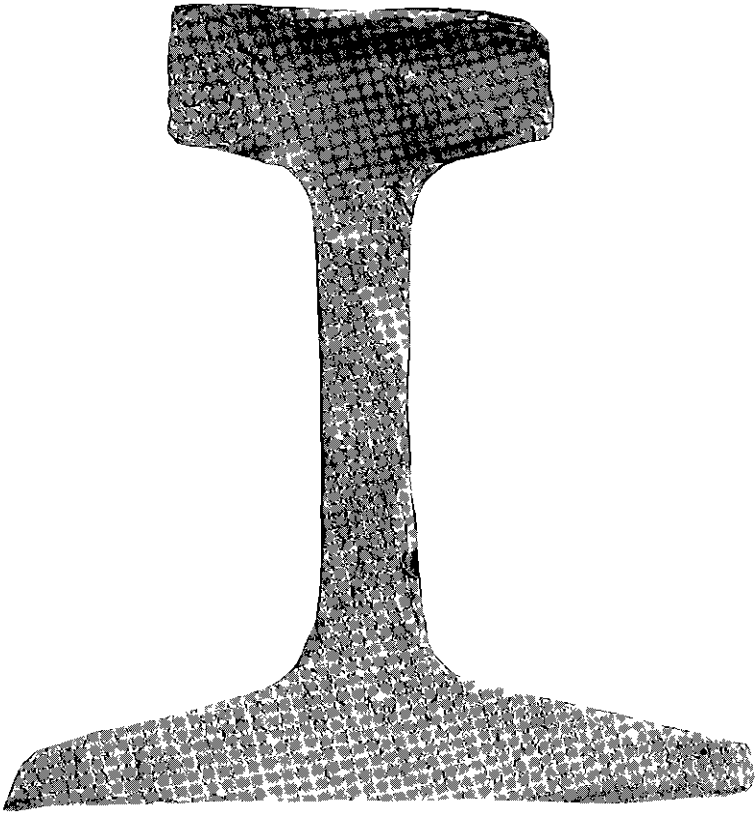
Photographic prints are introduced to illustrate the appearance of transverse fissures. Figure No. 1 shows a transverse fissure which was displayed by a 90-pound rail on the Chicago & Alton Railroad. This fracture, originating in the head over the gauge side of the web, separated the larger part of the cross section of the head. It had reached the peripheral surface when it fractured under a train. This rail had been in the track 7 years and 10 months.

FIG. 1 — Appearance of a transverse fissure in the head of a 90 pound iron

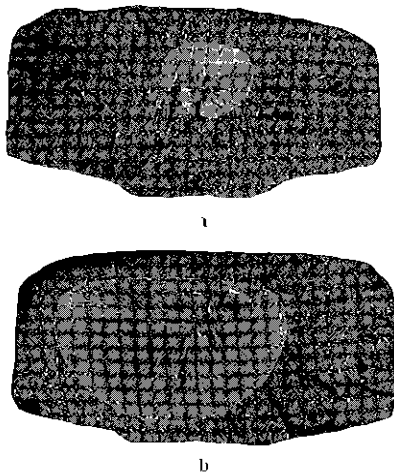
Figure No. 2, *a* and *b*, illustrates two other transverse fissures, from another rail, at earlier stages of development. These fissures presented a silvery luster, common to incipient fissures before exposure to the air. The surfaces are commonly darkened when viewed on transverse fissured rails which have caused a separation of the rail in the track.

Incipient transverse fissures at their earliest stages usually display silvery crescents, concentric with the nuclei. The nuclei of transverse fissures retain their gray color, whence it is inferred that in their formation the metal is torn apart by a longitudinal tensile force and the opposite faces do not again come into contact with each other. In regard to the corona of fissures, their silvery luster is attributed to a burnishing effect, the opposite faces making contact when the section of the rail, above its neutral axis, is strained by compression loads. There is no display of ductility in the steel in the extension of a transverse fissure. The burnished faces are separated hardly a measurable distance.

FIG. 2 (a and b) — Appearance of two transverse fissures at different stages of development in the same iron
