## INTERSTATE COMMERCE COMMISSION

REPORT OF THE DIRECTOR OF THE BUREAU OF SAFETY IN RE  
INVESTIGATION OF AN ACCIDENT WHICH OCCURRED ON THE  
NEW YORK, CHICAGO & ST LOUIS RAILROAD AT EDWARDS-  
VILLE, ILL , OF MARCH 26, 1929.

July 30, 1929.

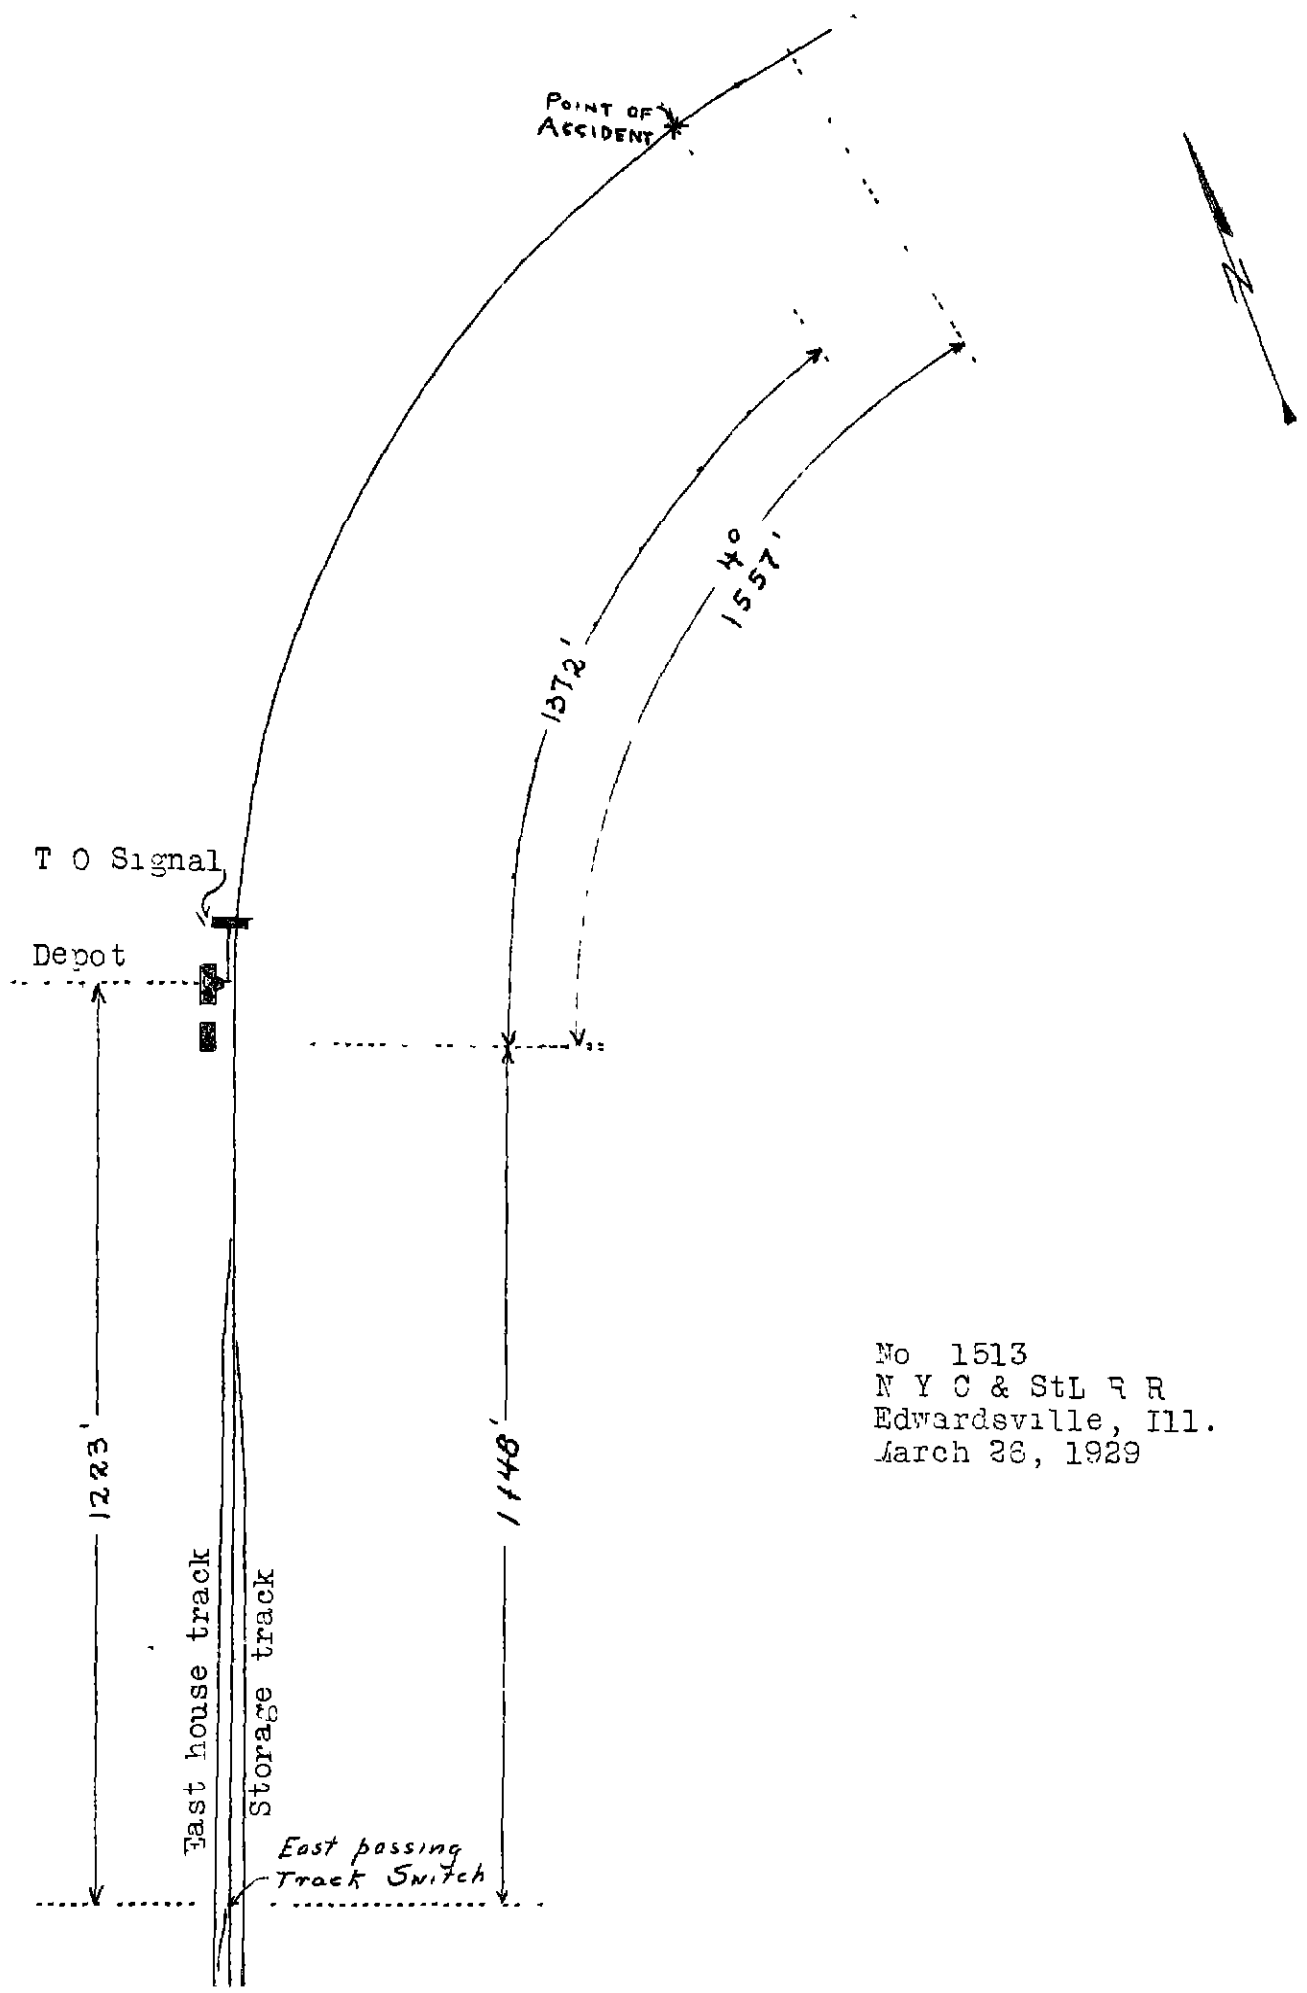
No 1513  
 N Y C & StL F R  
 Edwardsville, Ill.  
 March 26, 1929

On March 26, 1929, there was a head-end collision between two freight trains on the New York, Chicago & St. Louis Railroad at Edwardsville, Ill., resulting in the death of three employees and the injury of two employees.

Both engines were badly damaged, but remained upright, 12 cars were destroyed. The employees killed were the engineman, fireman and head brakeman of train first No. 44; the employees injured were the engineman and fireman of extra 904.
