REPORT OF THE DIRECTOR OF THE BUREAU OF SAFETY IN RE INVESTIGATION OF AN ACCIDENT WHICH OCCURRED ON THE CHICAGO, MILWAUKEE, ST. PAUL & PACIFIC RAILROAD AT WADSWORTH, ILL., ON AUGUST 9, 1929.

November 18, 1929

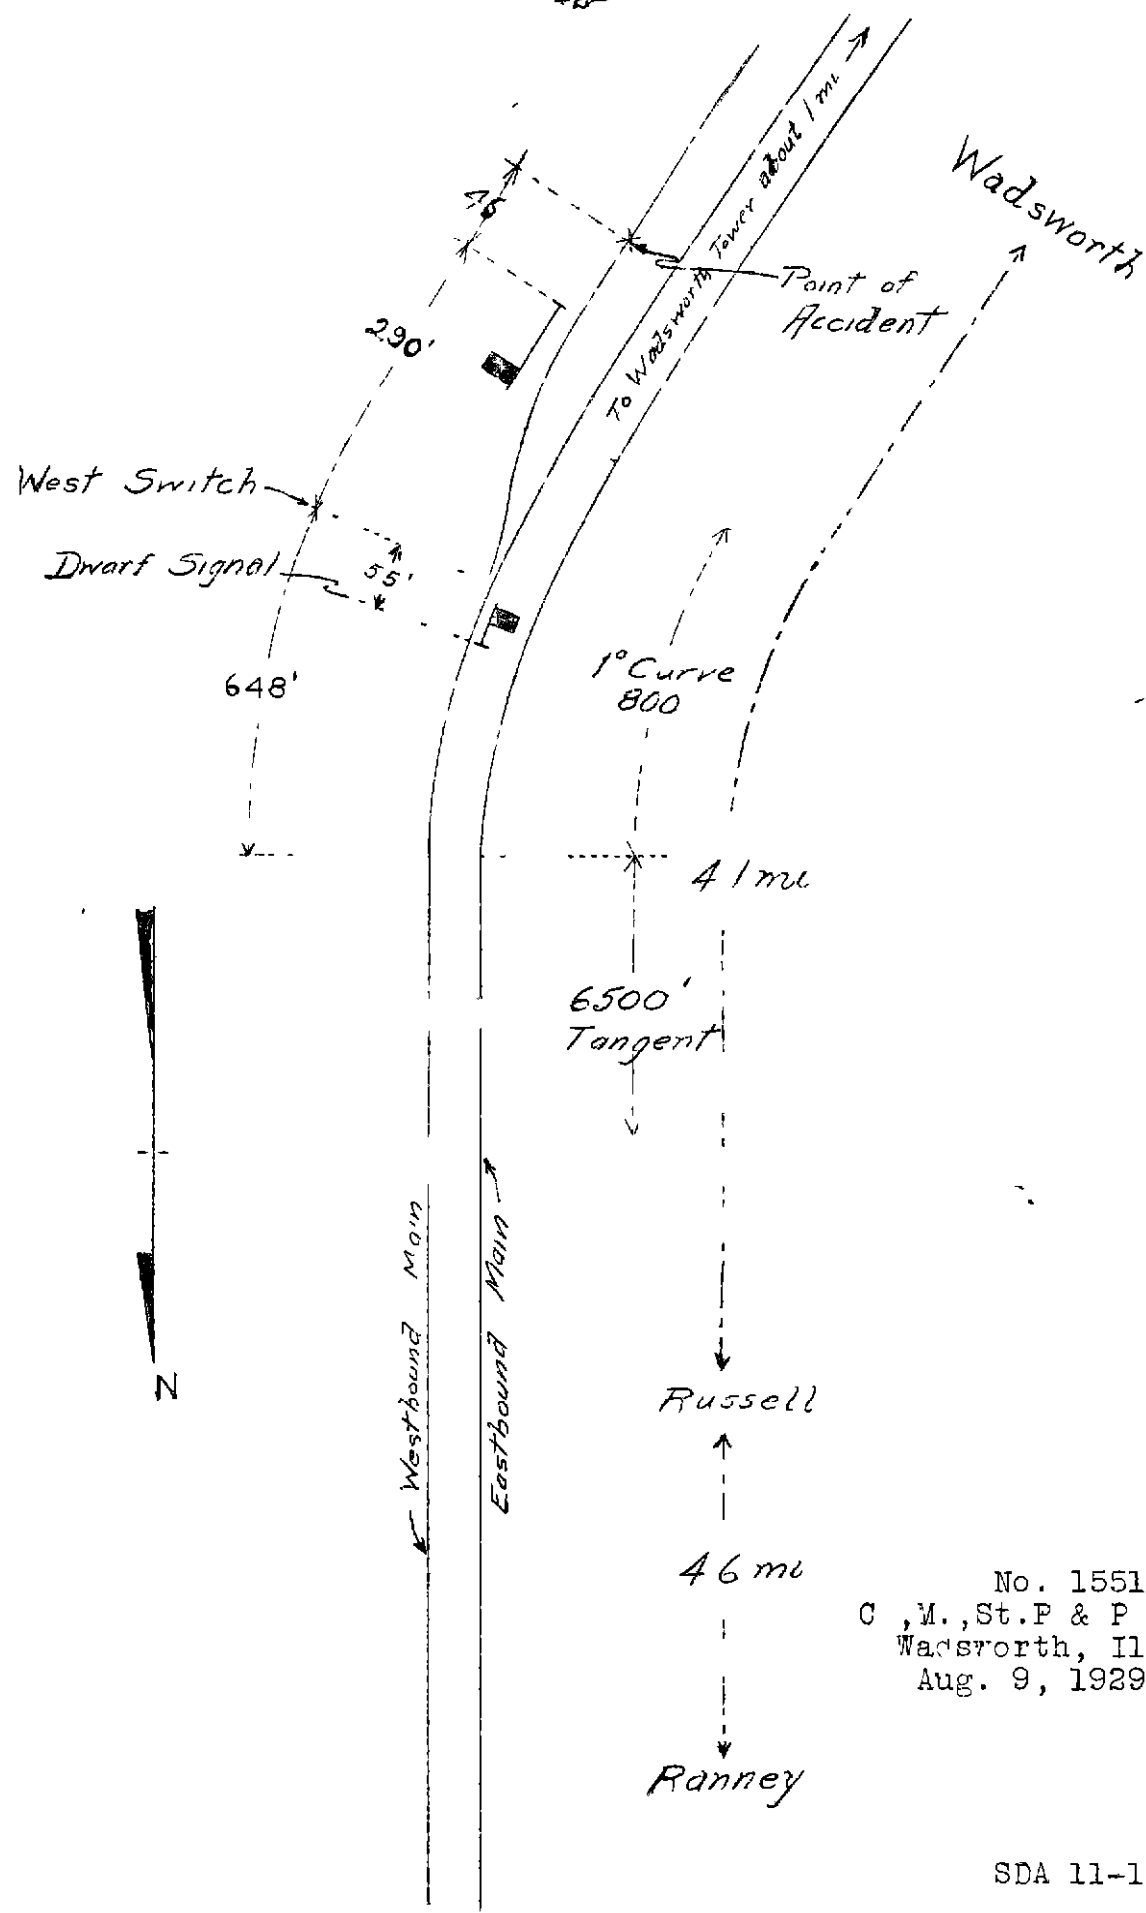
No. 1551  
 C, M., St. P & P R R.  
 Wadsworth, Ill.  
 Aug. 9, 1929.

The general direction of the track is north and south, but the time-table directions are east and west, and these latter directions are the directions used in this report. The accident occurred not in the interlocking limits of Wadsworth, at a point about 1 mile west of the tower, at the west switch of the passing track, a facing-point switch for trains moving against the current of traffic on the westbound track, the passing track parallels the main tracks on the north. Approaching from the west the track is tangent for a considerable distance, followed by a 1° curve to the right 800 feet in length, the switch being located on this curve at a point 152 feet from its eastern end. The grade for eastbound trains is slightly descending.

The switch involved is controlled from the tower at Newbury, the tower being located on the south side of the main tracks and directly opposite the station. Dwarf signal 5, of the two-position, upper-quadrant type, is located 55 feet west of the switch and between the main tracks, it normally displays a stop indication, and governs reverse movements either on the main track or into the passing track. The automatic block-signal system functions only for trains moving with the current of traffic.
