INTERSTATE COMMERCE COMMISSION

REPORT OF THE DIRECTOR OF THE BUREAU OF SAFETY IN RE
INVESTIGATION OF AN ACCIDENT WHICH OCCURRED ON THE
CHICAGO & EASTERN ILLINOIS RAILWAY AT SIDELL JUNCTION,
ILL., ON JANUARY 7, 1930.

March 14, 1930.

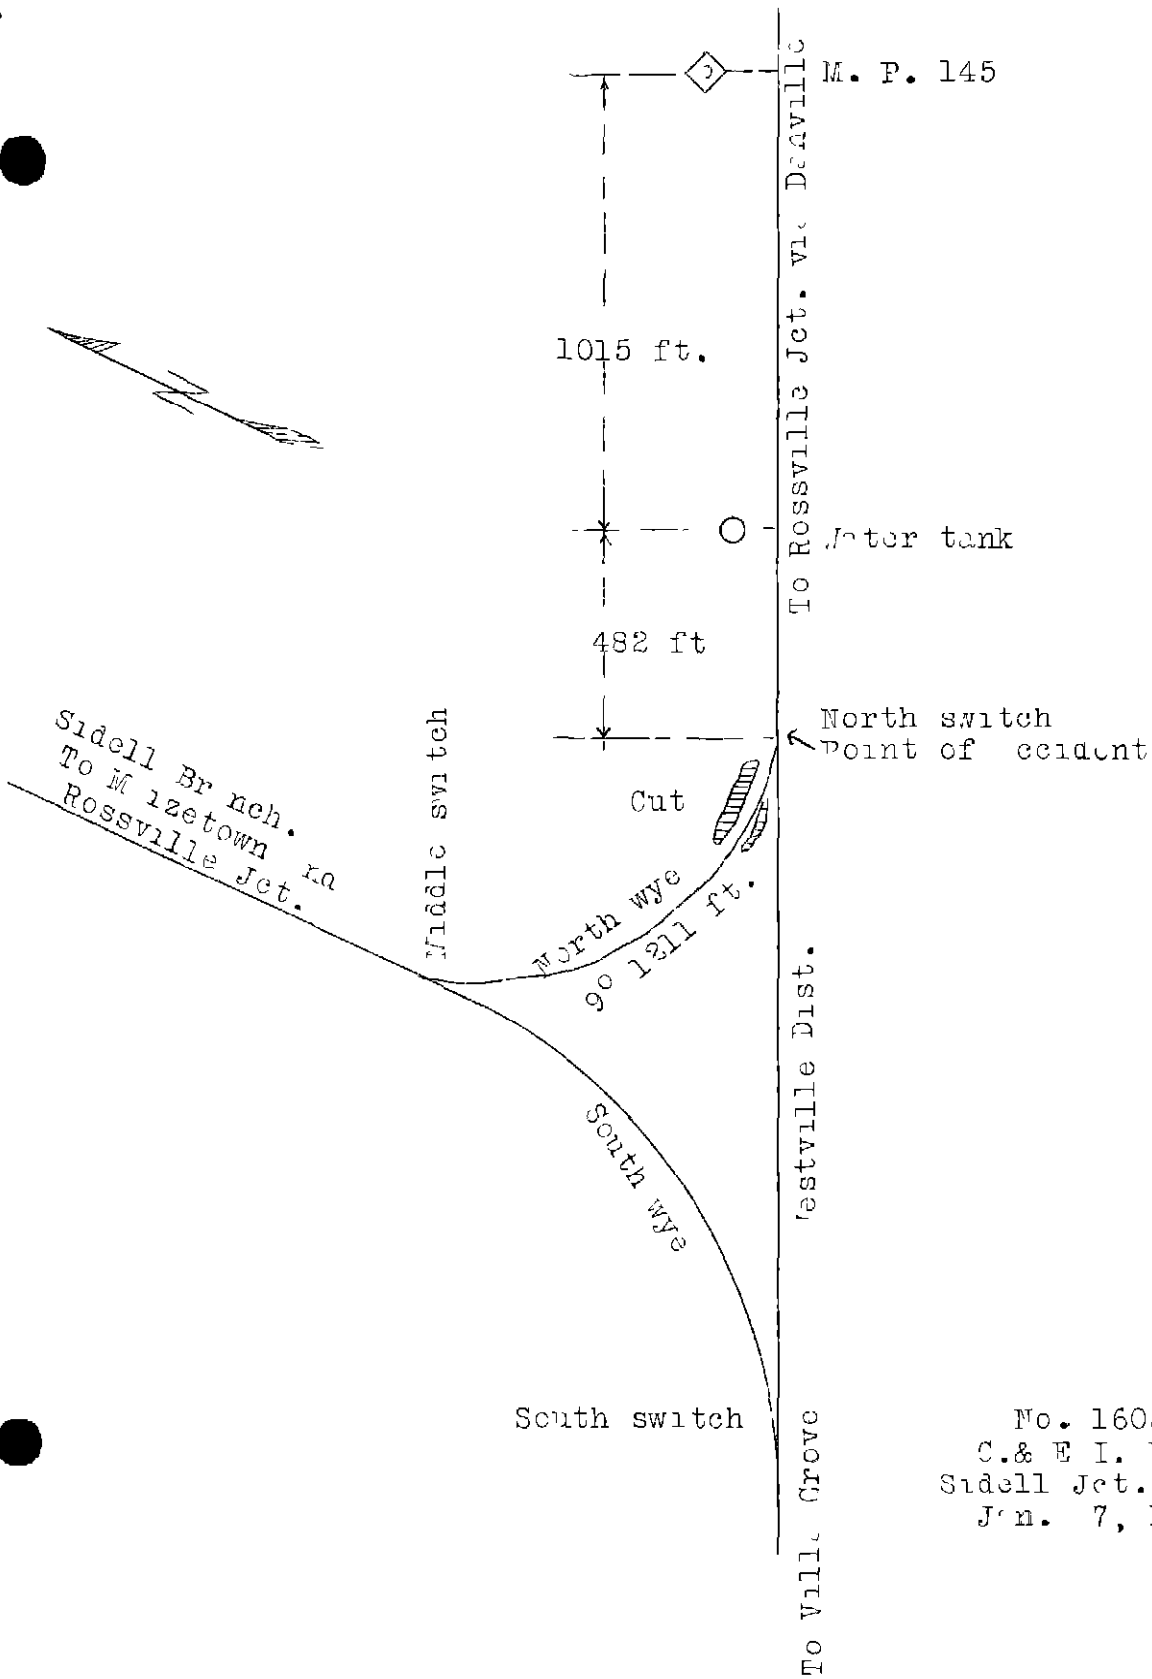
No. 1605
 C. & E. I. R.R.
 Sidell Jct., Ill.
 Jan. 7, 1930

The point at which the accident occurred is at the north switch of the North Wye. The switch stand at this point is located on the west side of the track; it is a standard main line stand surmounted by an oil burning lamp, the lens of which is 7 feet 4 inches above the rail. The lamp burns continuously and displays a green indication when set for the Westville District main line and red when set for the Wye leading to the Sidell Branch. The stand is also equipped with a metal banner 11 x 24 inches, which displays

red when the switch is set for the north wye. The center of this banner is 6 feet above the rail. On the opposite side of the track from the switch stand is a telephone booth where employees may communicate with the train dispatcher.

Located 482 feet north of the switch, on the west side of the track and $7\frac{1}{2}$ feet from the rail, is a water tank resting on upright timbers, the bottom of the tank being 13 feet above the rail. This tank, however, does not obstruct the view of the switch stand from an approaching southbound train, and the target can be seen for about half a mile. About 1,020 feet farther north of the water tank is mile post 145.
