## INTERSTATE COMMERCE COMMISSION

REPORT OF THE DIRECTOR OF THE BUREAU OF SAFETY IN RE INVESTIGATION OF AN ACCIDENT WHICH OCCURRED AT THE INTERSECTION OF THE TRACKS OF THE CHICAGO & NORTH WESTERN RAILWAY AND THE CHICAGO, MILWAUKEE, ST. PAUL & PACIFIC RAILROAD AT JANESVILLE, WIS., ON JANUARY 18, 1930.

March 10, 1930.

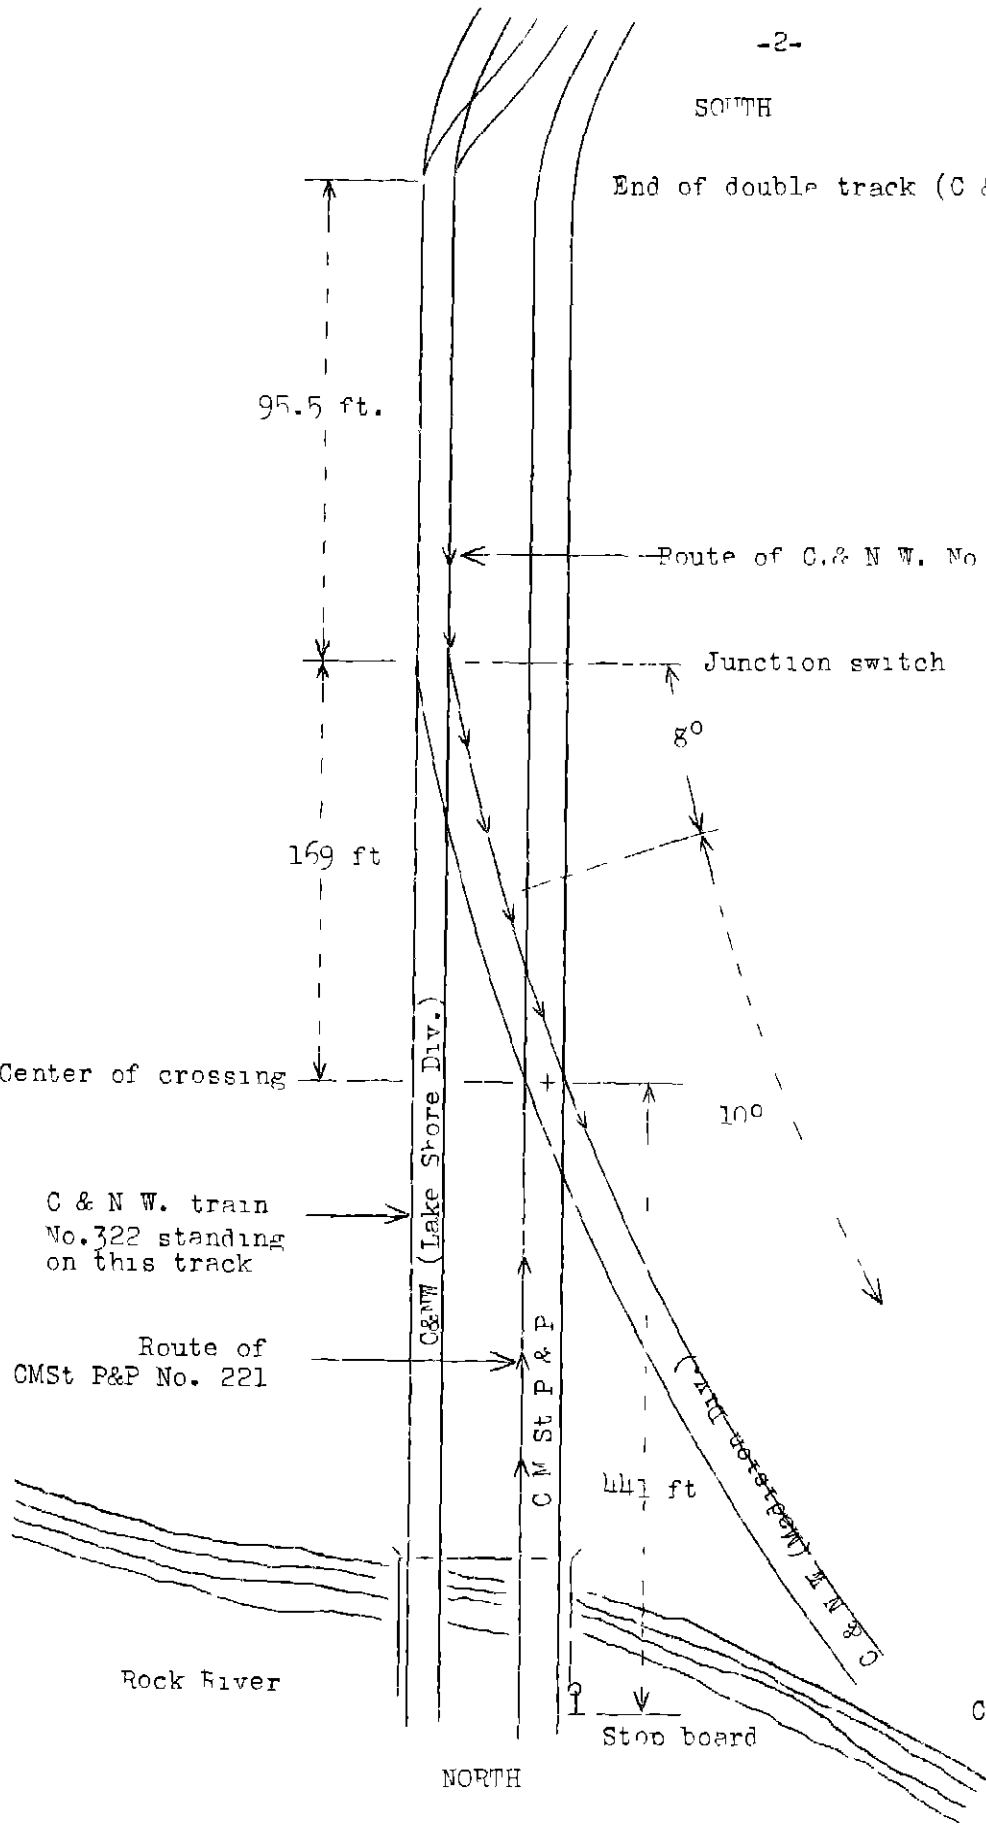
Inv No 1609  
C M St. P. & P. - C & N W  
Janesville, Wis  
Jan 18, 1930

This accident occurred at the intersection of the tracks of the Madison Division of the C&NWRy and the Madison Division of the CMStP&PRP, near Race Street and between River Street and Franklin Street; in the immediate vicinity of the point of accident both roads are single-track. On the C&NW lines in each direction there are automatic block signals but for a distance of 366 feet adjacent to the crossing train movements are governed by time-table and train orders, trains of the CMStP&PRR are operated by time-table, train orders and a manual block-signal system. The tracks of the two roads intersect at an angle of  $10^{\circ} 14'$  and the grade is practically level. Both trains involved were westbound, according to time-table direction, but for the purpose of this report compass directions are used. Approaching the crossing from the southwest, the direction from which the C&NW train approached, and beginning at the junction switch of the Lake Shore Division and the Madison Division, the switch being located 169 feet southwest of the center of the crossing, there is a compound curve to the left extending to and beyond the crossing. Approaching the crossing from the north, the direction from which the CMStP&P train approached, the track is tangent to and for a short distance beyond the crossing. On the CMStP&PRR there is a railroad crossing stop sign located on a telegraph pole on Rock River bridge at a point 441.5 feet from the center of the crossing, there was no stop sign on the C&NWRy at the time of the accident. There is no interlocking plant at this point, and it is provided by State law that all trains shall come to a full stop before arriving at or crossing the track of another railroad at grade, not protected by interlocking, and within 400 feet thereof; and the train arriving near said crossing first shall cross and move on first.

Approaching the crossing, from the southwest on the track of the C&NWRy from the vicinity of the junction switch a view of the crossing can be had across the inside of the curve from the fireman's side of an engine cab, however, while rounding the curve the fireman's view of the tracks north of the crossing is obscured from view by the engine; from the engineman's side of the cab the view of the crossing is considerably restricted around the outside of the curve. Approaching the crossing from the north on the track of the CMStP&PRR a view of the crossing can be had from either side of an engine cab for a considerable distance; however, a view of the approaching C&NW train could be had only from the fireman's side of the engine cab. At the time of the accident there was a C&NW freight train standing on the Lake Shore Division track of the C&NWRy which track parallels the CMStP&P track on the east, with the front end of the engine at a point approximately 191 feet north of the crossing.

This accident was caused by the failure of Engineman Higgins, of CMStP&P train No. 221, to ascertain definitely that the crossing was clear before attempting to pass over it.

There is no form of crossing protection at this point except the stop board located on the CMStP&PRR at a point 441.5 feet north of the center of the crossing; there is a daily movement of approximately 45 trains over this crossing, and the need for additional protection which would be provided by an interlocking plant should be given careful consideration.
