INTERSTATE COMMERCE COMMISSION

REPORT OF THE DIRECTOR OF THE BUREAU OF SAFETY IN
RE INVESTIGATION OF AN ACCIDENT WHICH OCCURRED
ON THE CHICAGO & NORTH WESTERN RAILWAY NEAR
JANESVILLE, WIS., ON APRIL 25, 1930.

May 16, 1930.

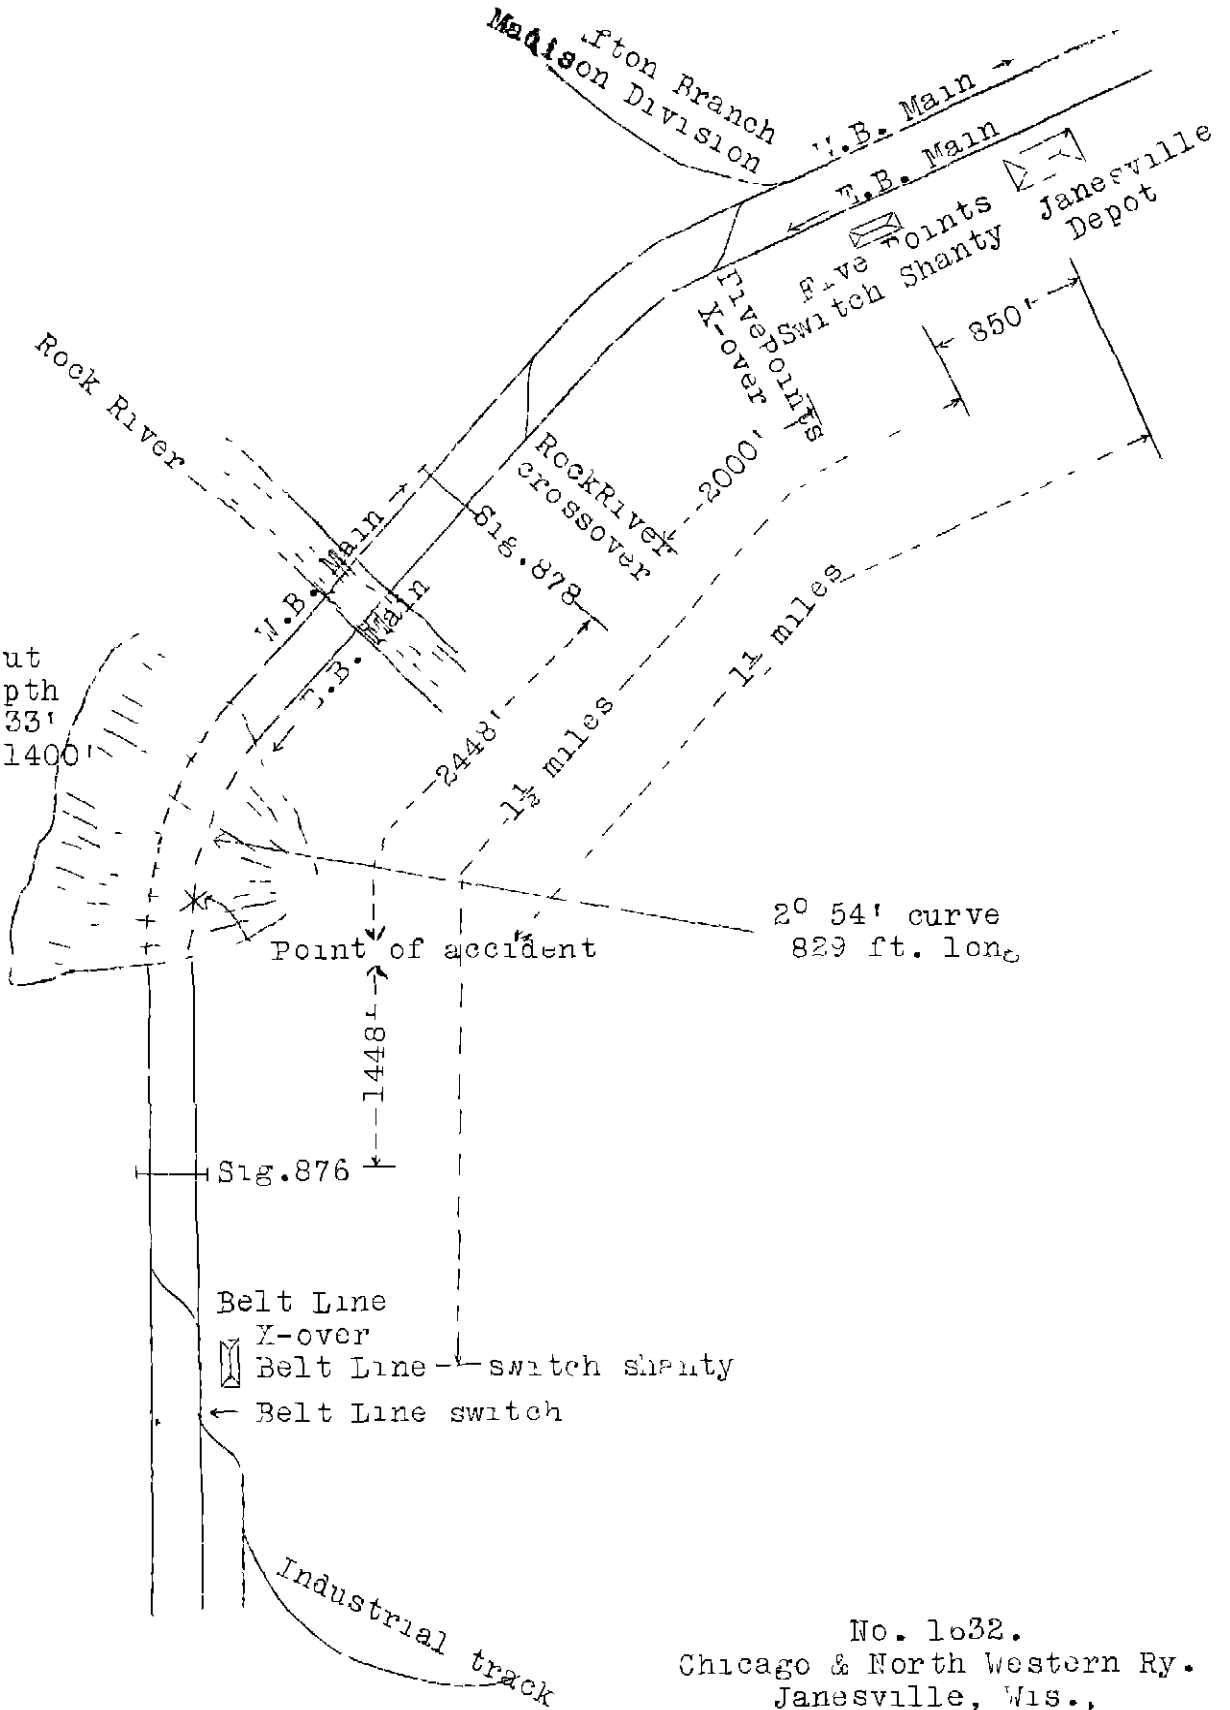
No. 1032.
 Chicago & North Western Ry.
 Janesville, Wis.,
 April 25, 1930.

Rock Cut
 Max. depth
 of cut 33'
 Length 1400'

The view of the point of accident around the curve from either an eastbound or a westbound engine is restricted to about 550 feet, as the cut in about the center of the curve is very narrow and at its maximum depth, it is also spanned by an overhead highway bridge at that point.
