Railroad accident investigation
no. 1651-1700

REPORT OF THE DIRECTOR OF THE BUREAU OF SAFETY INVESTIGATION OF AN ACCIDENT WHICH OCCURRED ON THE PENNSYLVANIA RAILROAD AT SOUTH ELIZABETH, N. J., ON JULY 19, 1930.

August 27, 1930.

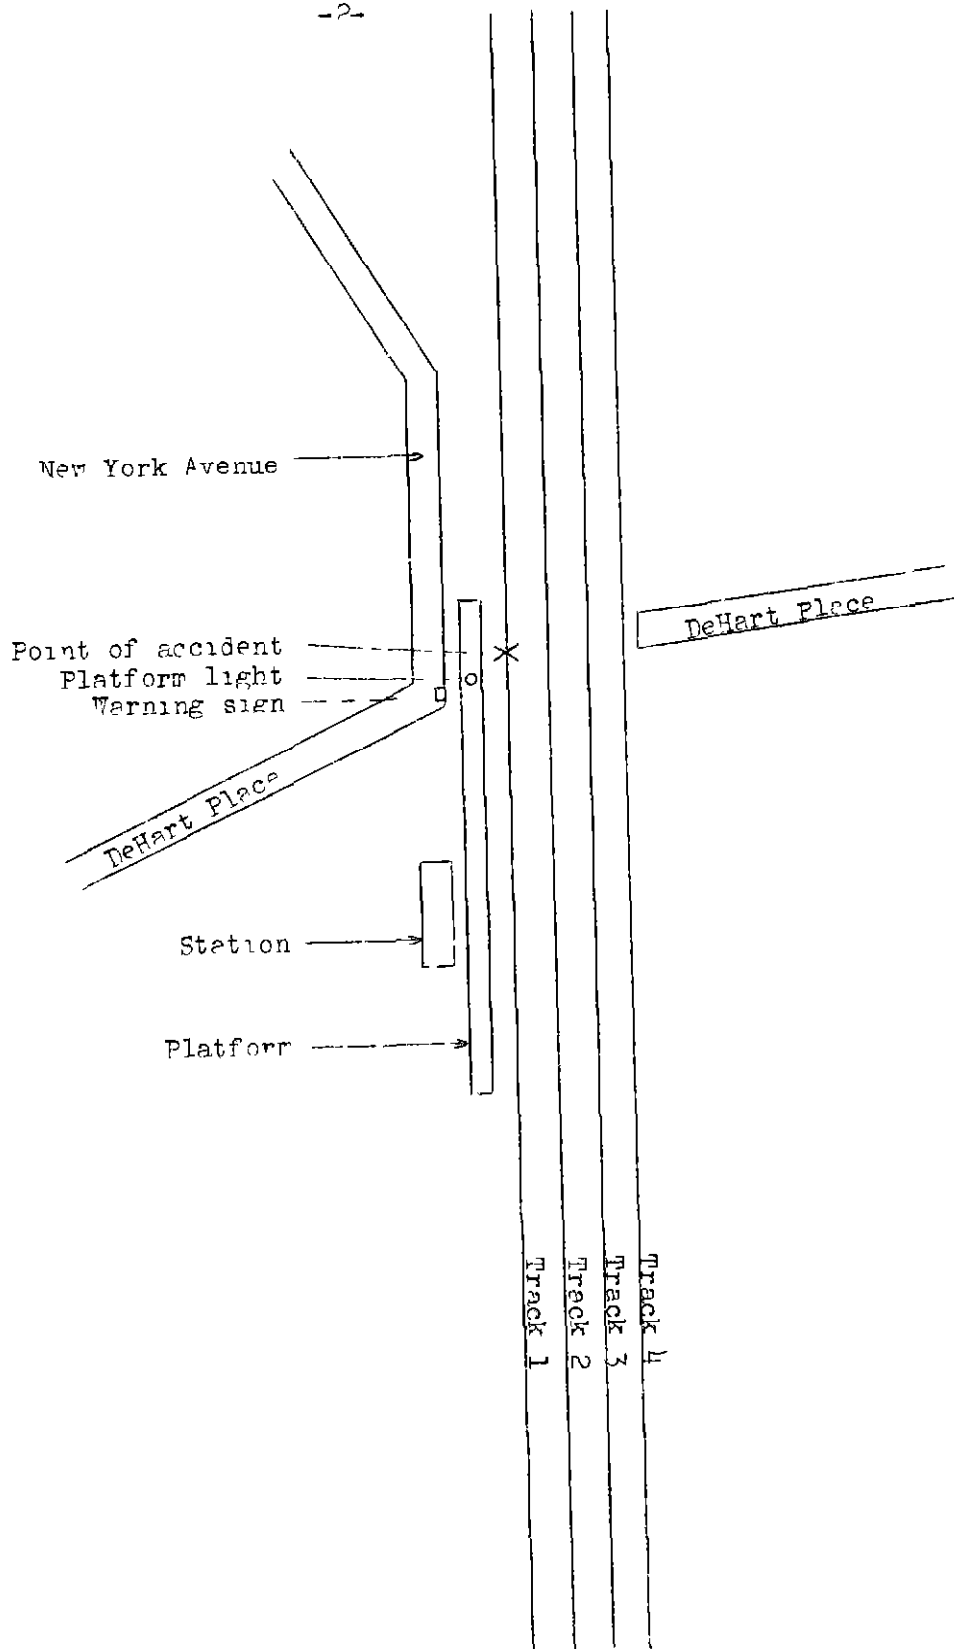
Inv. No 1651
Pennsylvania Railroad
South Elizabeth, N.J.
July 19, 1970

The automobile involved, a Studebaker Brougham, entered DeHart Place from South Street at a point about 320 feet south of the railroad and continued northward, was driven off the end of the street and over the station platform, and it was standing on track 1 when it was struck by train No. 228.

The engine and tender came to rest on their left sides on tracks 1 and 2 approximately 1,160 feet east of the point where the engine collided with the automobile. The first four cars in the train were also derailed, the first car remaining in an upright position and in line with the track about 10 feet to the rear of the tender, the second and third cars were derailed to the south and fell over a 12-foot retaining wall immediately behind the first car and rested on their right sides on an adjoining street, while the fourth car stopped in an upright position with its forward end extending over this wall at an angle of about 45 degrees.
