INTERSTATE COMMERCE COMMISSION

REPORT OF THE DIRECTOR OF THE BUREAU OF SAFETY IN RE INVESTIGATION OF AN ACCIDENT WHICH OCCURRED ON THE MICHIGAN CENTRAL RAILROAD AT TOWN LINE, MICH., ON MARCH 6, 1931.

April 13, 1931.

INV. NO. 1695
 MICHIGAN CENTRAL R. R.
 TOWN LINE, MICH.
 March 6, 1931.

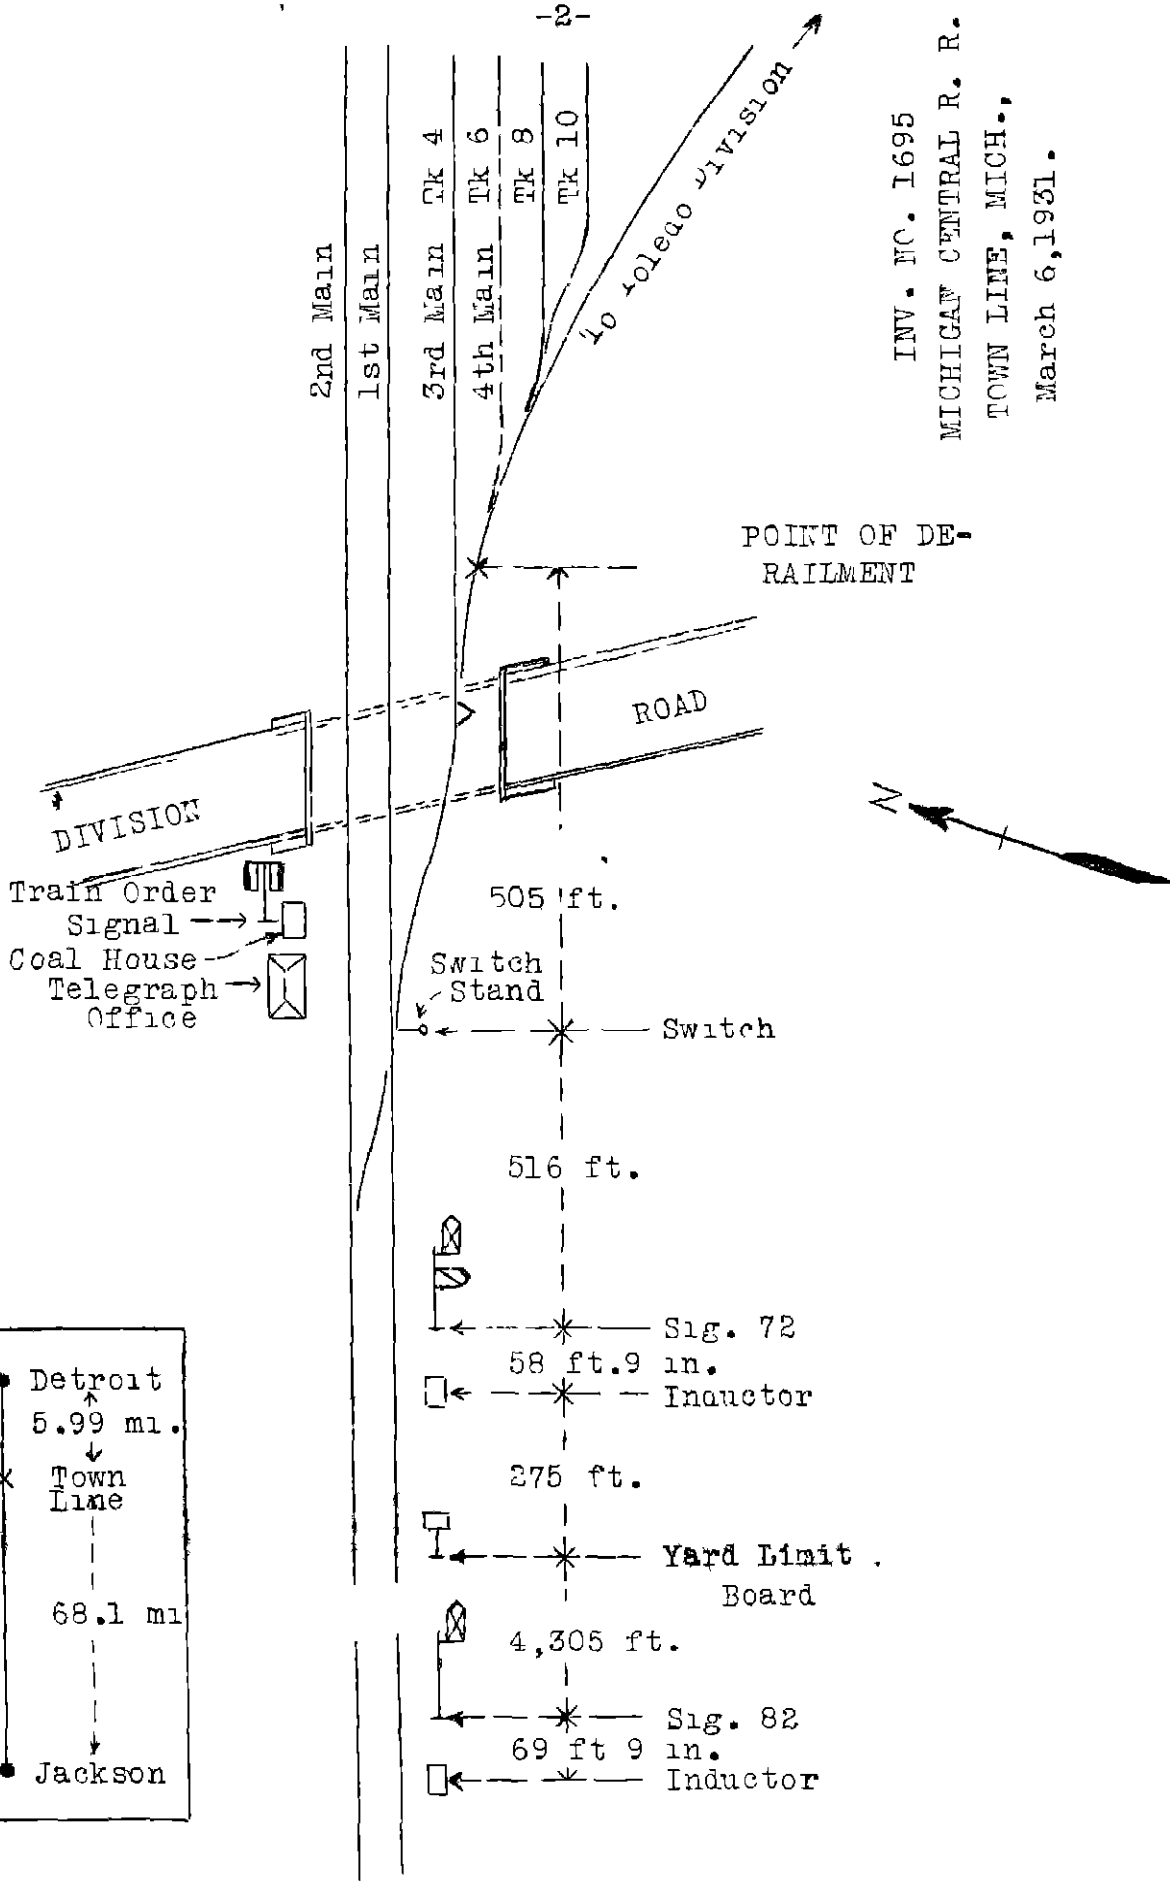
The signals involved are signals 72 and 82, located 516 feet and 5,155 feet, respectively west of the main line switch. Signal 72 is of the two-arm, three-position, upper quadrant type, the top arm governing main-track movements and the lower arm controlling diverging movements, and the inductors for signals 72 and 82 are located 58.9 feet and 69.9 feet, respectively, west of these signals. The train-order board is located north of the main tracks and immediately east of the telegraph office. The maximum speed permitted for passenger trains is 60 miles per hour.

The engine and tender stopped on their left sides about 960 feet east of the main track switch, across the third and fourth main tracks. The first eight cars were also derailed, stopping in various positions to the rear of the engine, while the last three cars in the train remained on the track. The engine was badly damaged, the first car was destroyed, and the other derailed cars were more or less damaged. The employees injured were the engineman, fireman, and the baggageman.

This accident was caused by a switch being opened directly in front of an approaching train, for which Operator Greenwood is responsible

The estimated speed of train No. 10 as it approached Town Line was about 60 miles per hour. The distance between signal 72 and the main line switch opposite the tower was 516 feet. At this rate of speed train No. 10 would have covered this distance in approximately six seconds. It would have been manifestly impossible for the operator to cross the tracks, open the switch and return to the platform in this short period of time. The operator must therefore at least have started across the track for the purpose of opening the switch when train No. 10 was some distance west of signal 72. It is believed that when he saw this train approaching some distance away, assuming it to be the local freight, he started across the track, opened the switch, returned to the platform and then discovered that the approaching train was the passenger train. This is not in conflict with the engineman's and fireman's statements. The engineman said he was watching the train-order signal for a distance of from 6 to 10 car-lengths west of signal 72 and during that interval did not observe the indication of signal 72. The fireman's view of signal 72 was cut off by the front end of his engine some distance west of signal 72, and it is entirely possible that this signal went to stop position during that interval.

The cause of this accident was practically identical with that of the accident on the Grand Trunk Railway at Battle Creek, Mich., on February 7, 1931, a report concerning which was issued by this Bureau on March 9. In that case a switchtender also opened a switch to a yard directly in front of an approaching high-speed train, having failed definitely to identify that train and having mistaken it for a freight train which was to be diverted to the yard. In the present case Operator Greenwood said that when he opened the switch to divert the local freight into the yard, he was never certain that the approaching train was the local freight. A switch for a diverging movement should not be operated directly in front of an approaching train until the train has been definitely identified and either it is a sufficient distance away to enable it to be properly controlled or it is known that the rate of speed is sufficiently low to permit the diverging movement to be made in safety. The operating conditions and practices at this point should at once be given proper attention by responsible officers of this railroad.
