INTERSTATE COMMERCE COMMISSION

REPORT OF THE DIRECTOR OF THE BUREAU OF SAFETY IN RE
INVESTIGATION OF AN ACCIDENT WHICH OCCURRED ON THE
WABASH RAILWAY NEAR CHICAGO RIDGE, ILL., ON MAY 6, 1931.

June 13, 1931.

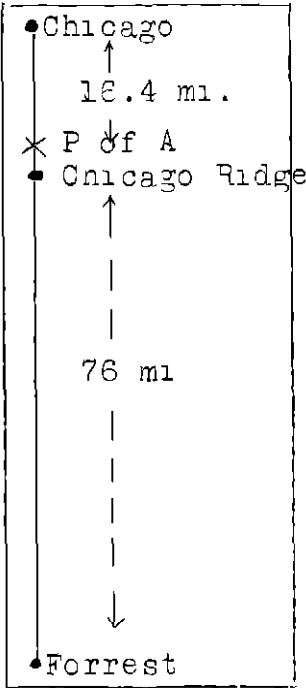
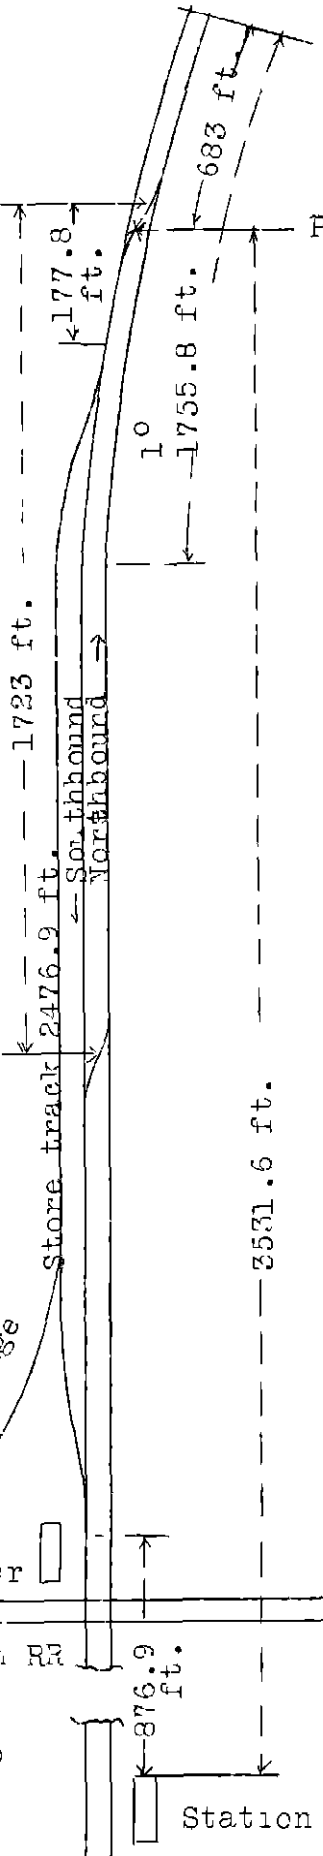
Inv No 1704
Wabash Railway
Chicago Ridge, Ill
May 6, 1931

North crossover Point of accident

The crossover involved is known as the north crossover and is 204 feet in length, another trailing-point crossover, known as the middle crossover, is located 1,723 feet south thereof. Yard-limit boards are located 3,401 feet north and 8,754 feet south of the point of accident. Time-table instructions restrict the speed of dead freight trains to 25 miles per hour, while rule D-93 provides in part that extra trains must move within yard limits prepared to stop unless the main track is seen or known to be clear.
