INTERSTATE COMMERCE COMMISSION

REPORT OF THE DIRECTOR OF THE BUREAU OF SAFETY IN RE
INVESTIGATION OF AN ACCIDENT WHICH OCCURRED ON
THE CHICAGO & NORTH WESTERN RAILWAY AT BARRINGTON,
ILL , ON NOVEMBER 21, 1931

December 11, 1931.

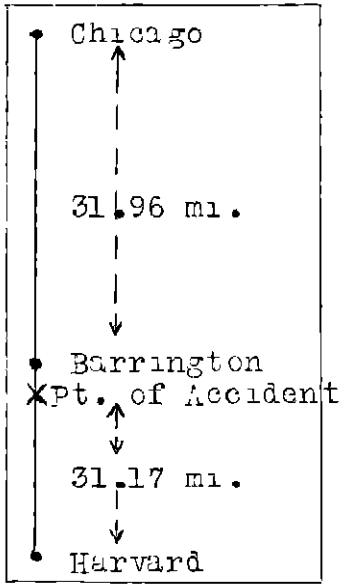
Inv. No. 1736
 Chicago & North Western Railway
 Barrington, Ill.
 November 21, 1931.

The signal governing eastbound movements in the block in which the accident occurred is interlocking home signal 2, a three-panel color-light signal, located at a point 565 feet west of the EJ&E crossing. The block extends a distance of 5,020 feet to the eastbound interlocking home signal for the remote control interlocking plant at the beginning of the three-track line. The circuits are so arranged that when the block is occupied the bottom or call-on panel key show yellow with the two top panels

displaying red lights, thus indicating "proceed at restricted speed" The approach or distant signal for the Barrington plant, governing eastbound movements, is a lower-quadrant, lever-controlled, slotted semaphore signal, located 3,350 feet west of home signal 2. This signal will have the blade in the horizontal position, displaying red and green lights, indicating "prepare to stop at next signal; train exceeding 30 miles per hour must at once reduce to that speed," when the track in advance is occupied, or when home signal 2 displays stop indications on the two top panels with the call-on arm displaying either red or yellow indications.
