INTERSTATE COMMERCE COMMISSION

REPORT OF THE DIRECTOR OF THE BUREAU OF SAFETY IN RE
INVESTIGATION OF AN ACCIDENT WHICH OCCURRED ON
THE PENNSYLVANIA RAILROAD NEAR WILKES-BARRE, PA ,
ON JANUARY 28, 1932.

March 10, 1932.

INV. NO. 1748
 PENNSYLVANIA R. R.
 WILKES-BARRE, PA.,
 JAN. 28, 1932.

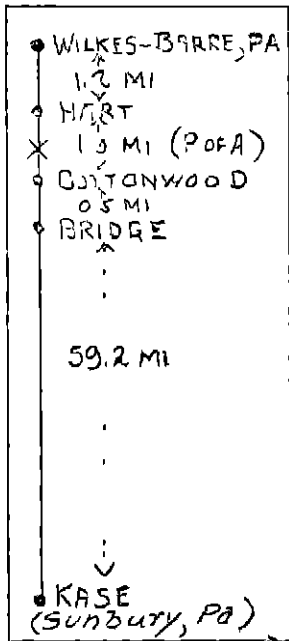
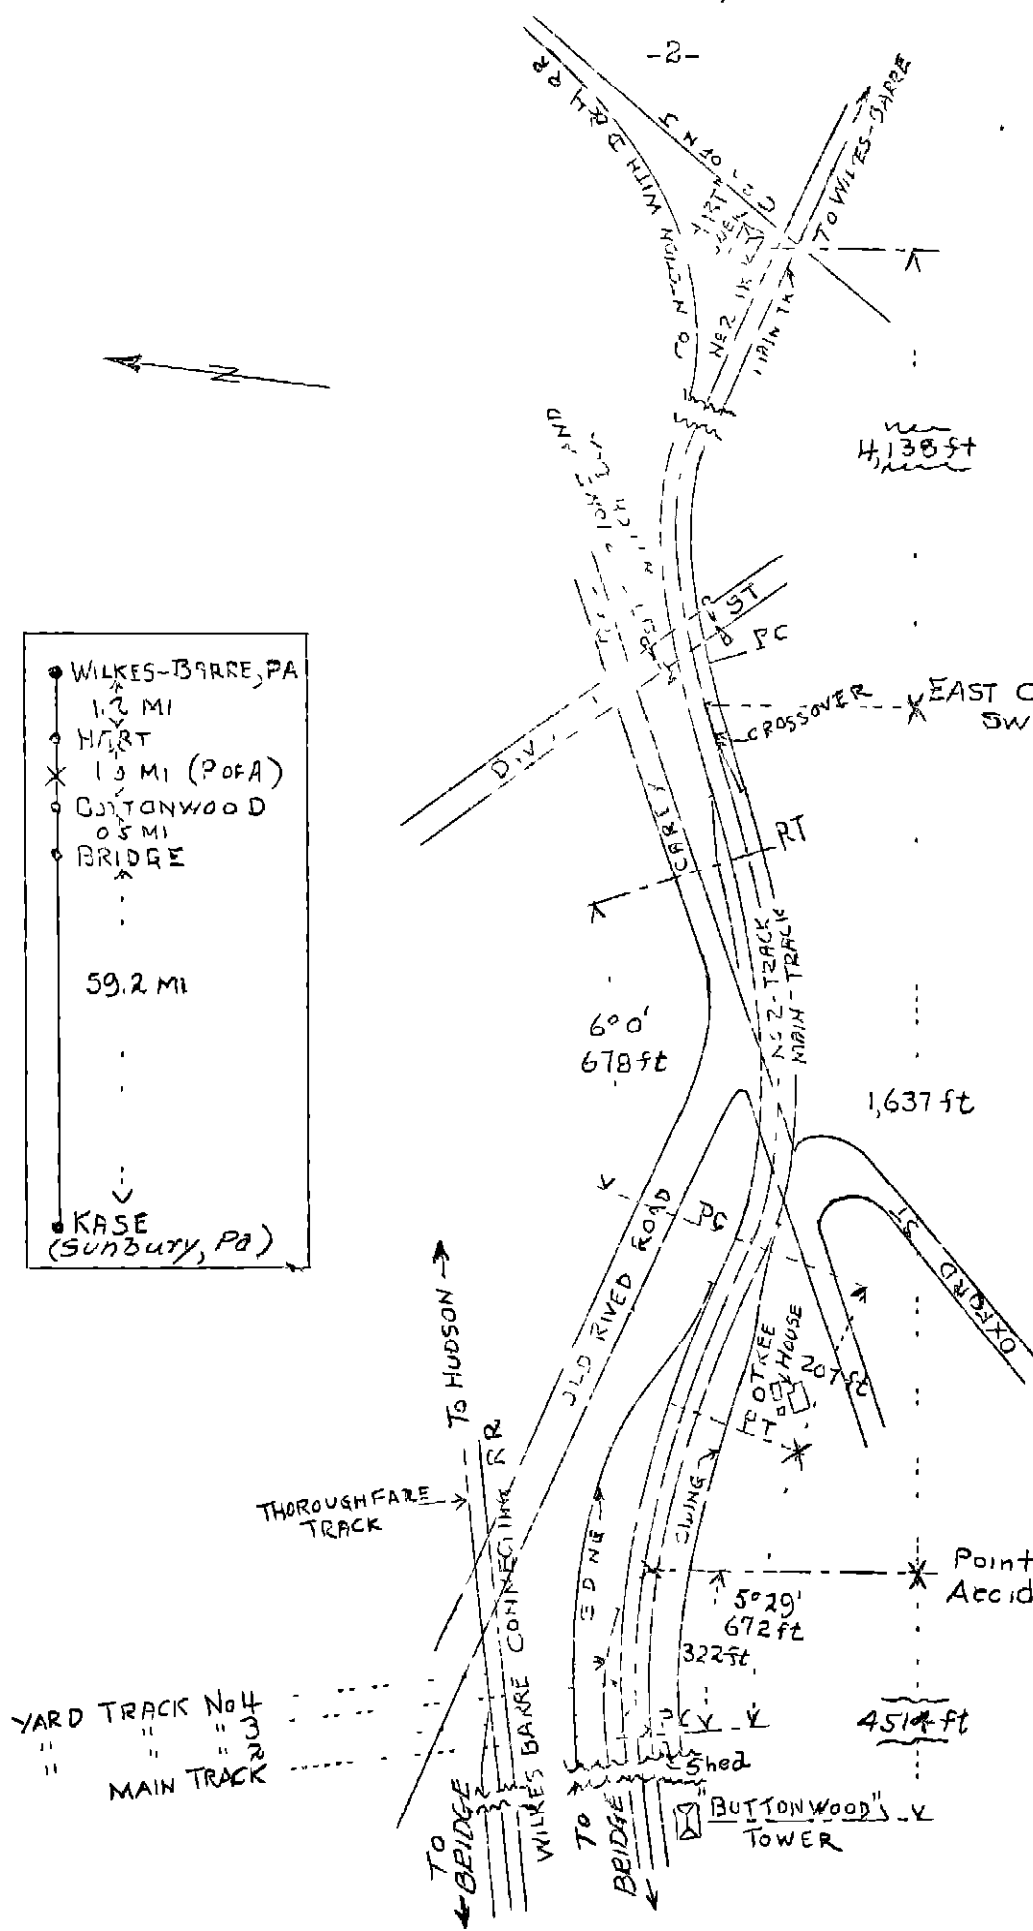
The view is obscured by buildings and sheds located south of the main track and on each end of the curve on which the accident occurred, and an embankment on the inside of the curve which varies in height from 3 feet to $6\frac{1}{2}$ feet above the rails. At the time of the accident a freight train was standing on yard track 2, with its rear end about 10 car-lengths west of the point of accident.
