INTERSTATE COMMERCE COMMISSION

REPORT OF THE DIRECTOR OF THE BUREAU OF SAFETY CONCERNING AN
ACCIDENT WHICH OCCURRED ON THE NEW YORK CENTRAL RAILROAD
AT CLAY BANK, OHIO, ON JUNE 18, 1932.

August 5, 1932.

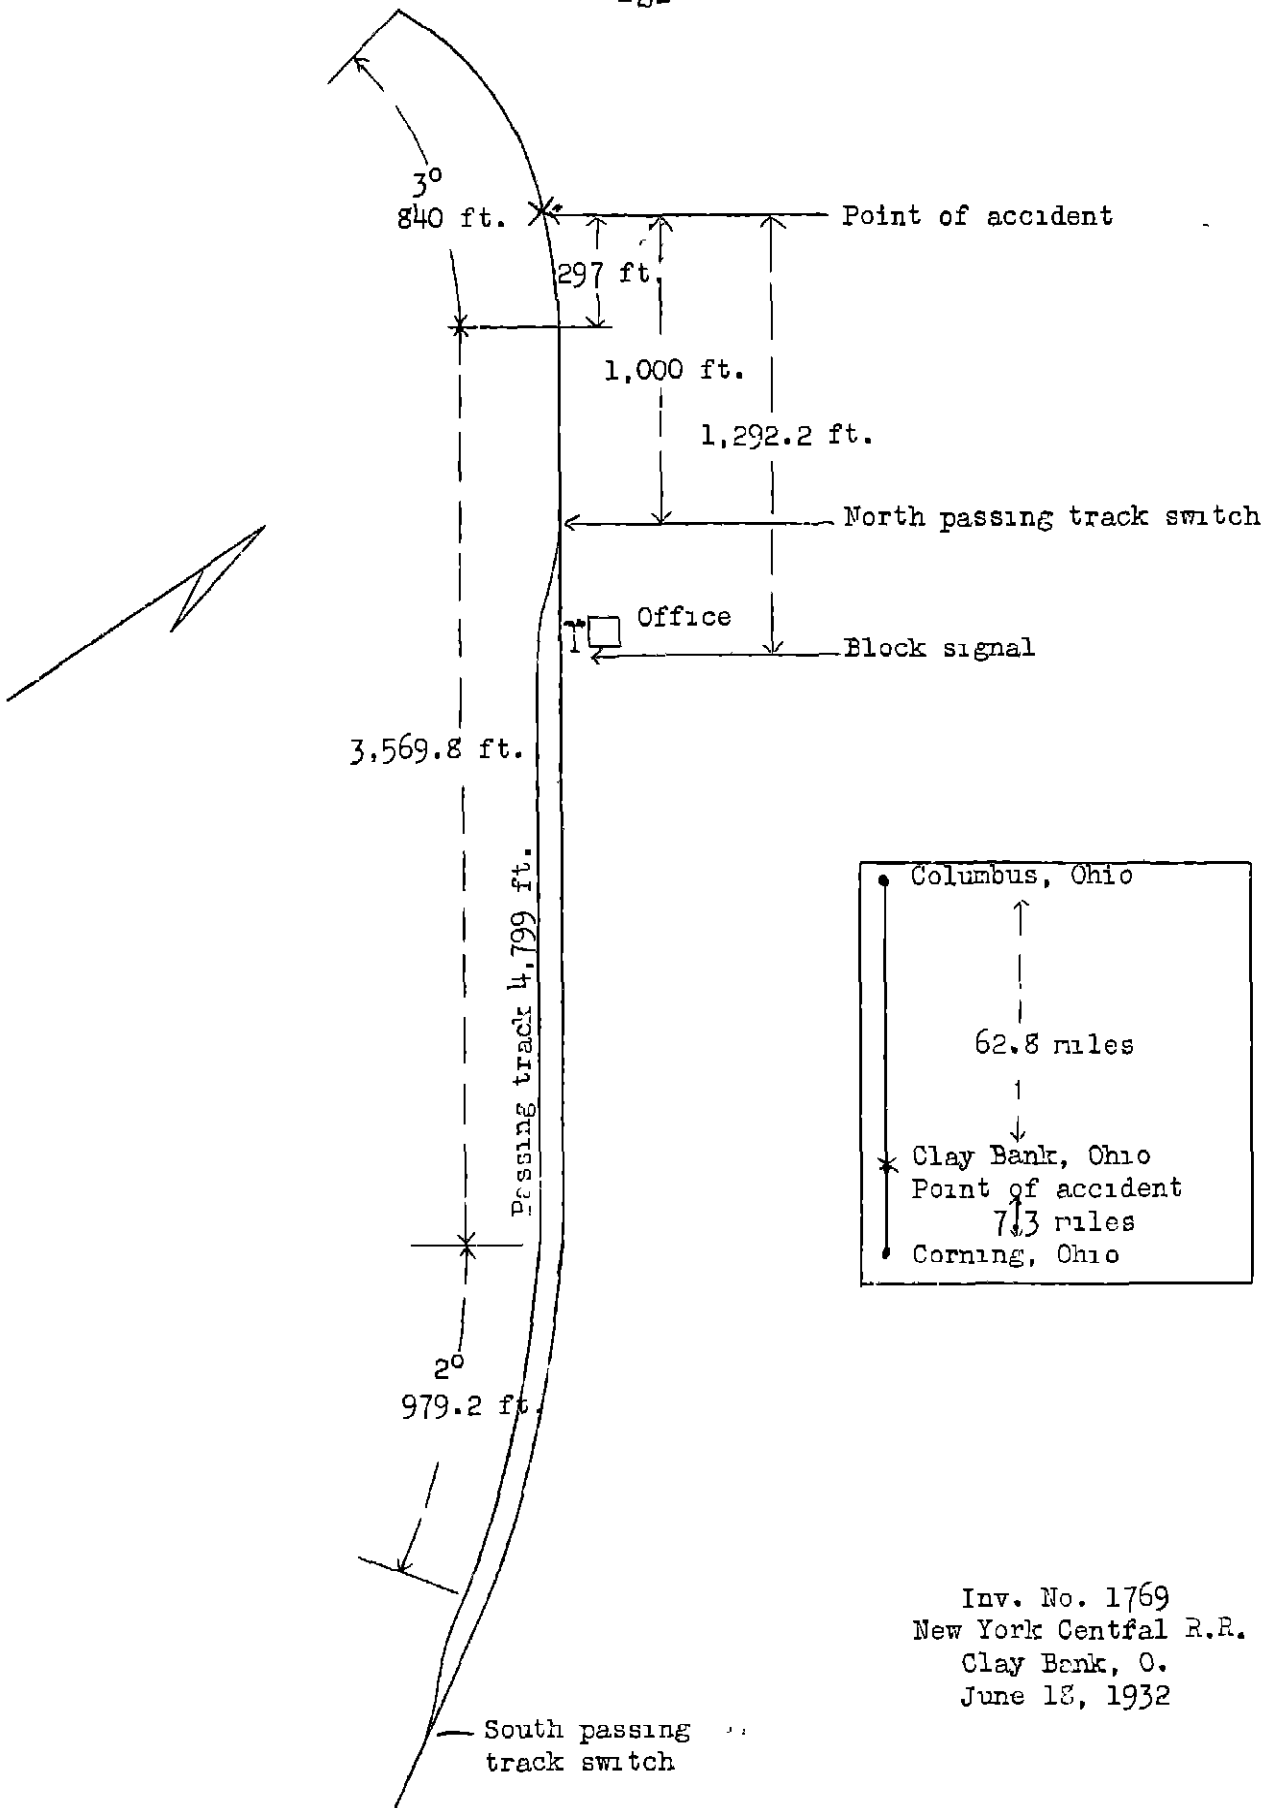
Inv. No. 1769
New York Central R.R.
Clay Bank, O.
June 18, 1932

This train left Corning, 7.3 miles south of Clay Bank, at 4.15 p. m., 30 minutes late, without any orders concerning train No. 62, and approached Clay Bank, the next open office, at a speed of 35 or 40 miles per hour, it passed the block signal, which was in the stop position, passed the north switch, and collided with train No. 62 at a speed estimated to have been between 7 and 20 miles per hour.
