INTERSTATE COMMERCE COMMISSION

REPORT OF THE DIRECTOR OF THE BUREAU OF SAFETY CONCERNING AN
ACCIDENT WHICH OCCURRED ON THE PENNSYLVANIA RAILROAD AT
PERRYMAN, MD., ON OCTOBER 18, 1932.

December 21, 1932.

Inv. No. 1791
 Pennsylvania Railroad
 Perryman, Md.
 Oct. 18, 1932

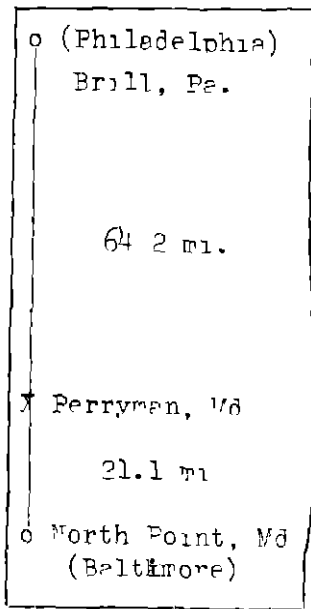
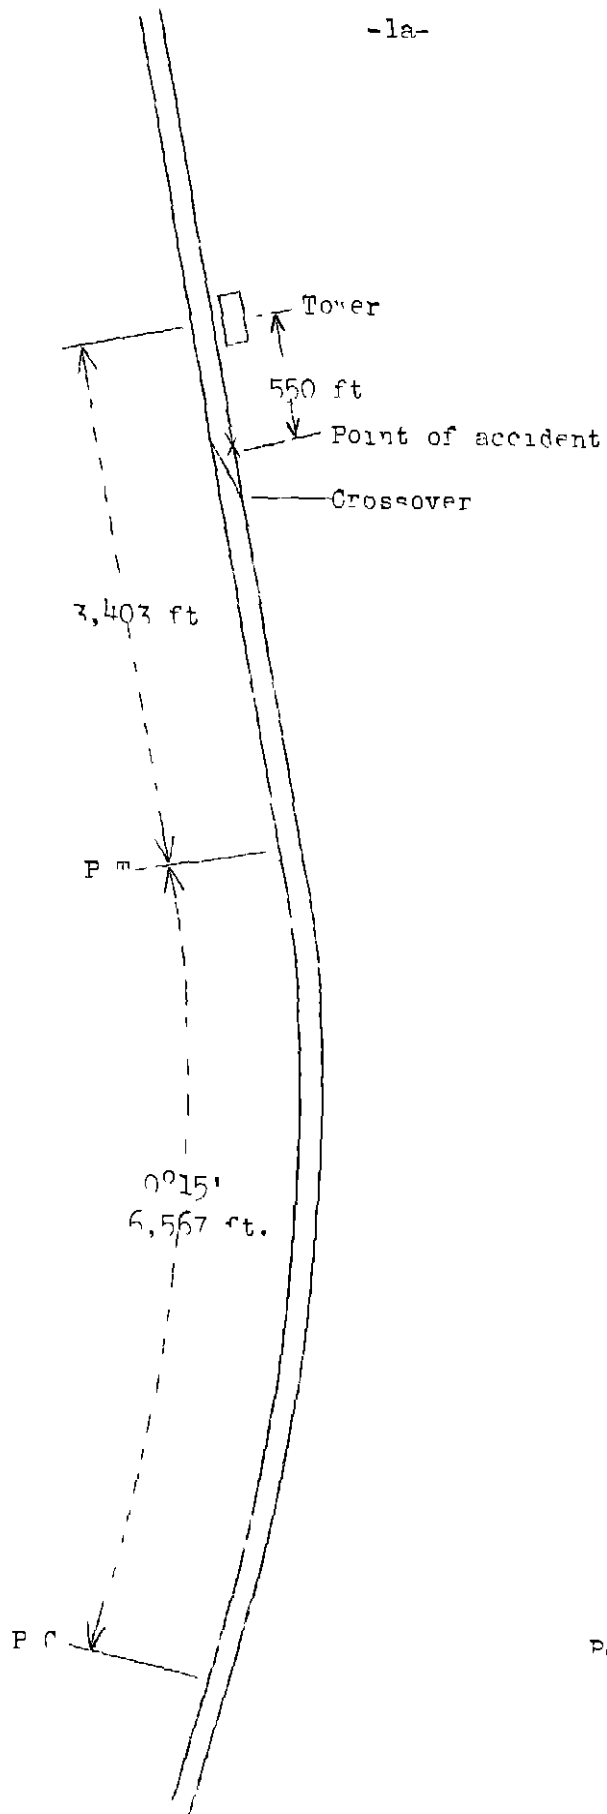
The engine and first 8 cars stopped with the head end of the engine 1,485 feet north of the tower; the rear truck of the eighth car and the following 16 cars were derailed and stopped in various positions within a space of 275 feet near the location of the tower. Some of the cars were destroyed, others badly damaged, the tower was demolished and the interlocking plant was badly damaged. The employee killed was a signalman and the employee injured was a block operator, both of whom were in the tower at the time of the accident.

An inspection of the track made by the Commission's inspectors subsequent to the accident revealed that the track was in good condition and nothing was found that could have contributed to the cause of the accident. A mark was found in the ballast at the Bush River Neck highway crossing which was 6 inches from the outside of the west rail; it was about 1 inch deep and extended entirely over the crossing. The next mark was on the west rail of the crossover south of the tower and conformed in position to the mark at the highway crossing, the final derailment occurring just north of this point. Examination of the rear truck of UTLX tank car 31871 disclosed that the bottom arch bar on the left side of the truck was broken at the bend in front of the journal box and the top arch bar was bent downward. The forward column bolt was broken and the truck, while it remained in its position under the car, was in a badly-damaged condition. An inspection of the broken arch bar showed an old defect which began at the lower outside corner near the bend at the journal box and extended 1 5/8 inches inward and 1 inch upward. Another old defect appeared near the center end on the bottom side of the arch bar, this defect extending 2 1/2 inches across the bar and being 3/8 inch deep.

This accident apparently was caused by the failure of an arch-bar truck under the eighth car in the train.

According to the statements of the members of the train crew, they had no knowledge of anything wrong until the train was derailed. An inspection of the track disclosed that something had been dragging, the first indication being a mark on a highway crossing on the outside of the left or west rail approximately 3 miles south of the point of accident. Another mark was found on the outside of the west rail of the crossover a short distance south of Perryman tower, followed by a mark on top of the main rail and then flange marks appeared on the ties. An examination of the rear truck of UTLX tank car 31871, the eighth car in the train, showed it to be in a badly-damaged condition. The lower arch bar on the left side was broken and the top bar was bent, a column bolt and the brake beams were also broken. Inspection of the broken arch bar revealed that it had been cracked for some time at the point of failure, and painted over subsequent to that time, thus preventing its detection when inspected by car inspectors.
