INTERSTATE COMMERCE COMMISSION

REPORT OF THE DIRECTOR OF THE BUREAU OF SAFETY CONCERNING AN
ACCIDENT ON THE NEW YORK CENTRAL RAILROAD AT PLEASANTVILLE,
OHIO, ON DECEMBER 10, 1932.

January 19, 1933.

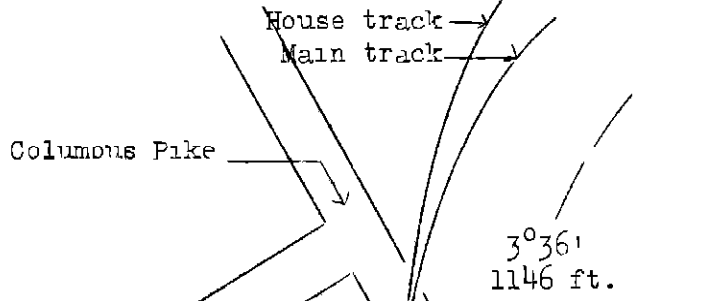
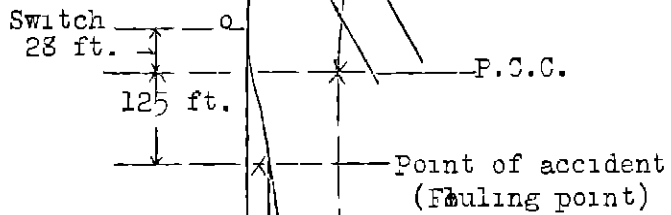
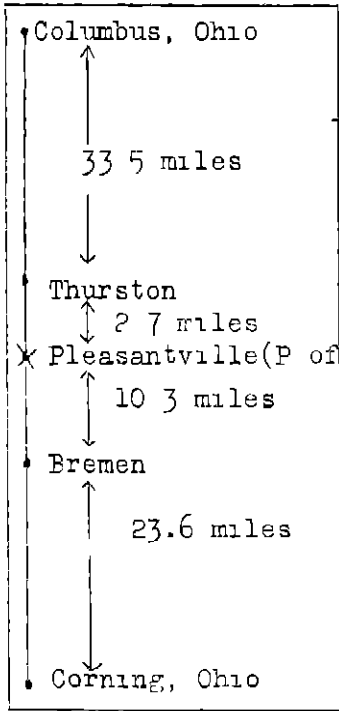
Inv No 1797
New York Central P R.
Pleasantville, Ohio
December 10, 1932

at Pleasantville. Extra 18 departed from Thurston at 11 16 p.m., according to the train sheet, and on arrival at Pleasantville it pulled in and stopped behind engine 7980, with the rear four cars and caboose extending out upon the main track, while standing in this position they were struck by train third No. 91.

Engine 87 was not derailed, but it derailed and overturned the fourth, third and second cars ahead of the caboose in extra 18, and then coupled into the first car ahead of the caboose and shoved that car and the caboose backward about six car lengths. The employees injured were the engineman and fireman of train third No. 91, who jumped just before the accident.
