INTERSTATE COMMERCE COMMISSION

REPORT OF THE DIRECTOR OF THE BUREAU OF SAFETY CONCERNING AN
ACCIDENT ON THE PENNSYLVANIA RAILROAD AT TYRONE, Pa.,
ON DECEMBER 24, 1932.

February 11, 1933

Inv. No. 1801
 Pennsylvania R.R.
 Tyrone, Pa.
 December 24, 1932

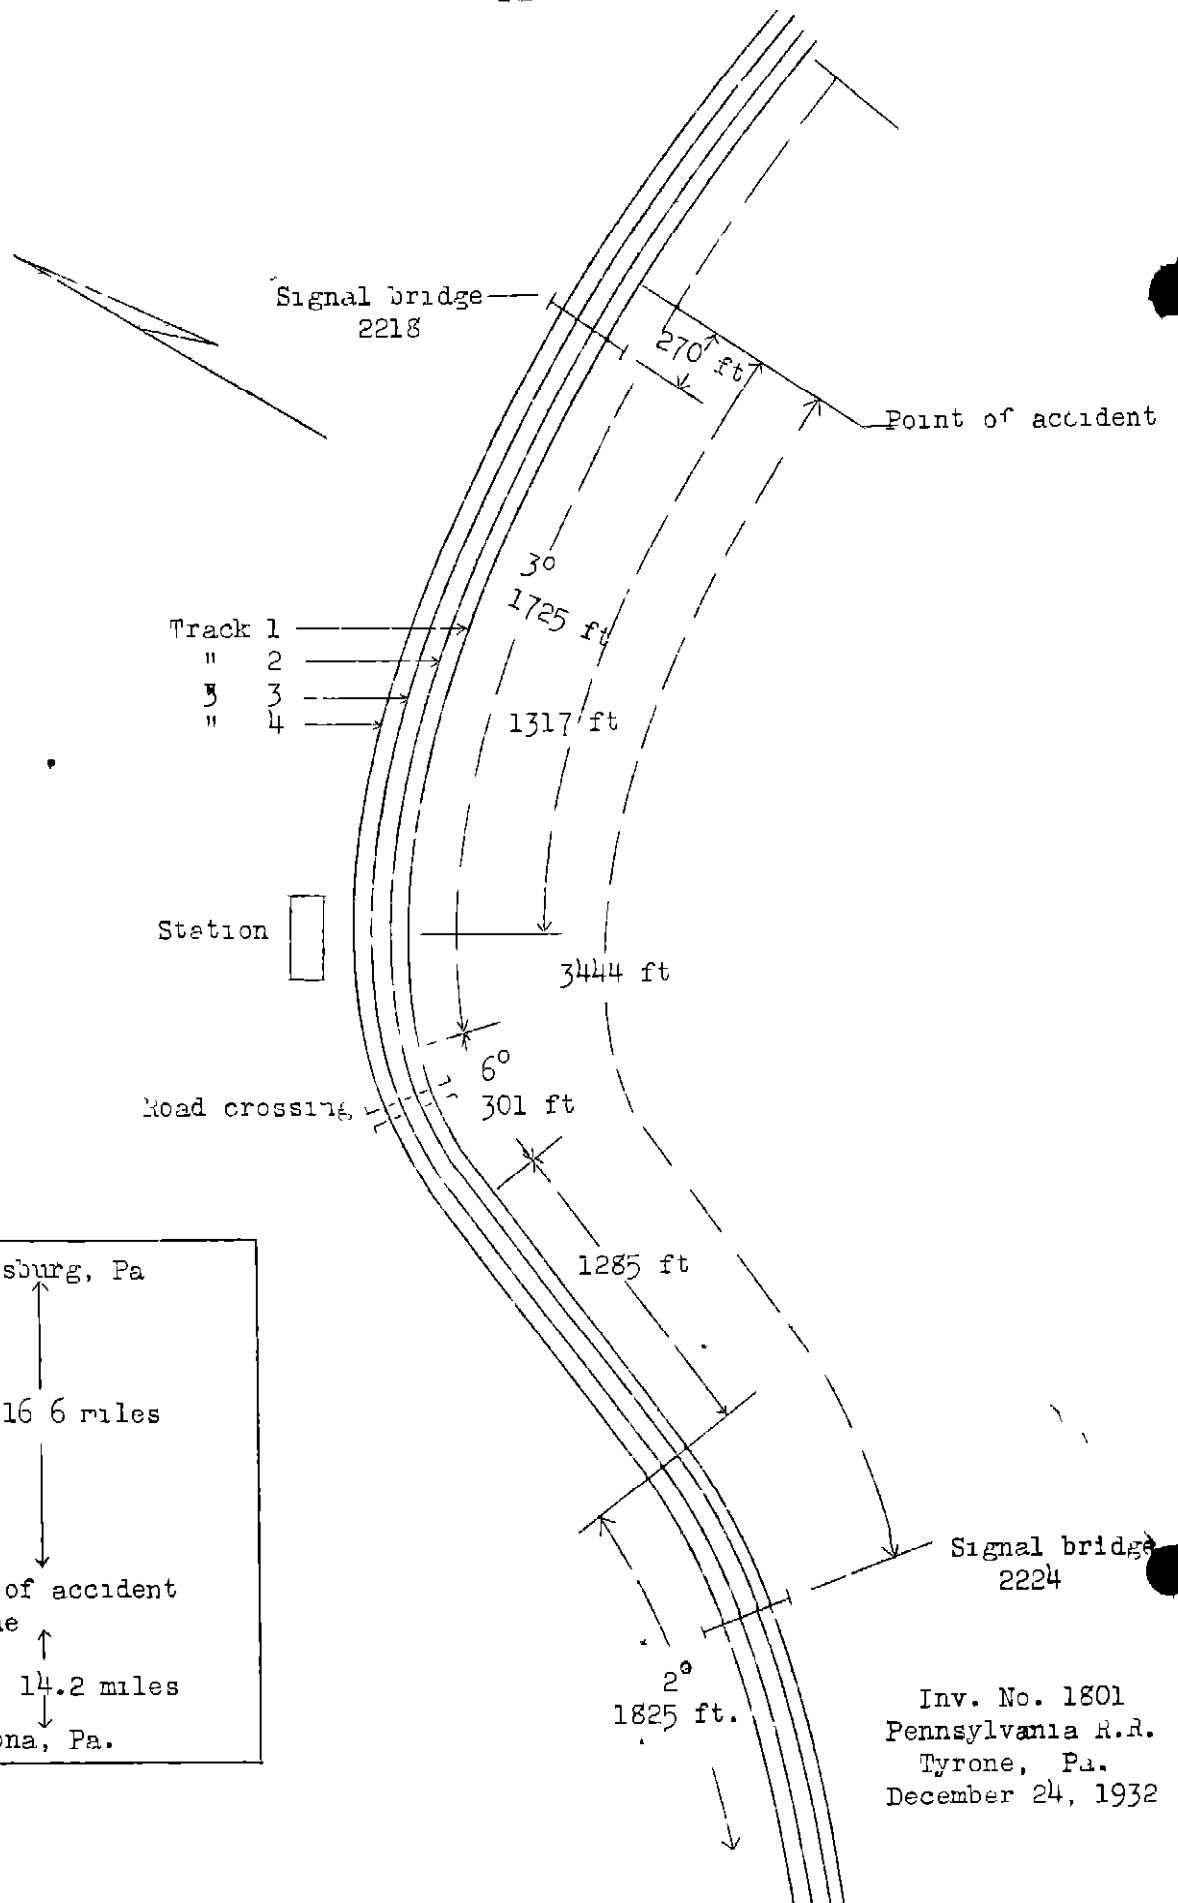
The signals involved are mounted on signal bridges 2224 and 2218, located 3,444 feet and 270 feet, respectively, west of the point of accident, the eastbound signal on bridge 2218 is the distant signal to the home signal at Forge interlocking which is 1 mile east of Tyrone. The signals are of the position-light type. The maximum authorized speed for the trains involved in the territory from Altoona to the point of accident is 25 miles per hour.
