INTERSTATE COMMERCE COMMISSION

REPORT OF THE DIRECTOR OF THE BUREAU OF SAFETY CONCERNING AN
ACCIDENT AT THE INTERSECTION OF THE TRACKS OF THE ILLINOIS
CENTRAL RAILROAD AND THE CHICAGO AND EASTERN ILLINOIS
RAILWAY AT MARION, ILL., ON AUGUST 3, 1933.

Inv. No. 1841
Illinois Central RR
Chicago & Eastern Illinois Ry
Marion, Ill.
August 3, 1933.

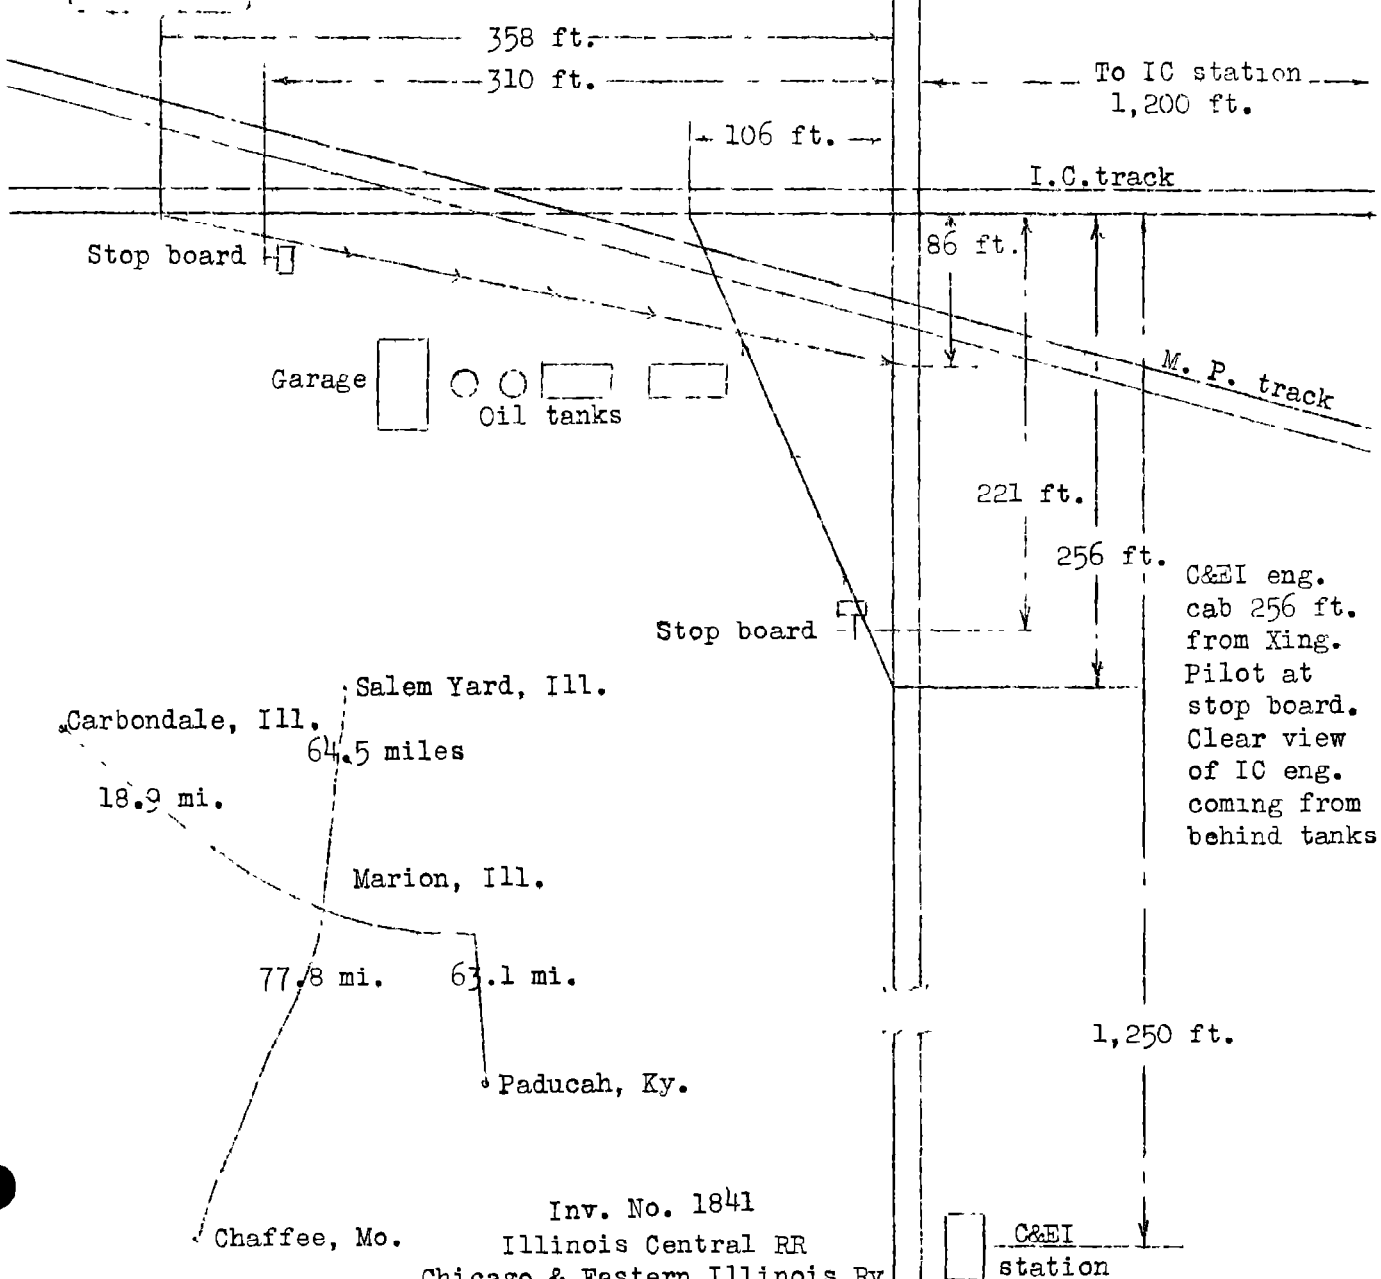
IC eng. cab 358 ft. from Xing. Pilot at stop board. Clear view of C&EI engine 86 ft. from crossing.

C&EI eng. cab 256 ft. from Xing. Pilot at stop board. Clear view of IC eng. coming from behind tanks

Due to buildings and oil tanks of the Mid-Continent Oil Company being located in the southwest corner of the crossing, the views had by the engineman of a south-bound IC train and the fireman of a north-bound C&EI train are considerably restricted. When an engine of an IC train is at the stop board 310 feet from the crossing, the engineman is unable to see a north-bound C&EI train until that train reaches a point 86 feet south of the crossing; with the engine of a C&EI train at the stop board 221 feet from the crossing, the fireman is unable to see a south-bound IC train until it reaches a point 106 feet west of the crossing. As each train approaches the crossing the view of the other track gradually lengthens.
