INTERSTATE COMMERCE COMMISSION

REPORT OF THE DIRECTOR OF THE BUREAU OF SAFETY CONCERNING AN
ACCIDENT ON THE PENNSYLVANIA RAILROAD AT PITTSBURGH, PA.,
ON FEBRUARY 26, 1934.

April 4, 1934.

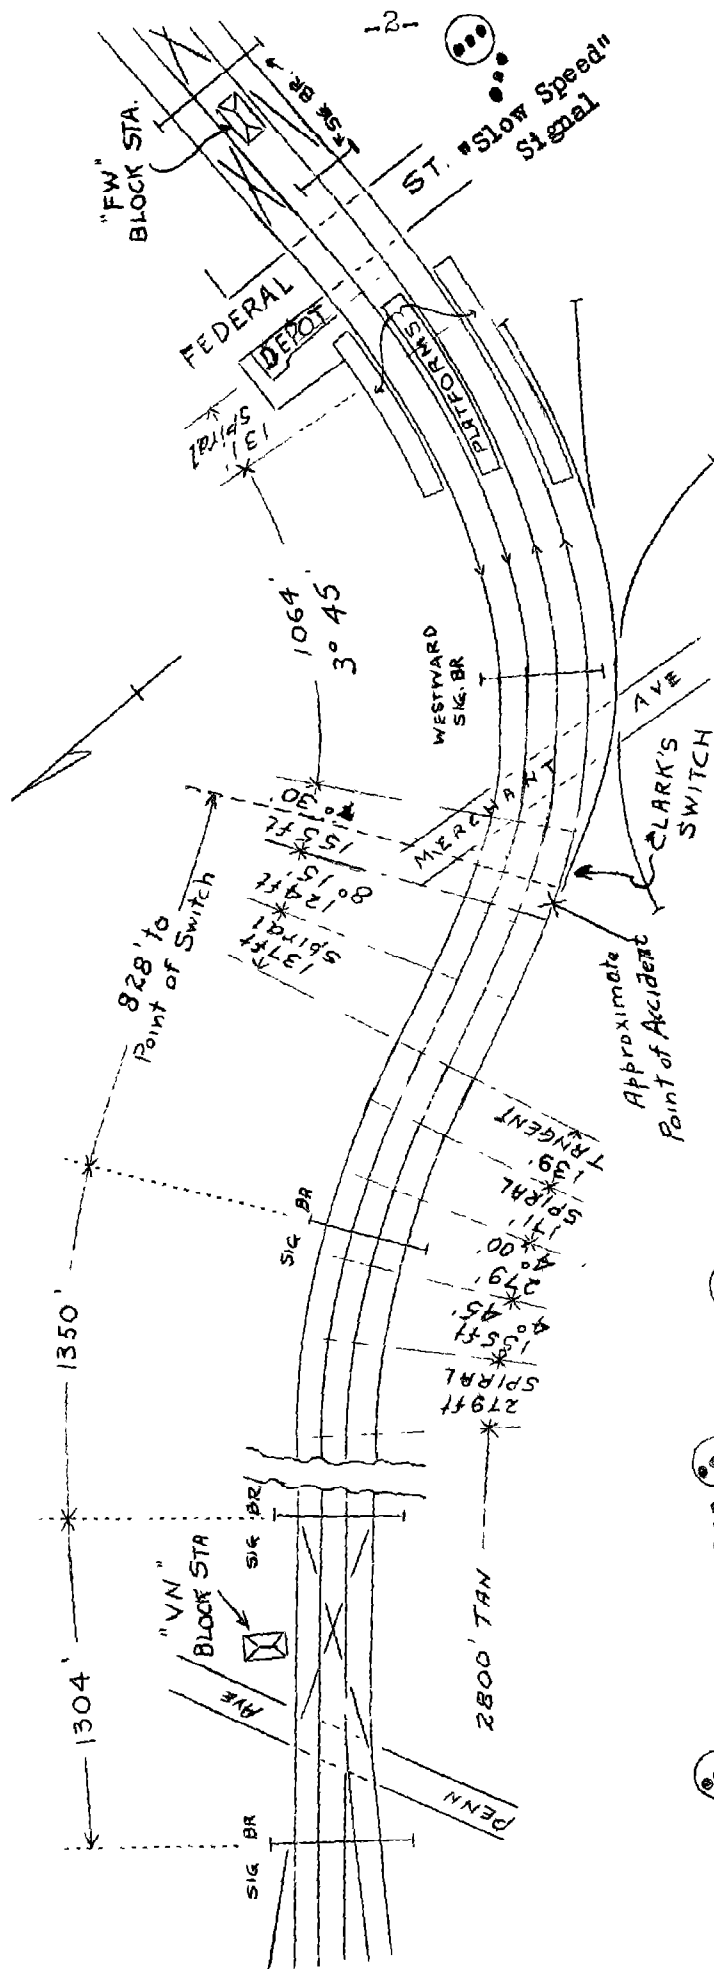
INV. NO. 1897
 PENNSYLVANIA RAILROAD
 PITTSBURGH PA.
 Feb. 26, 1934

Signal Indication shown for Train No. 1638

The signals in the vicinity, of the position-light type, are mounted on signal bridges which span all of the main tracks. One of these signal bridges is located at Pennsylvania Avenue west of the tower, another is a short distance east of the tower, and a third is located on the curve to the right immediately preceding the curve on which the accident occurred. These signal bridges are located 3,482, 2,178, and 828 feet, respectively, west of Clark's switch, and the circuits are so arranged that when the track ahead is clear the engineman of an east-bound train receives an approach-restricting indication at each of the first two signals and an approach indication at the last signal, these being the most favorable indications displayed by these signals. Under the rules, a train receiving an approach-restricting indication is required to "approach next signal at not exceeding one-half its maximum authorized speed at point involved but not exceeding 30 miles per hour," while an approach indication requires the train governed thereby to "approach next signal prepared to stop. A train exceeding one-half its maximum authorized speed at point involved must at once reduce to not exceeding that speed."
