INTERSTATE COMMERCE COMMISSION

REPORT OF THE DIRECTOR OF THE BUREAU OF SAFETY CONCERNING AN
ACCIDENT ON THE BALTIMORE & OHIO RAILROAD AT SAND PATCH,
PA., ON FEBRUARY 28, 1934.

May 14, 1934.

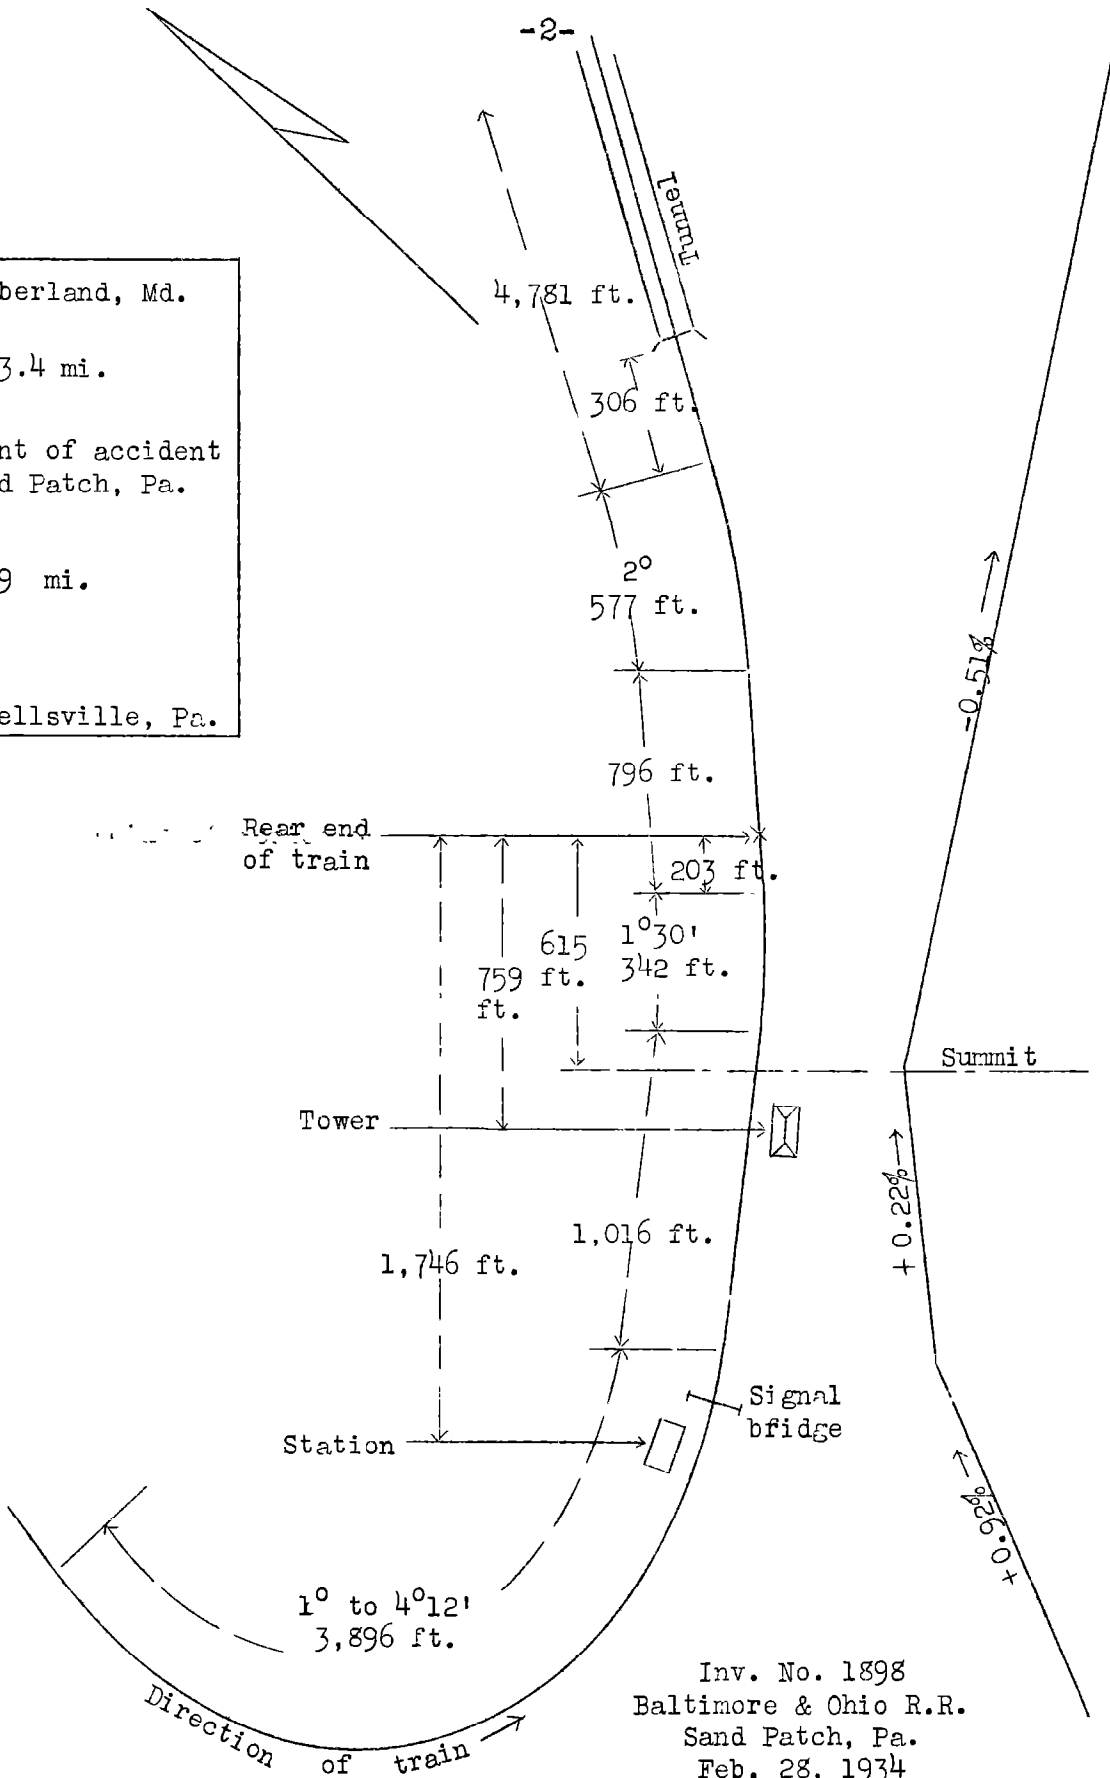
Inv. No. 1898
 Baltimore & Ohio R.R.
 Sand Patch, Pa.
 Feb. 28, 1934

The south corner of the steel rear platform of the caboose was crushed, the rear end being forced over toward the west-bound track. The rear coupler was broken off and the left corner of the front platform was slightly crushed by the end of the car ahead of it. The rear truck of the caboose was derailed, and engine 6166 was slightly damaged. The coupler in the front end of the first car in the train was broken off, as was the rear portion of the coupler yoke in the front end of the nineteenth car. The employee killed was the helper flagman, who was crushed between the caboose platform and pilot of engine 6166.

Examination of the head end of the nineteenth car by the Commission's inspectors disclosed that the draft gear yoke was broken off at each rear angle of the loop; approximately 15 percent of each fracture was slightly oxidized. The drawbar at the head end of the first car was broken at the keyway, apparently a new break resulting from the accident. The 5-by-7-inch shank of the A.R.A. type D coupler in the rear end of the caboose was broken off, also apparently a new break.

This accident was caused by Train Second No. 94 breaking in two between the eighteenth and nineteenth cars.

The break-in-two which resulted in this accident probably was due to a combination of several factors. When Conductor Fair first made an attempt to cut off the helper engines the major portion of the train was on the descending grade and it is believed that with the helper engines being eased off and throttles finally closed preparatory to cutting off from the caboose, the train was stretched out and extra strain exerted on the defective coupler yoke on the nineteenth car, resulting in its failure. The temperature was reported to have been about 27° below zero and may have been a factor by reason of increasing the brittleness of the metal. The parting of the train in turn caused an emergency application of the air brakes, with the consequent derailment and damage to the caboose due to the force exerted by the two helper engines behind it. While the coupler on the first car in the train also was broken, there was no indication of an old defect, and it is believed that this break was a result of the accident.

Attention is called to the potential hazard involved in massing motive power against any caboose car or car used for similar purposes. The caboose involved in this accident was well constructed, but its strength was insufficient to withstand the crushing force exerted by the two heavy helper engines when the brakes on the train were applied in emergency after the angle cock at the rear of the caboose had been closed and when steam was being used on the helpers to provide
