Railroad: Pennsylvania
Date: February 5, 1955
Location: Edgewood, Md.
Kind of accident: Rear-end collision
Trains involved: Passenger and freight
Casualties: 32 passengers and 18 employees
injured.
Cause: Failure of engineer to obey
signal indications.

INTERSTATE COMMERCE COMMISSION

REPORT OF THE DIRECTOR OF THE BUREAU OF SAFETY CONCERNING AN
ACCIDENT ON THE PENNSYLVANIA RAILROAD NEAR EDGEWOOD, MD.,
ON FEBRUARY 5, 1935.

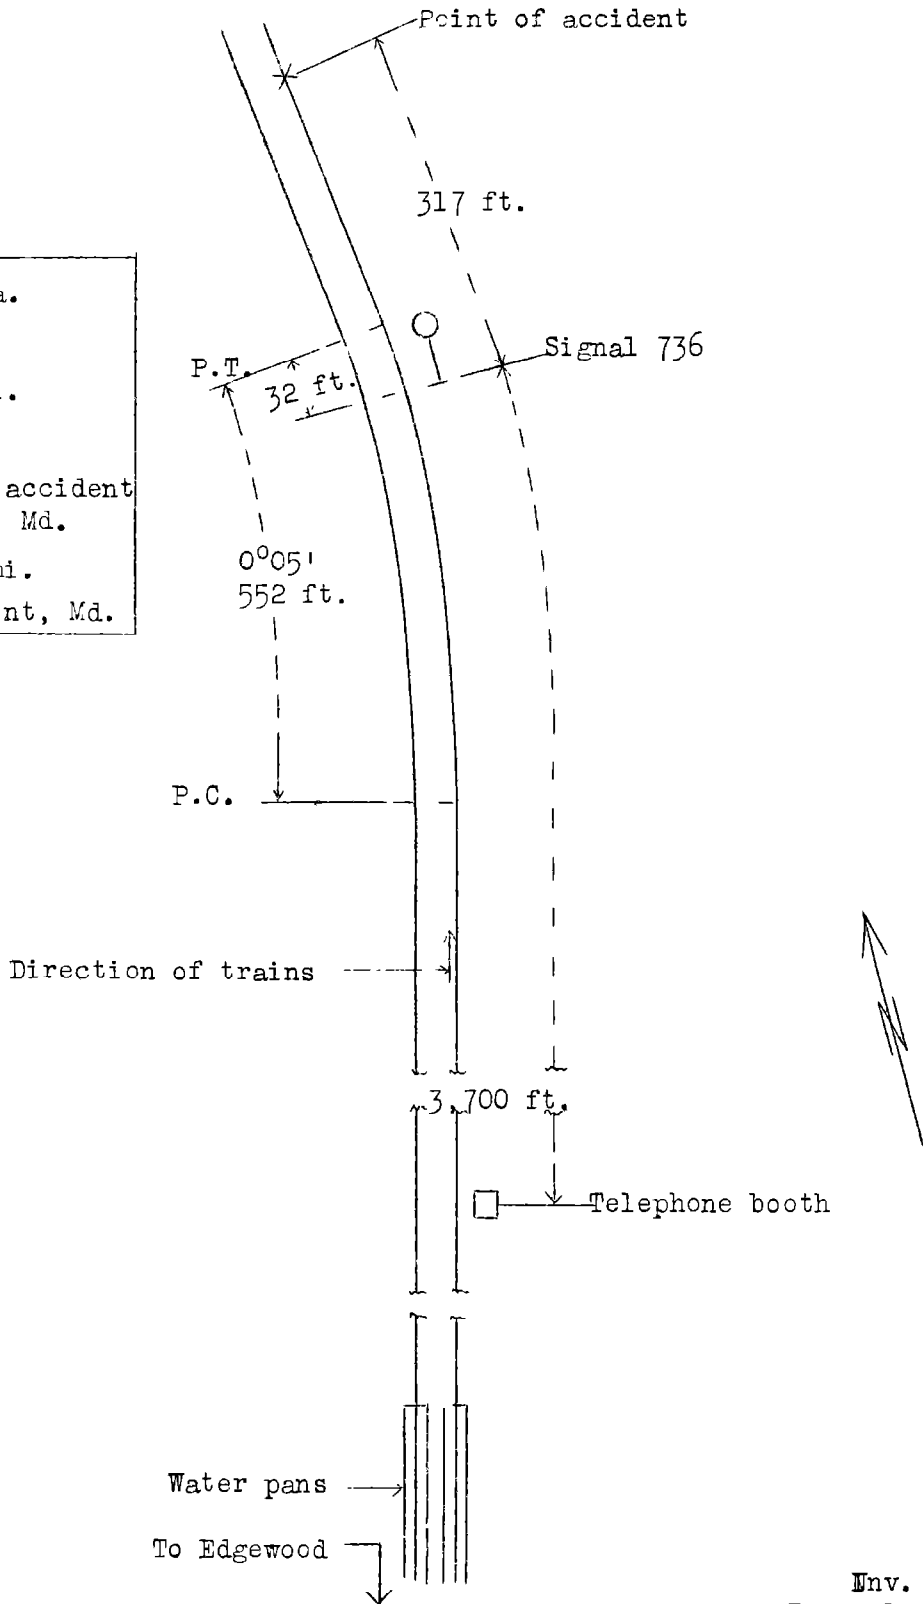
Inv. No. 1964
Pennsylvania Railroad
Edgewood, Md
Feb. 5, 1935

The signals are of the position-light type, those involved being dwarf signal 15-E and automatic signal 736, which is mounted on a mast and displays three indications, namely, clear, approach, and stop-and-proceed. Dwarf signal 15-E governs movements from Arsenal siding at Edgewood interlocking plant, and is located 9,377 feet south of signal 736. The cab-signal system is of the position-light type and displays four indications, namely, clear, approach-restricting, approach and caution-slow-speed.

Train MD-114, a north-bound local freight train, consisted of six cars and a caboose, hauled by engine 391, and was in charge of Conductor Veasey and Engineman Ruckle. This train stood on Arsenal siding at Edgewood until Train No. 136 passed and then pulled out behind that train at 11:54 a.m., passing dwarf signal 15-E, which was displaying a caution-slow-speed indication, with the same indication also being displayed by the cab signal. After entering upon the main track the cab-signal indication changed to approach and the train proceeded, passed the flagman of Train No. 136 and also signal 733 displaying a stop indication, and collided with Train No. 136 while traveling at a low rate of speed.
