REPORT OF THE DIRECTOR  
BUREAU OF SAFETY

ACCIDENT ON THE  
CINCINNATI UNION TERMINAL

FEBRUARY 23, 1936

INVESTIGATION NO. 2046

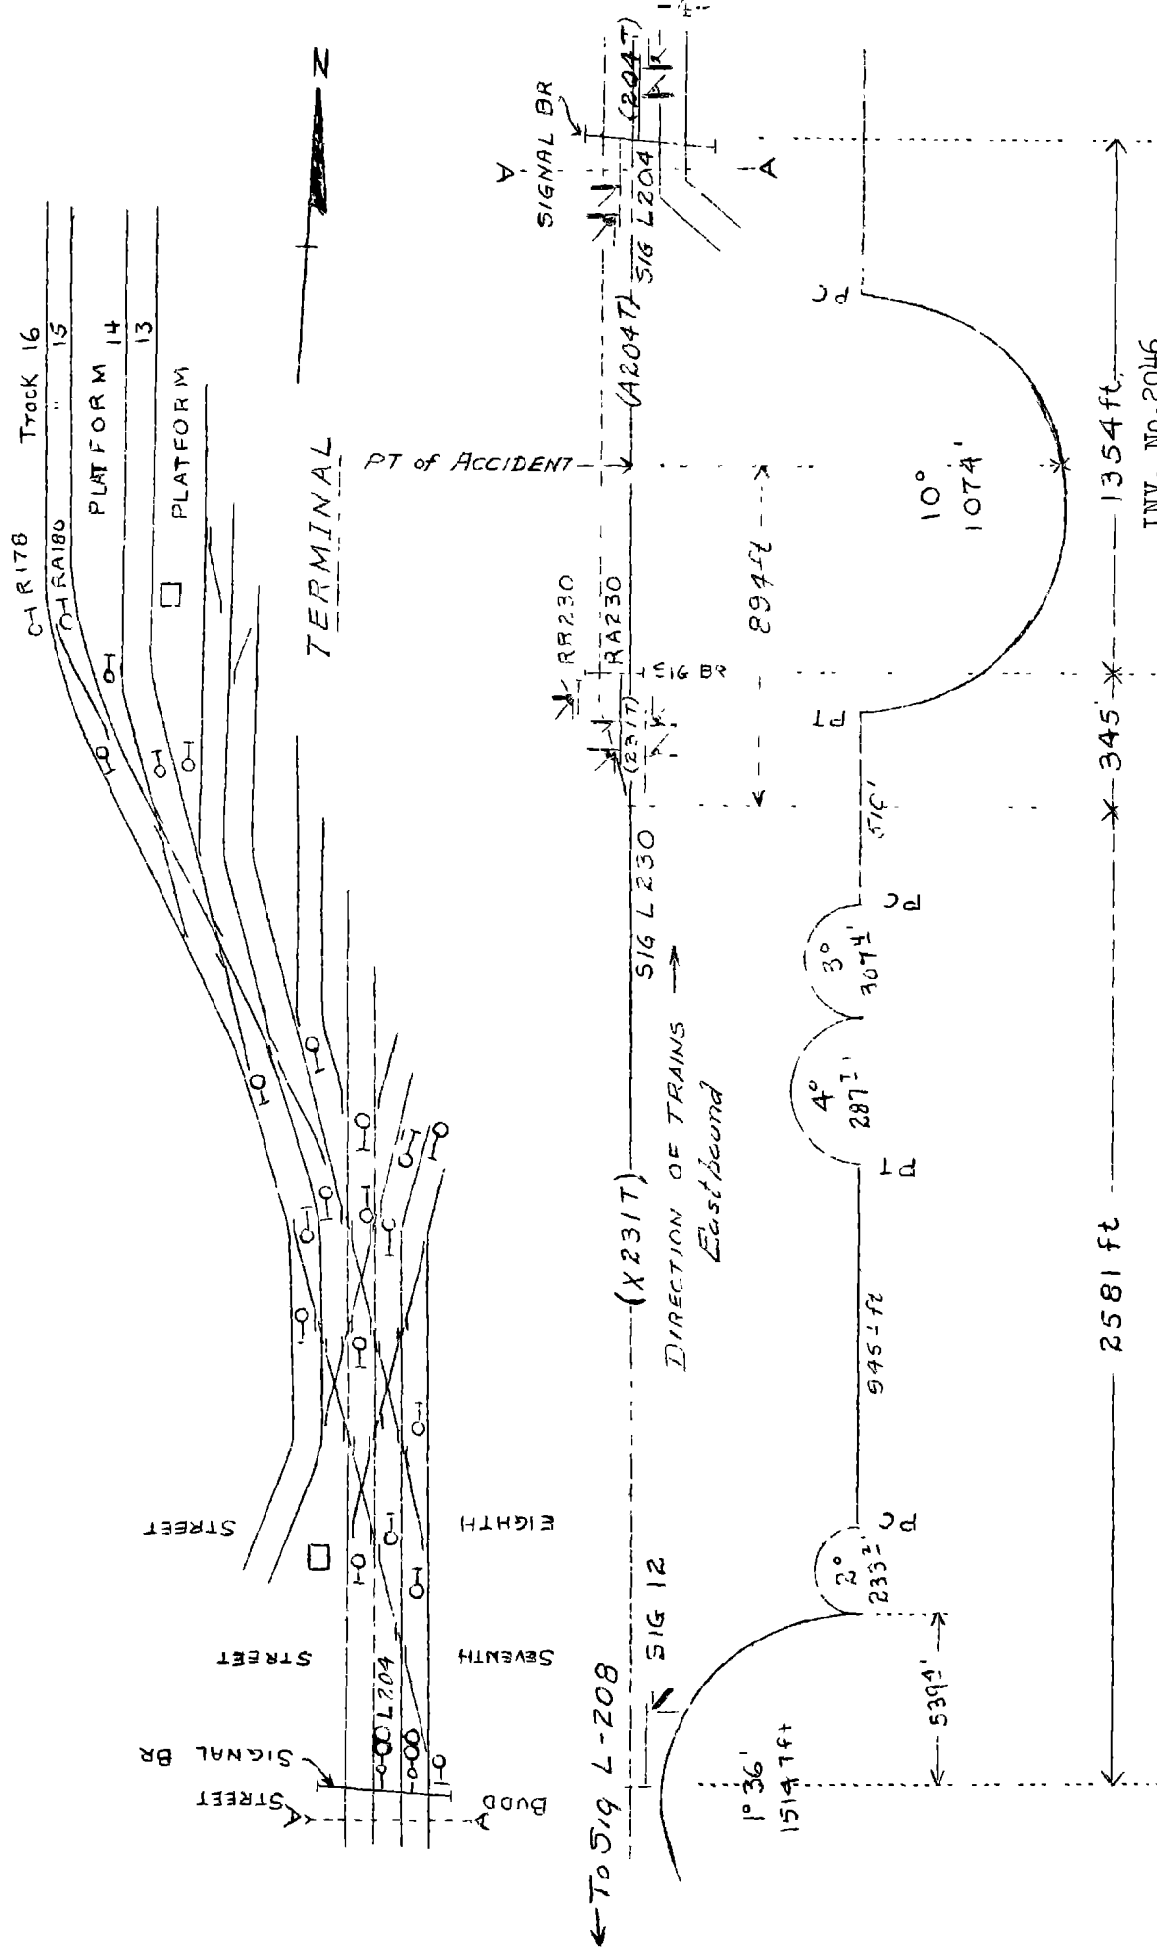
INV. No. 2046  
 THE CINCINNATI UNION TERMINAL CO.  
 CINCINNATI, O.  
 February 23, 1936.

This accident was caused by interlocking signal L230 and automatic signal 12 displaying false proceed indications, the false proceed indication displayed by signal L230 was caused by an error in its control circuit, while as a result of this error automatic signal 12 also displayed a false proceed indication through the normal operation of its circuit.
