REPORT OF THE DIRECTOR

ACCIDENT ON THE

PENNSYLVANIA RAILROAD

INVESTIGATION NO. 2085

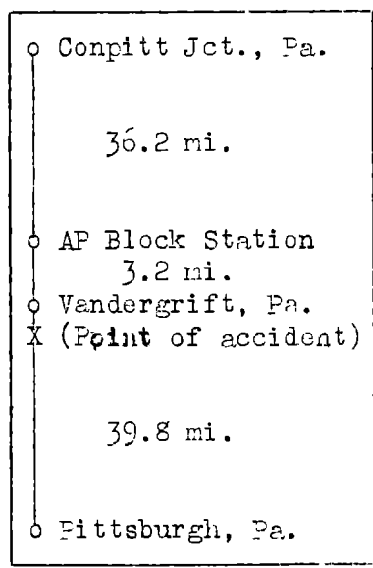
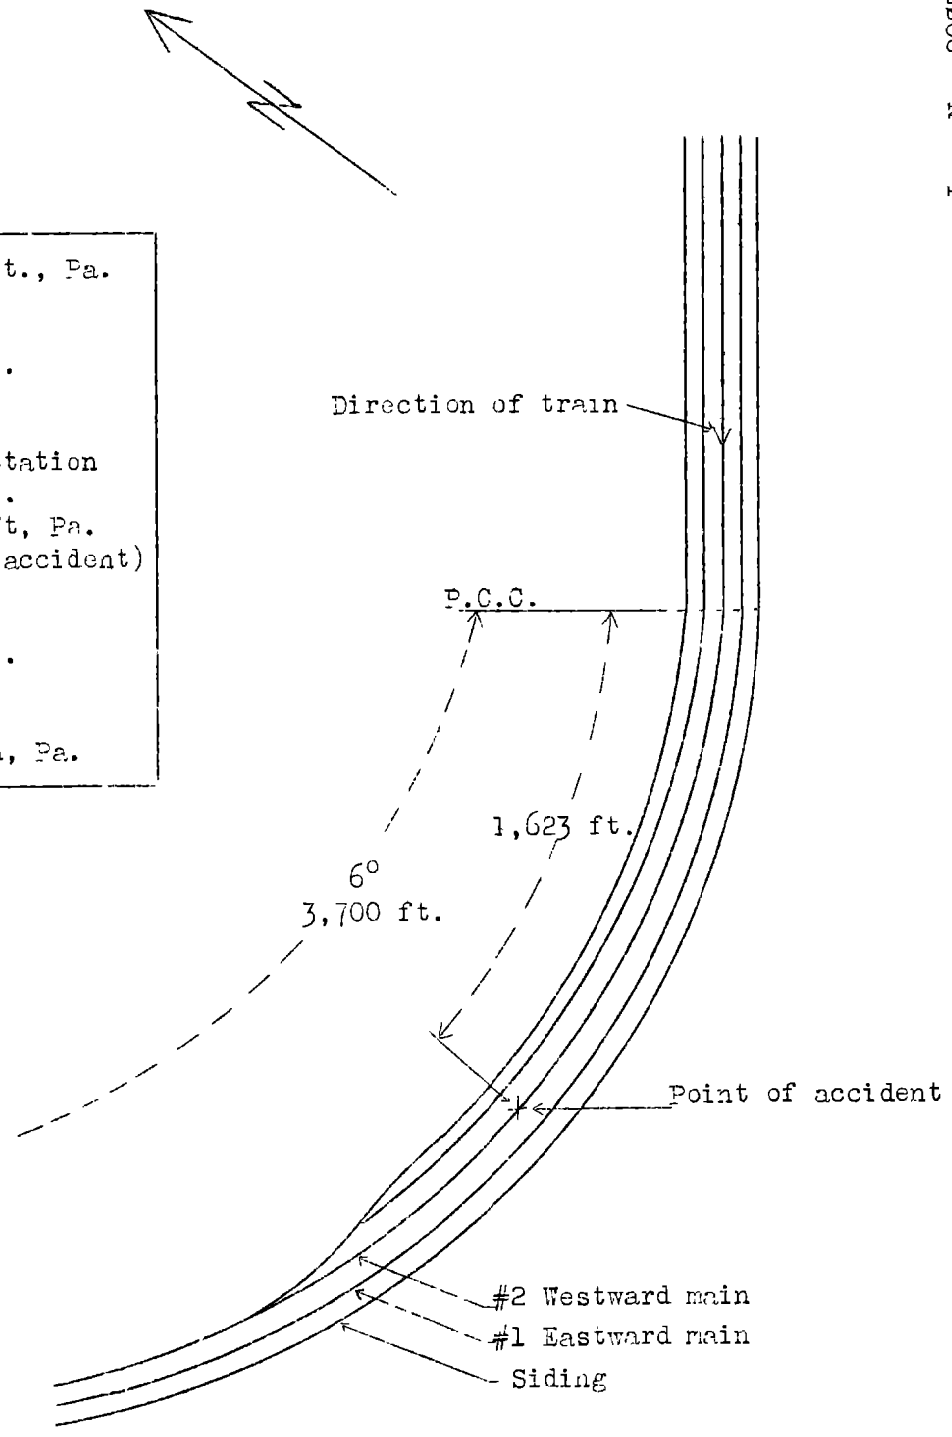
Inv. No. 2085
Pennsylvania Railroad
Vandergrift, Pa.
July 21, 1936

The indications were that the leading pair of engine-truck wheels were the first to be derailed; when they struck the frog of the trailing-point switch of the auxiliary tracks, the engine, tender, and first 9 cars were derailed, obstructing both main tracks and the siding; 4 other cars farther back in the train were also derailed and damaged. The engine stopped on its left side on the eastward main track, with its front end 295 feet west of the switch frog. The employee killed was the fireman, while the employees injured were the engineman and head brakeman.

The investigation developed that a piece of strap iron, found on the ties on the outside of the high rail of the curve, measuring $8\frac{1}{2}$ " x $1-7/8$ " x $\frac{1}{2}$ ", had been placed on top of the rail by a 12-year old boy who was arrested and confessed to having placed the iron on the track.

This accident was caused by a piece of iron having been placed on the track by a 12-year old boy.
