ERIE RAILROAD

DECATUR, IND.

FEBRUARY 14, 1937

INVESTIGATION NO. 2147

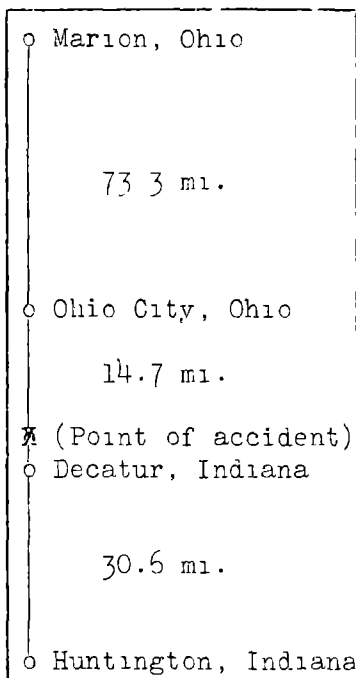
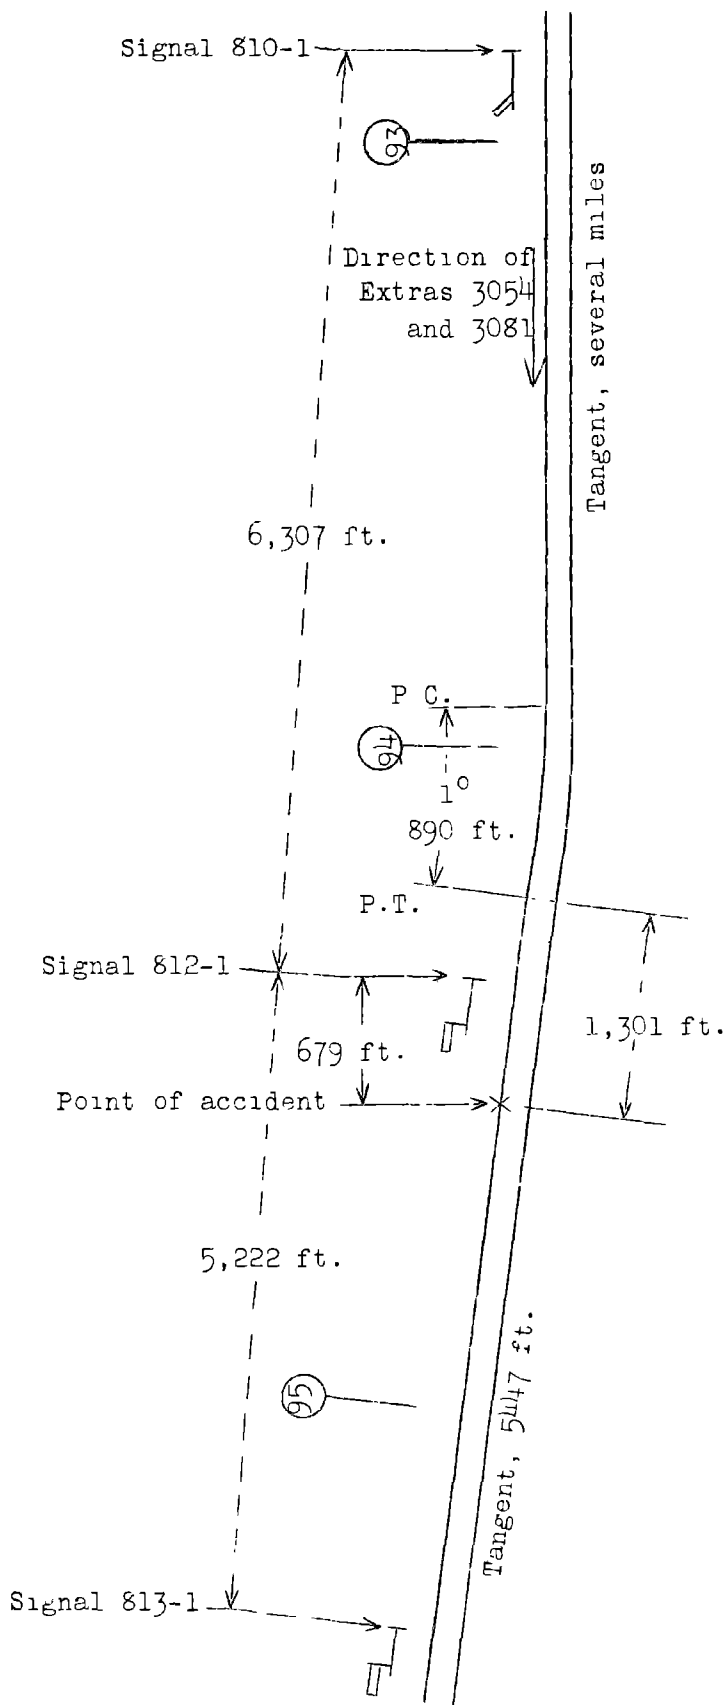
Inv. No. 2147  
Erie Railroad  
Decatur, Ind.  
Feb. 14, 1937

The signals involved are automatic signals 810-1 and 812-1. These are 3-position, upper quadrant, semaphore signals showing green, yellow or red, for proceed, approach, and stop and proceed, respectively. Signals 810-1 and 812-1 are located 6,986 feet, and 679 feet, respectively, east of the point of accident. To the Engineman of a west-bound train an unobstructed view of signal 812-1 is restricted to 1,581 feet, because of a telegraph line, with poles spaced 125 feet apart, which parallels the tracks at a distance of 40 feet from the center of the west-bound track, but between points 2,681 feet and 1,681 feet east of that signal it is visible through the spaces between the poles. The maximum distance at which this signal can be seen by the fireman of a west-bound train is 1,031 feet.
