REPORT OF THE DIRECTOR
BUREAU OF SAFETY

ACCIDENT ON THE
ILLINOIS CENTRAL RAILROAD
AND THE
CHICAGO, MILWAUKEE, ST. PAUL & PACIFIC RAILROAD

CHARLES CITY, IOWA

INVESTIGATION NO. 2329

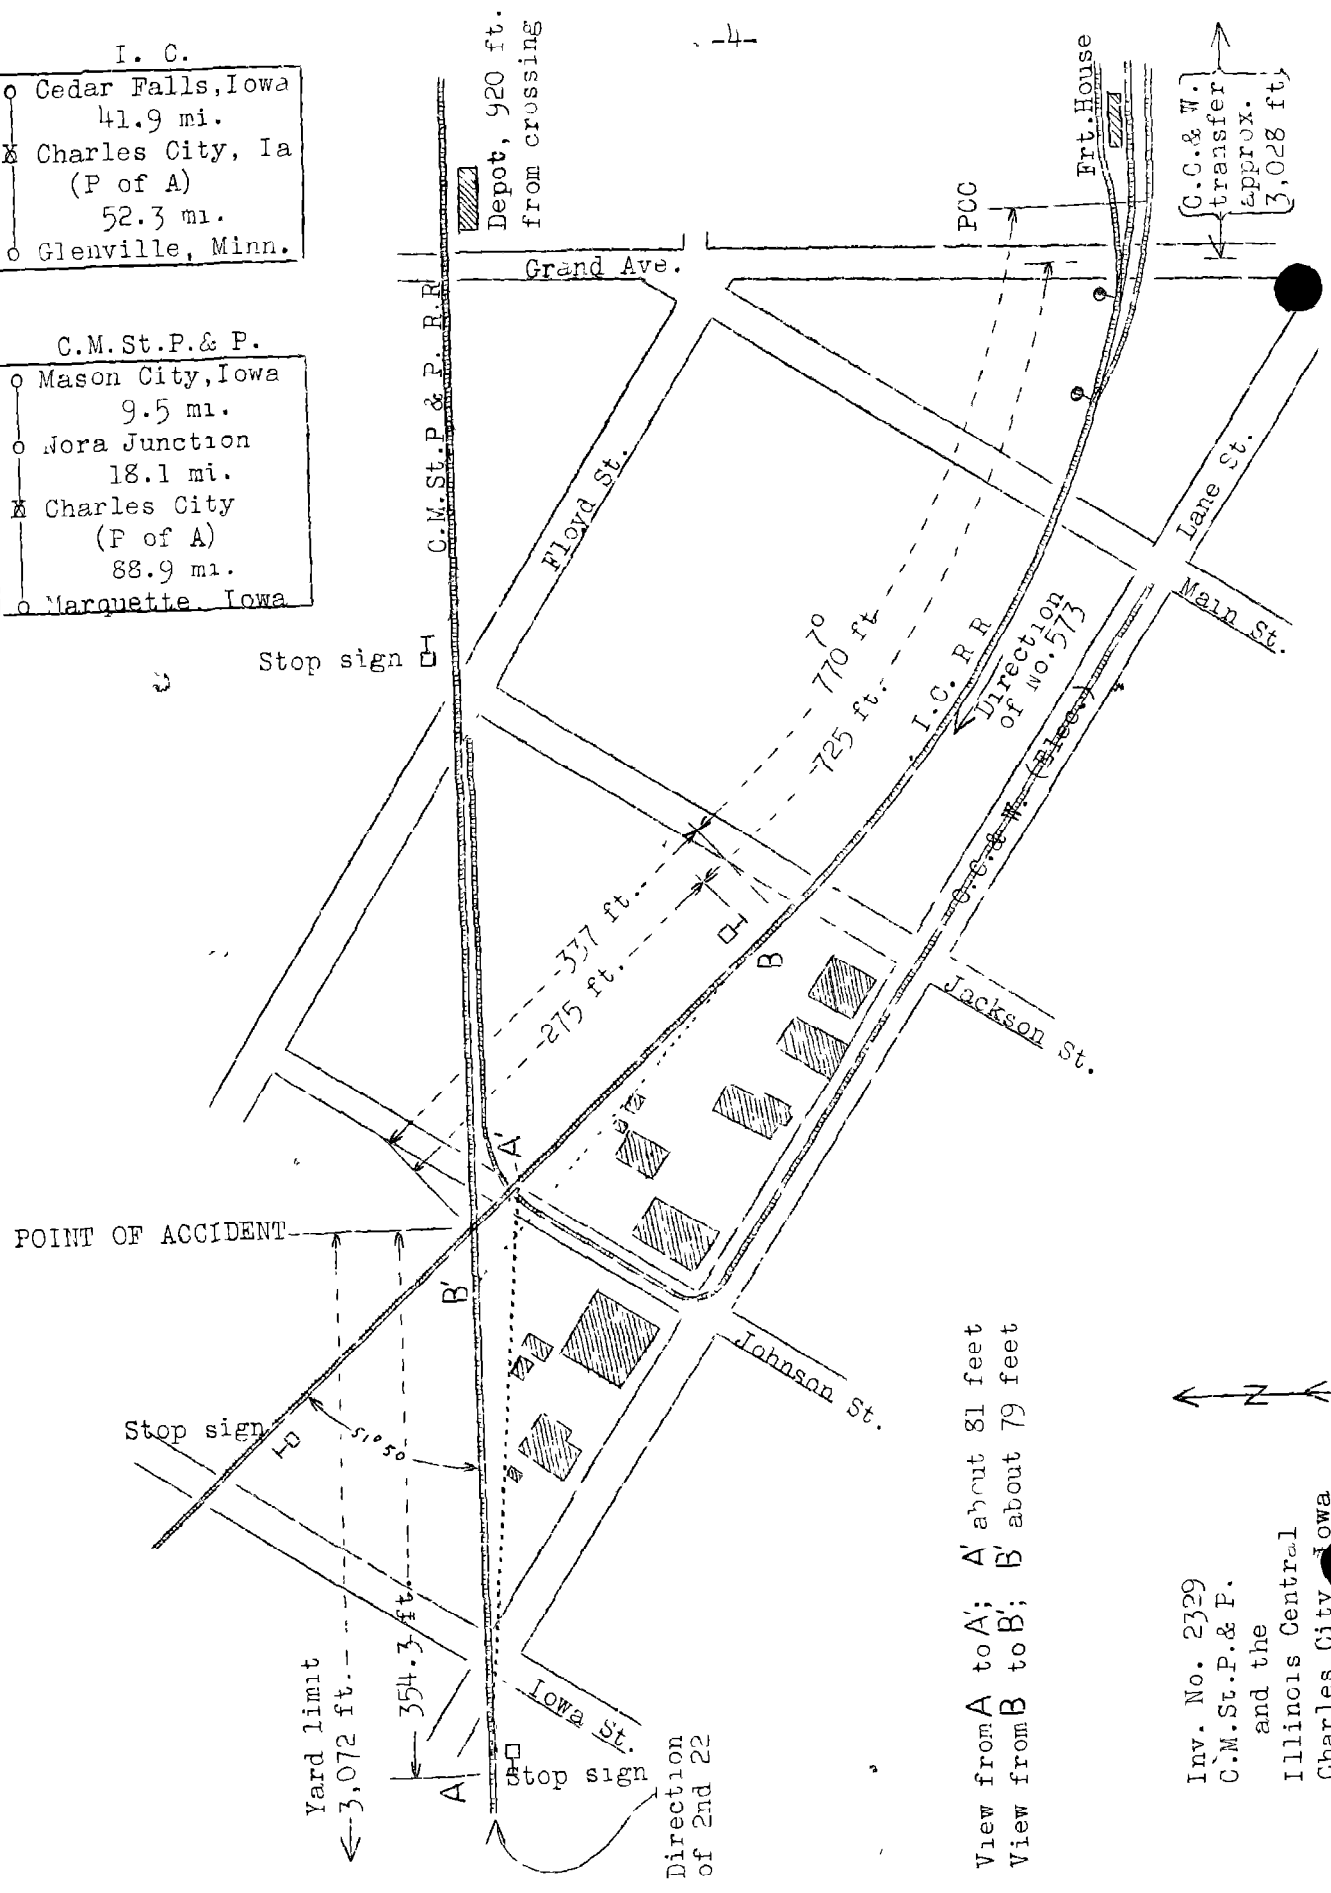
Inv. No. 2329
 C.M. St. P. & P.
 and the
 Illinois Central
 Charles City, Iowa
 February 9, 1909

View from A to A'; A' about 81 feet
 View from B to B'; B' about 79 feet

The crossings are situated in a residential section and buildings restrict the view from the fireman's side of an I.C. engine, with its pilot opposite the I.C. stop board, to a distance of 78.5 feet west of the center-line of the C.M.St.P.& P. crossing, and the view from the engineman's side of a C.M.St.P. & P. east-bound engine standing with its pilot opposite the C.M. St.P.& P. stop board is restricted to 81 feet east of the center-line of the crossing on the I.C. track.
