INTERSTATE COMMERCE COMMISSION

ACCIDENT ON THE

ALTON RAILROAD

INVESTIGATION NO. 2342

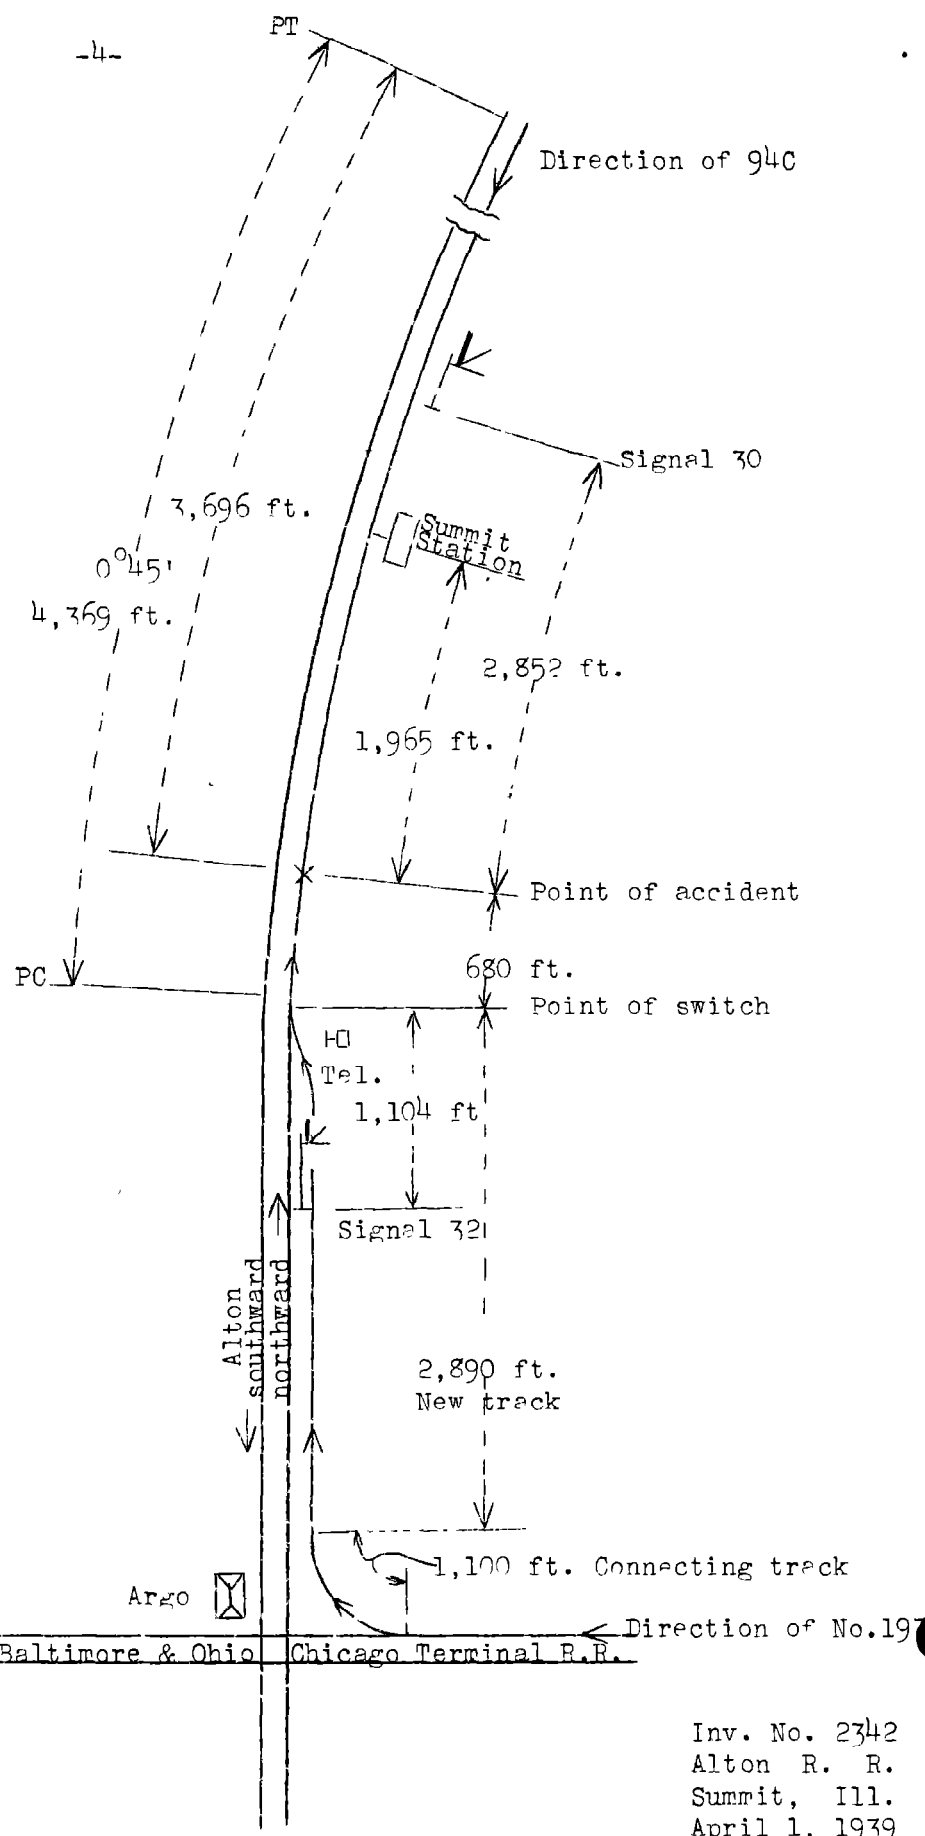
Inv. No. 2342  
 Alton R. R.  
 Summit, Ill.  
 April 1, 1939

○	Chicago, Ill.
	10.3 mi.
○	Glenn
	1.6 mi.
○	Summit
	0.38 mi.
X	Point of accident
	0.82 mi.
○	Argo, Ill.
