ACCIDENT ON THE  
PENNSYLVANIA RAILROAD

PHILADELPHIA, PA.

OCTOBER 13, 1939

INVESTIGATION NO. 2387

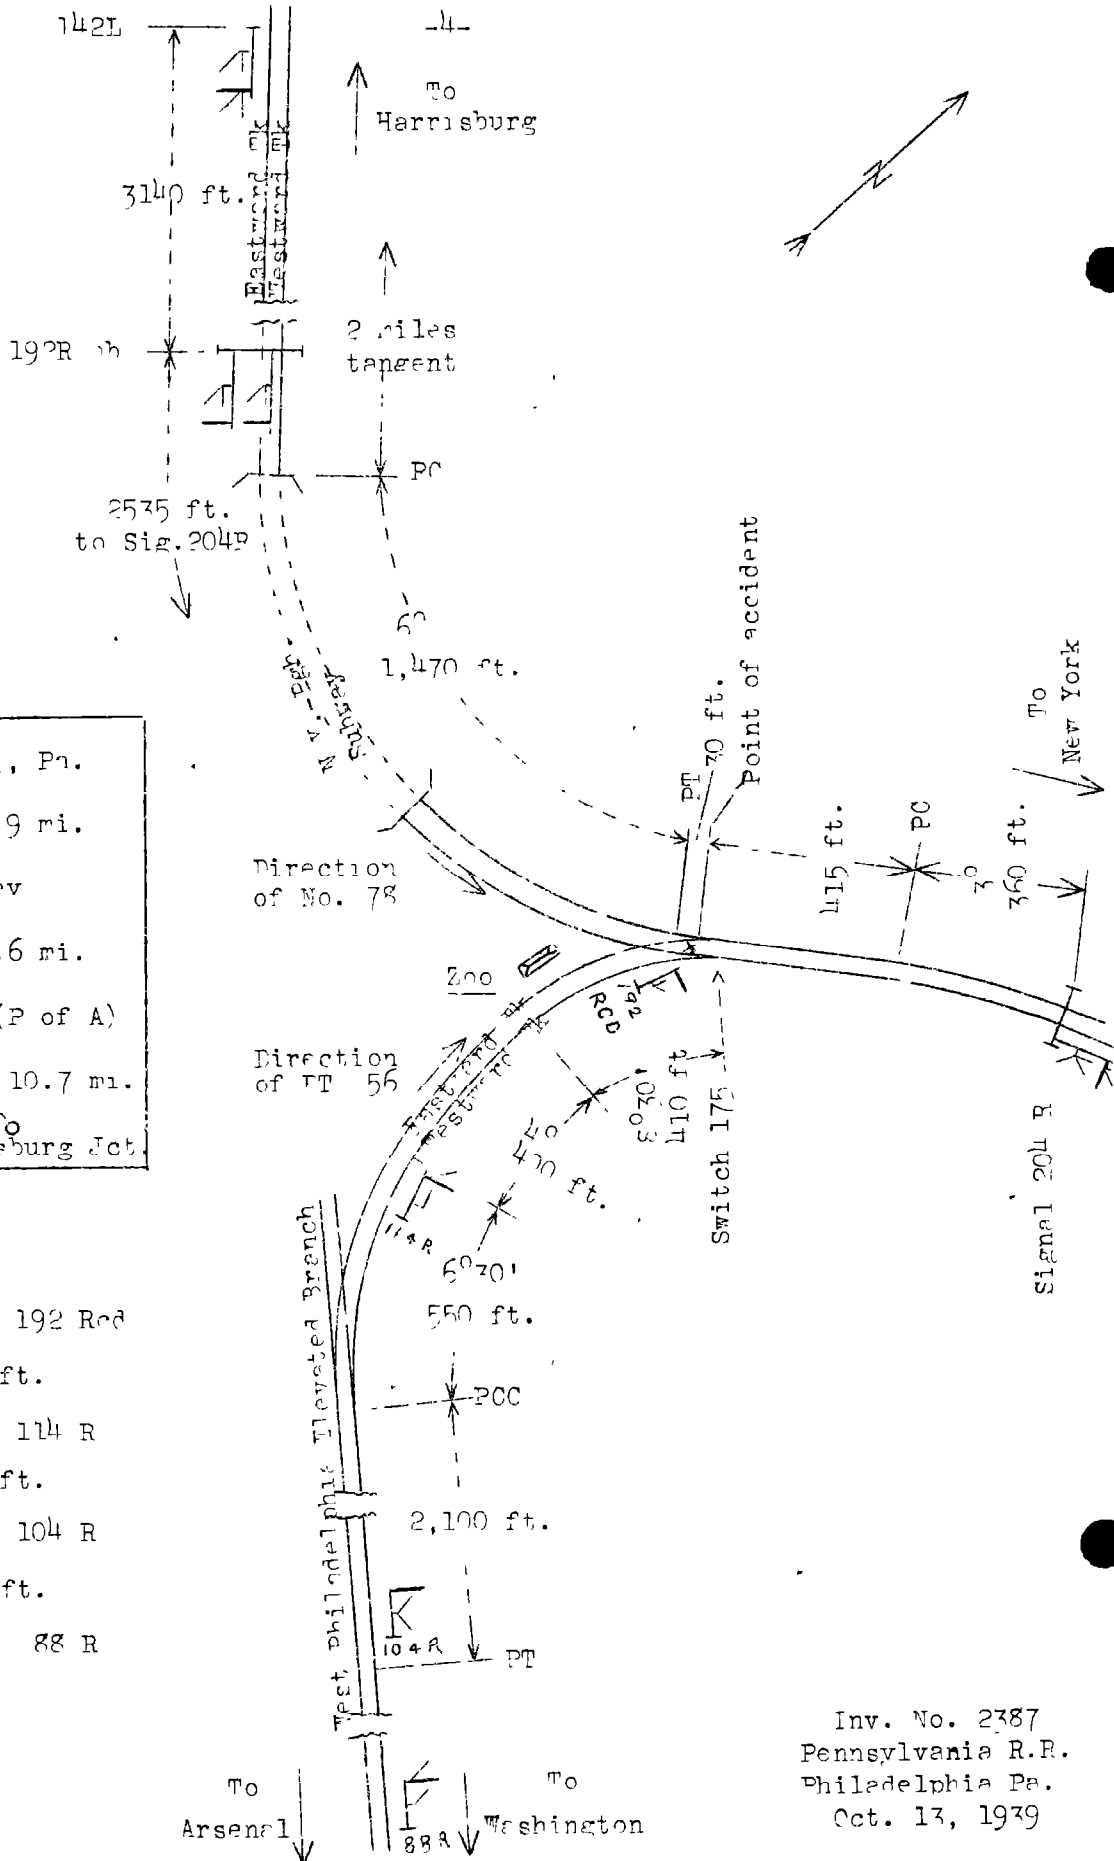
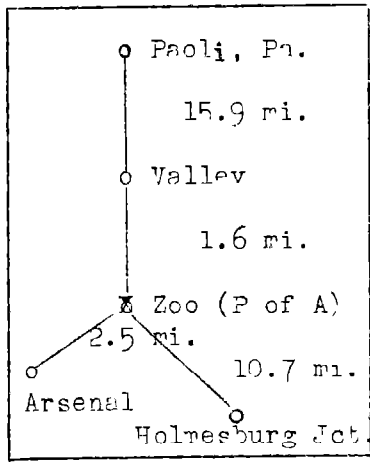
Inv. No. 2387  
 Pennsylvania R.R.  
 Philadelphia Pa.  
 Oct. 13, 1939

- Signal 192 Red  
765 ft.
- Signal 114 R  
1400 ft.
- Signal 104 R  
1894 ft.
- Signal 88 R
