INVESTIGATION NO. 2675
THE NEW YORK CENTRAL RAILROAD COMPANY
REPORT IN RE ACCIDENT
AT UTICA, N. Y., ON
FEBRUARY 13, 1943

Railroad: New York Central
Date: February 13, 1943
Location: Utica, N. Y.
Kind of accident: Derailment
Train involved: Freight
Train number: Extra 2774 East
Engine number: 2774
Consist: 81 cars, caboose
Speed: 25-30 m. p. h.
Operation: Automatic block-signal and
automatic train-stop system
Track: 4; 1°02' left curve;
practically level
Weather: Snowing
Time: About 5:50 p. m.
Casualties: 1 killed; 3 injured
Cause: Accident caused by a broken
truck side-frame

Accident at Utica, N. Y., on February 13, 1943, caused by
a broken truck side-frame.

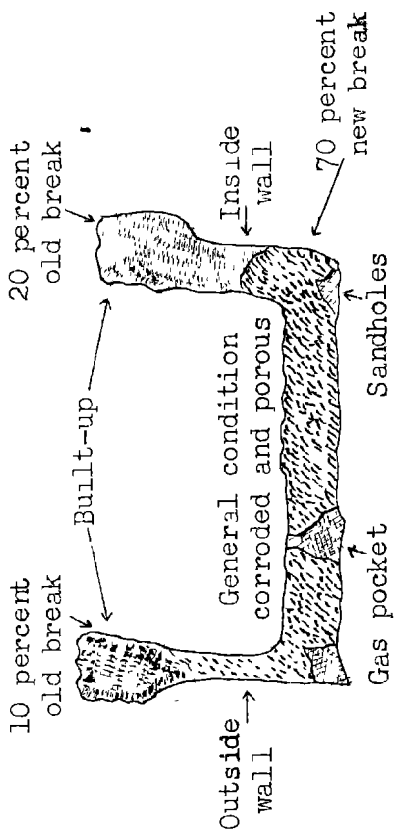
Cross section of tension member

After the accident the right side-frame was found to be broken through the compression member and the tension member at points, respectively, 20-3/8 inches and 8-1/8 inches ahead of the center-line of the rear journal box. The fracture in the compression member was new and there was no evidence of defective metal. The fracture in the tension member was 10 percent old break through the outside wall and 20 percent through the inside wall.

porosity present. The fracture through the compression member was new, but 10 percent of the cross-sectional area of the outside wall of the tension member and 20 percent of the inside wall were old breaks. The fracture of the tension member occurred 8-1/2 inches ahead of the center-line of the rear journal box. The old fracture extended from the beaded edge downward 1-5/8 inches in the outside wall and 1-5/4 inches in the inside wall. The fracture of the bottom part was new; however, sand holes were present and a gas pocket, which was 1/8 inch wide at the top and 3/8 inch wide at the bottom, extended throughout this member 1-1/2 inches inward from the outer surface. Areas adjacent to the fracture of the tension member indicated that welding had produced added cross-sectional area to the beading and that the old fractures had originated in this built-up portion. Near the front journal-box, several cracks were found in the beaded portion of the tension member but there was no evidence of fracture at these points. Throughout the side-frame considerable oxidation existed and fractures that had not opened could not be detected by ordinary inspection.
