INVESTIGATION NO. 2861
THE BALTIMORE & OHIO RAILROAD COMPANY
REPORT IN RE ACCIDENT
AT CARROLL, MD., ON
JANUARY 17, 1945

Accident at Carroll, Md., on January 17, 1945, caused by
failure to obey an interlocking signal indication.

Inv. No. 2861
 Baltimore & Ohio Railroad
 Carroll, Md.
 January 17, 1945

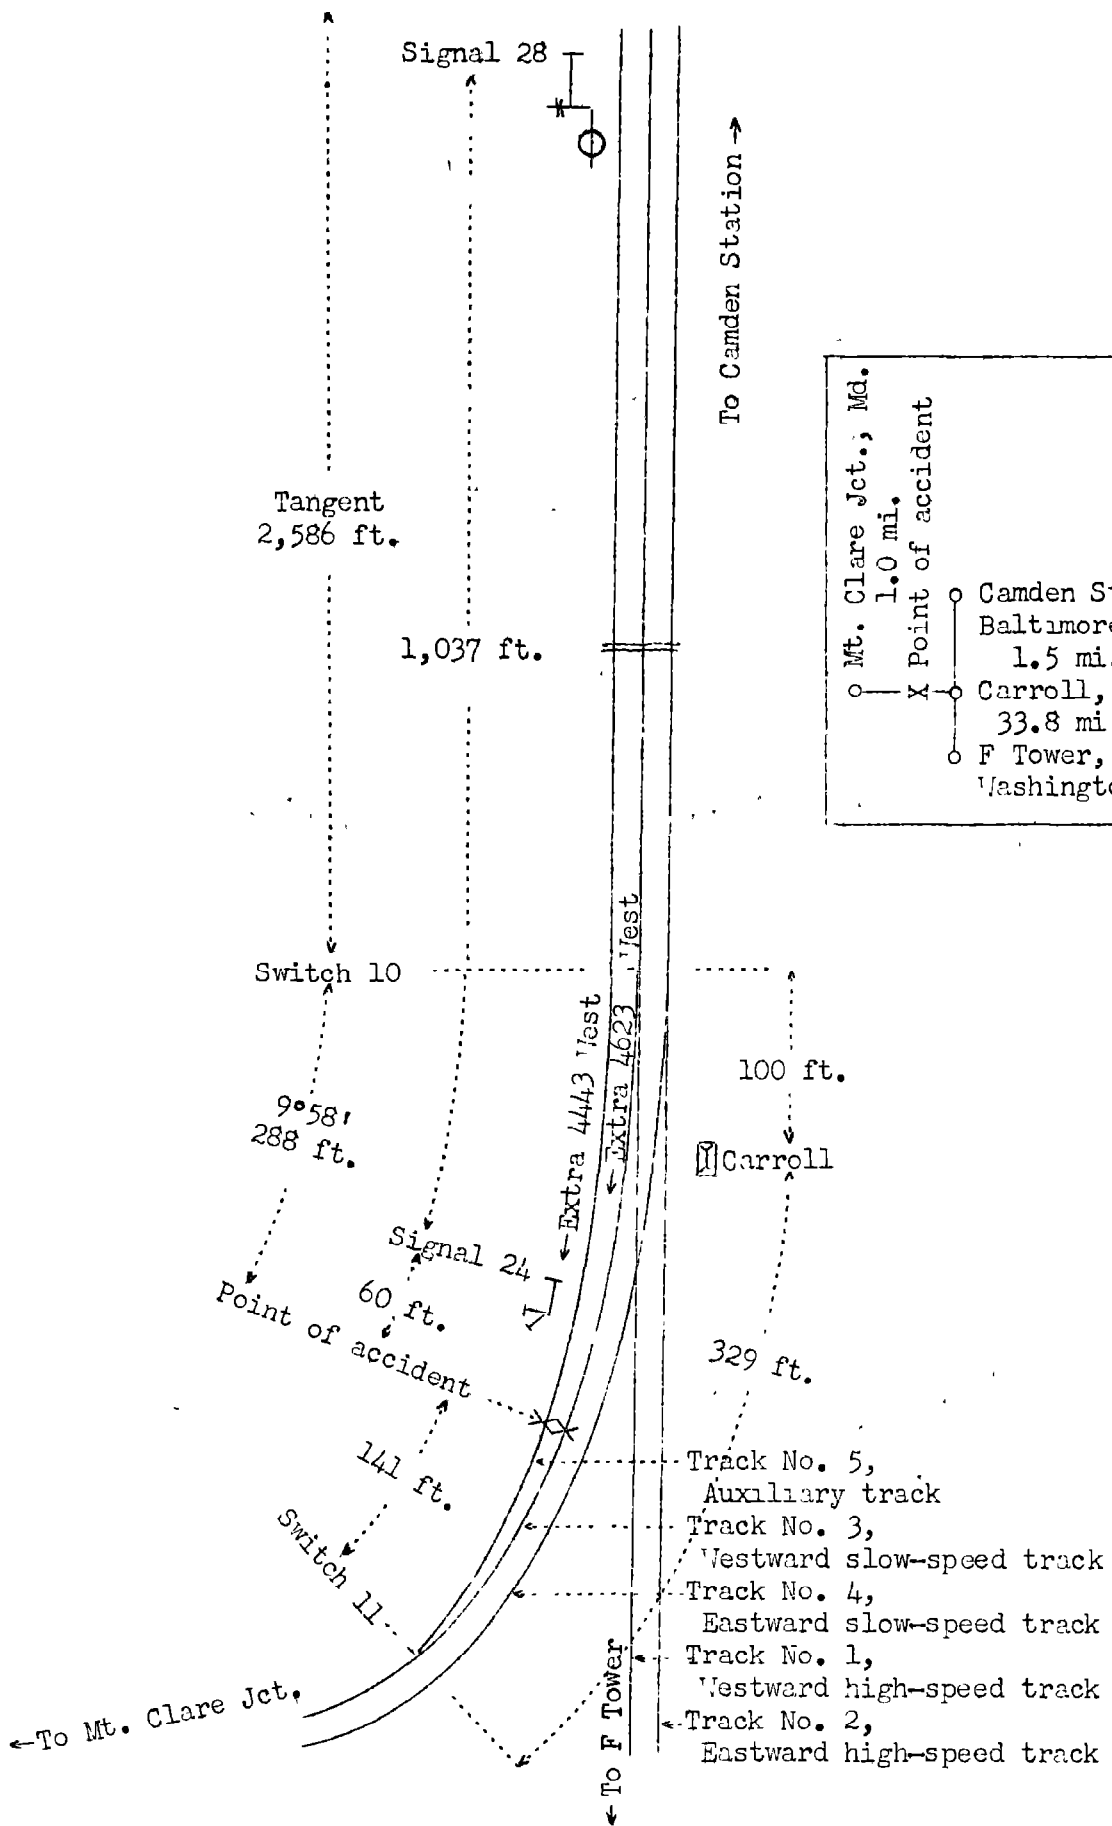
This accident occurred on that part of the Baltimore Terminal Division extending northward from Carroll to Mt. Clare Jct., Md., 1 mile. This was a double-track line. Within interlocking limits at Carroll this line converged with a double-track line extending westward from Camden Station, Baltimore, Md., to F Tower, near Washington, D. C., 35.3 miles. Time-table directions were eastward and westward for both lines. Hereinafter, time-table directions will be used in this report. The main tracks extending between Carroll and Mt. Clare Jct. were designated, from north to south, as track No. 3, westward slow-speed track, and track No. 4, eastward slow-speed track. The main tracks extending between Camden Station and F Tower were designated, from north to south, as track No. 1, westward high-speed track, and track No. 2, eastward high-speed track. In the vicinity of Carroll an auxiliary track, hereinafter referred to as track No. 5, paralleled track No. 3 on the north. Switch 10, which connected tracks No. 1 and No. 3, and switch 11, which connected tracks No. 3 and No. 5, were, respectively, 100 feet east and 329 feet west of the tower. The accident occurred at the fouling point of track No. 3 and the turnout of track No. 5, at a point 141 feet east of switch 11. From the east track No. 1 was tangent 2,586 feet to switch 10, and beyond this switch on track No. 3 there was a 9°58' curve to the right 288 feet to the point of accident. The grade was practically level.

Interlocking signal 28, governing west-bound movements from track No. 1 through switch 10 to track No. 3, and interlocking signal 24, governing movements from track No. 5 through switch 11 to track No. 3, were, respectively, 1,097 feet and 60 feet east of the point of accident. Signal 28 was of the color-position-light type, and signal 24 was a dwarf signal of the one-arm, upper-quadrant, semaphore type. The involved aspects and corresponding indications and names of these signals were as follows:

Extra 4443 West, a west-bound engine headed eastward, stopped on track No. 5 in the vicinity of the tower at Carroll about 7:29 a. m. About 3 minutes later, while moving westward on track No. 5 at an estimated speed of 3 miles per hour, this engine passed signal 24, which displayed stop, entered the turnout of switch 11 and was struck by Extra 4623 West.

Extra 4623 West, a west-bound freight train, consisted of engine 4623, 35 cars and a caboose. This train passed Camden Station at 7:25 a. m., passed signal 28, which displayed slow-approach, entered track No. 3 at switch 10 and while moving at an estimated speed of 10 miles per hour it struck Extra 4443 West.
