INVESTIGATION NO. 2919

THE ATCHISON, TOPEKA AND SANTA FE
RAILWAY COMPANY

THE BALTIMORE AND OHIO CHICAGO TERMINAL
RAILROAD COMPANY

REPORT IN RE ACCIDENT

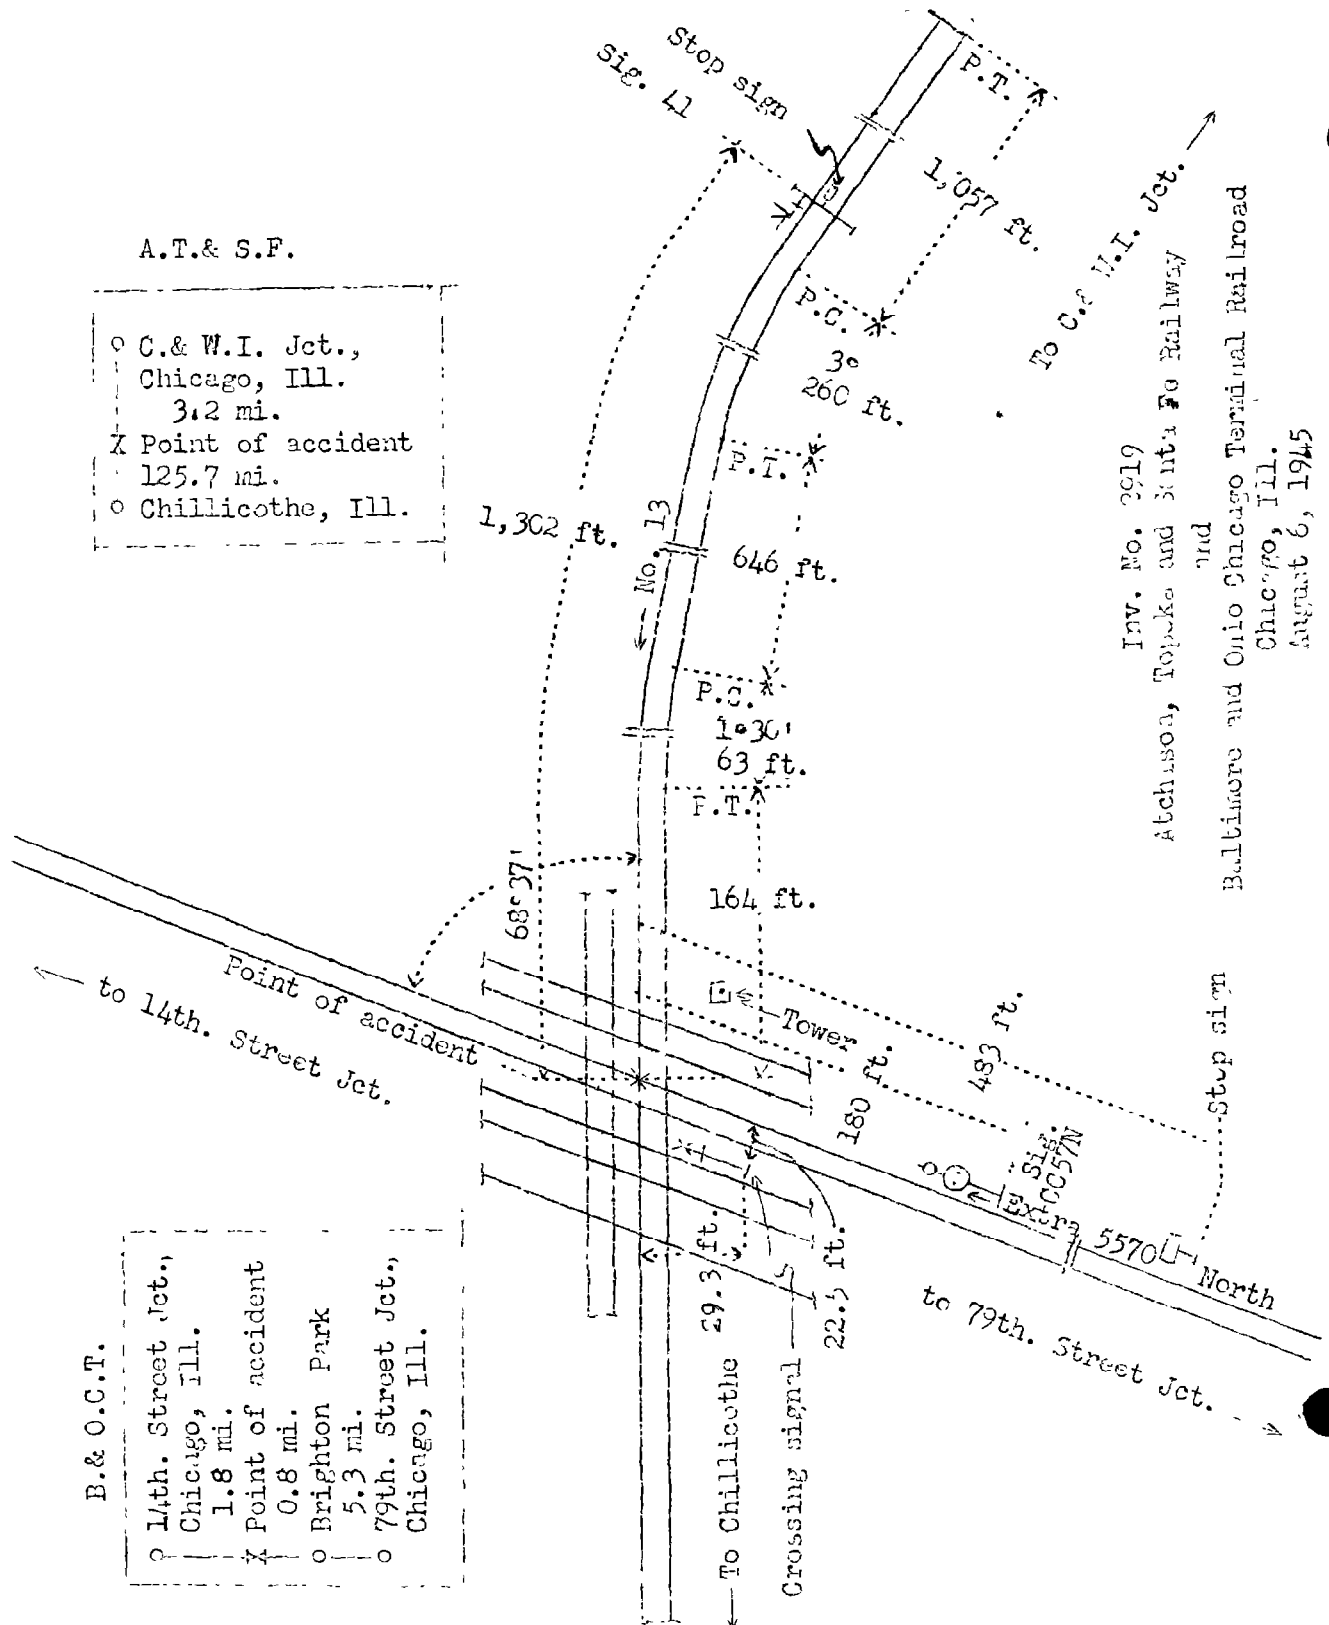
Inv. No. 2919

This accident occurred at an intersection of a line of the Atchison, Topeka and Santa Fe Railway and the Baltimore and Ohio Chicago Terminal Railroad, hereinafter referred to, respectively, as the A.T. & S.F. and the B. & O.C.T. The crossing is located on that part of the Illinois Division of the A.T. & S.F. designated as the First District and extending westward from C. & W.I. Jct., Chicago, to Chillicothe, Ill., 128.9 miles, and on that part of the B. & O.C.T. extending northward from 79th Street Jct. to 14th Street Jct., Chicago, 7.9 miles. The crossing is 3.2 miles west of C. & W.I. Jct. and 6.1 miles north of 79th Street Jct. In the vicinity of the point of accident both are double-track lines, over which trains moving with the current of traffic are operated by signal indications. Trains of the Baltimore and Ohio Railroad, hereinafter referred to as the B. & O., are regularly operated over the line of the B. & O.C.T. At the crossing the main tracks of the A.T. & S.F. and two tracks of another line intersect the main tracks of the B. & O.C.T. and five tracks of two other lines at an angle of 68°37'. The accident occurred at the intersection of the westward main track of the A.T. & S.F. and the northward main track of the B. & O.C.T. From the east on the A.T. & S.F. there are, in succession, a tangent 1,057 feet in length, a 3° curve to the left 260 feet, a tangent 646 feet, a 1°30' curve to the left 63 feet, and a tangent 164 feet to the point of accident and a considerable distance westward. The grade is 0.13 percent descending westward. The B. & O.C.T. main tracks are tangent throughout a considerable distance immediately south of the crossing and some distance northward. The grade is 0.08 percent descending northward.

Movements over the crossing on either line are governed by a four-arm two-position semaphore-type signal mounted on a mast located 29.3 feet south and 22.5 feet west of the intersection of the A.T. & S.F. westward main track and the B. & O.C.T. northward main track. The semaphore arms governing east-bound and west-bound movements over the crossing are 24 feet 8 inches above the tops of the rails, and the semaphore arms governing north-bound and south-bound movements are 33 feet 1 inch above the tops of the rails. The signal is in the charge of an operator-leverman and is controlled from a tower located in the southeast angle of the intersection. The involved day aspects and corresponding indications of the signal are as follows:

Automatic signal 41, governing west-bound movements on the A.T. & S.F. westward main track, is located on an overhead bridge 1,302 feet east of the point of accident. This signal is of the three-position, upper-quadrant, semaphore type, and is approach lighted. Automatic signal CC57N, governing north-bound movements on the B. & O.C.T. northward main track is 180 feet south of the point of accident. This signal is of the color-position-light type and is approach lighted. The involved aspects, indications and names of these signals are as follows:

Stop signs governing west-bound movements on the A.T. & S.F. and north-bound movements on the B. & O.C.T. are, respectively, 1,304 feet east and 483 feet south of the crossing.
